## APPENDIX F PHOTOGRAPHIC RECORD

### PHOTOGRAPHIC LOG

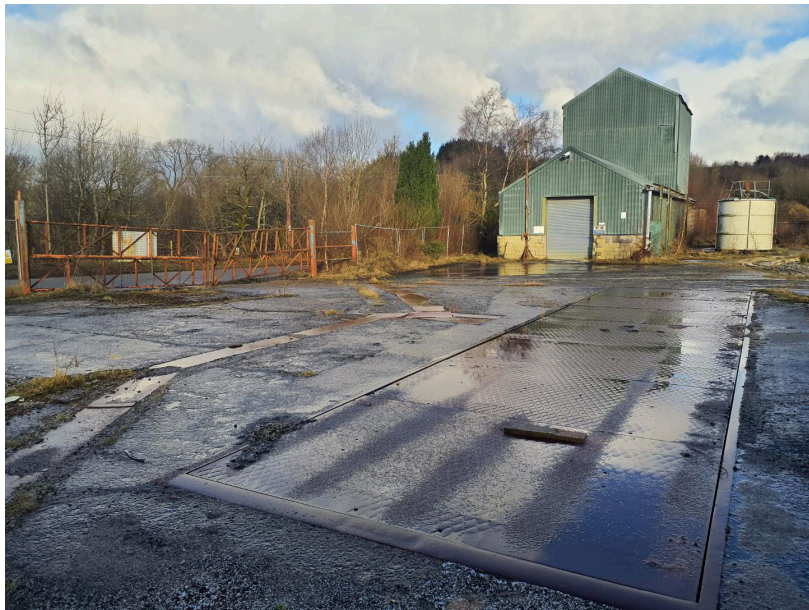
| 1 | 30/01/25 |

Main access gate, hardstanding, AST and northern shed.

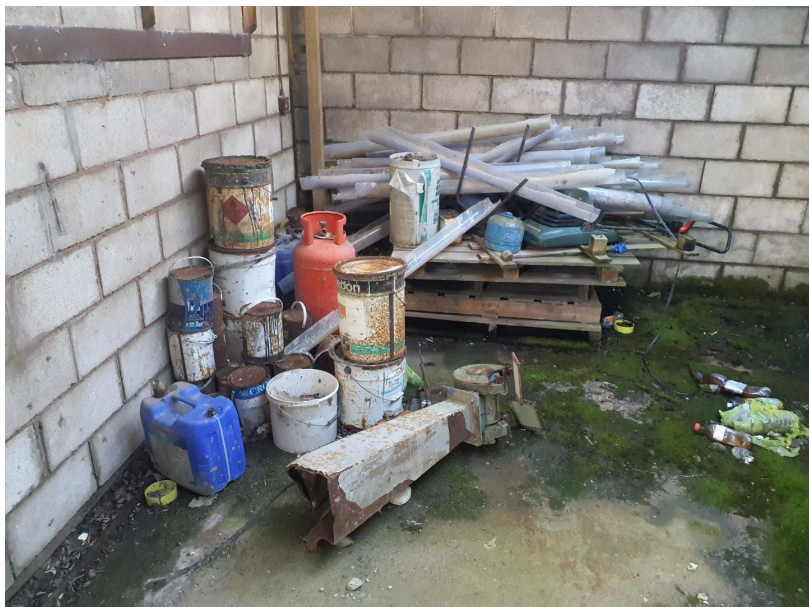
| 2 | 30/01/25 |

Paint tins, some labelled flammable and gas cylinder within southern building.

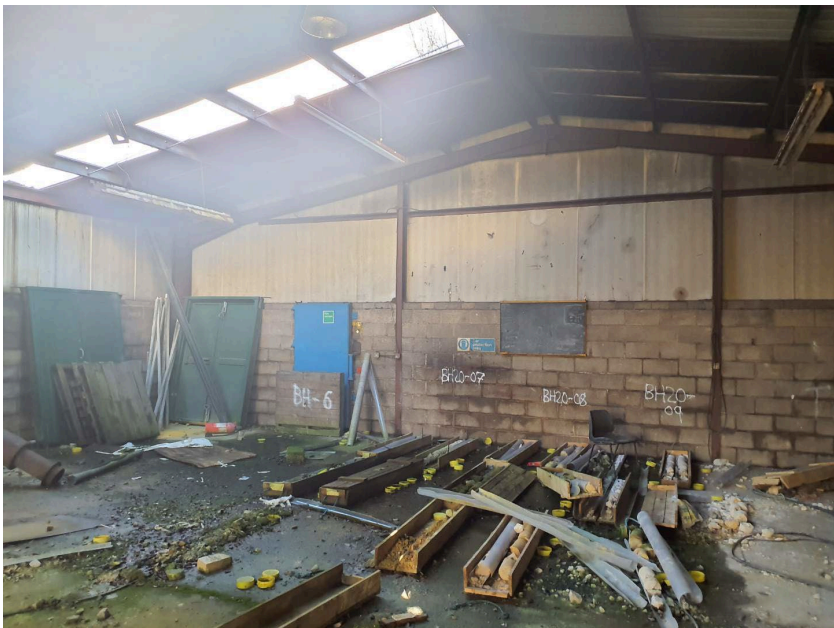
| <b>Photo No.</b><br><br>3 | <b>Date:</b><br><br>30/01/25 | |

| <b>Description:</b><br><br>Evidence of previous site investigation (inc. rock cores, liners and boxes) and damaged roof within southern building.<br><br>View: south | | |

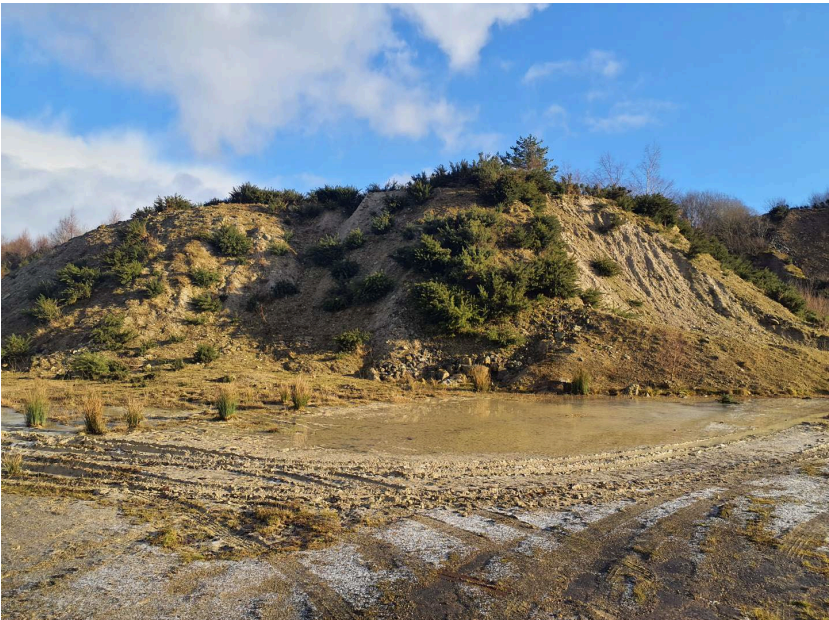
| <b>Photo No.</b><br><b>4</b> | <b>Date:</b><br>30/01/25 | |

| <b>Description:</b><br>Spoil heap located north-east of hardstanding and sheds.<br>View: north-east | | |

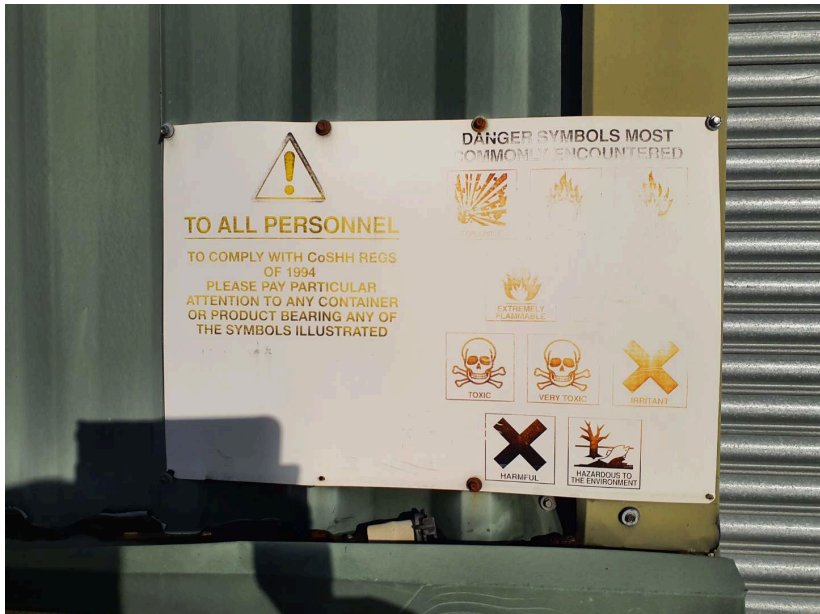
| <b>Photo No.</b><br><br><b>5</b> | <b>Date:</b><br><br><b>30/01/25</b> |

| <b>Description:</b><br><br>COSHH warning sign on northern shed.<br><br>View: north | |

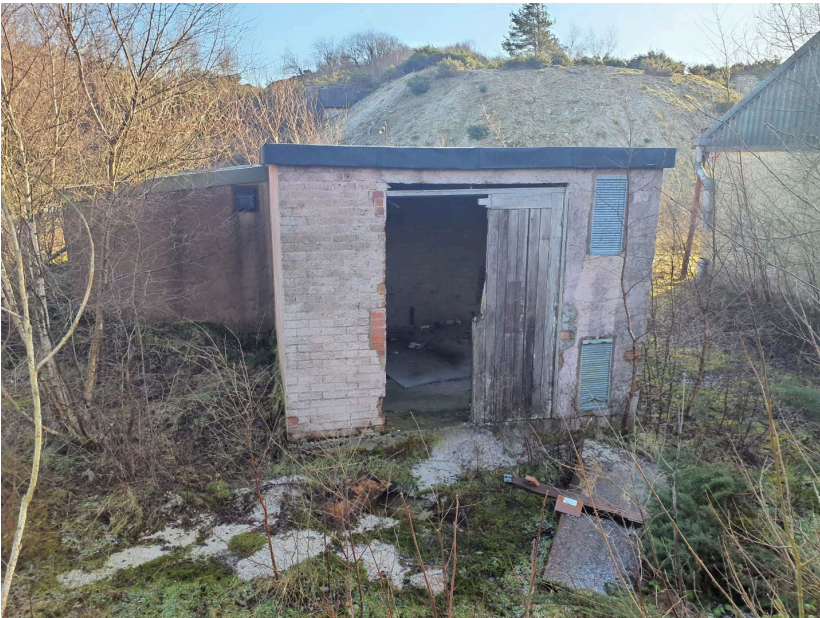
| <b>Photo No.</b><br><b>6</b> | <b>Date:</b><br><b>30/01/25</b> | |

| <b>Description:</b><br>Site of removed electrical substation beside electric pylon, north of the northern shed.<br><br>View: east | | |

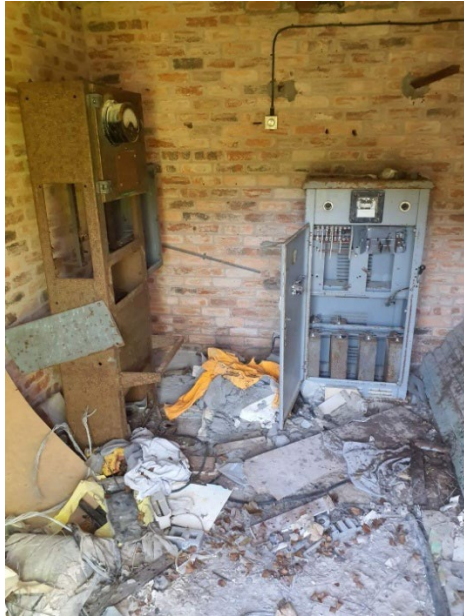
| <b>Photo No.</b><br><br>7 | <b>Date:</b><br><br>30/01/25 | |

| <b>Description:</b><br><br>Electrical infrastructure within previous electrical substation building.<br><br>View: west | | |

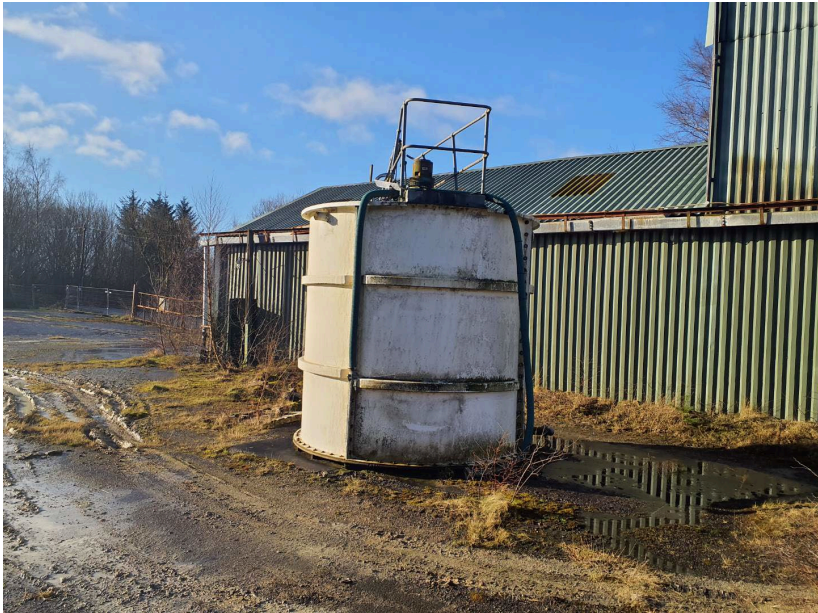
| <b>Photo No.</b><br>8 | <b>Date:</b><br>30/01/25 | |

| <b>Description:</b><br>AST by northern shed.<br><br>View: south-west | | |

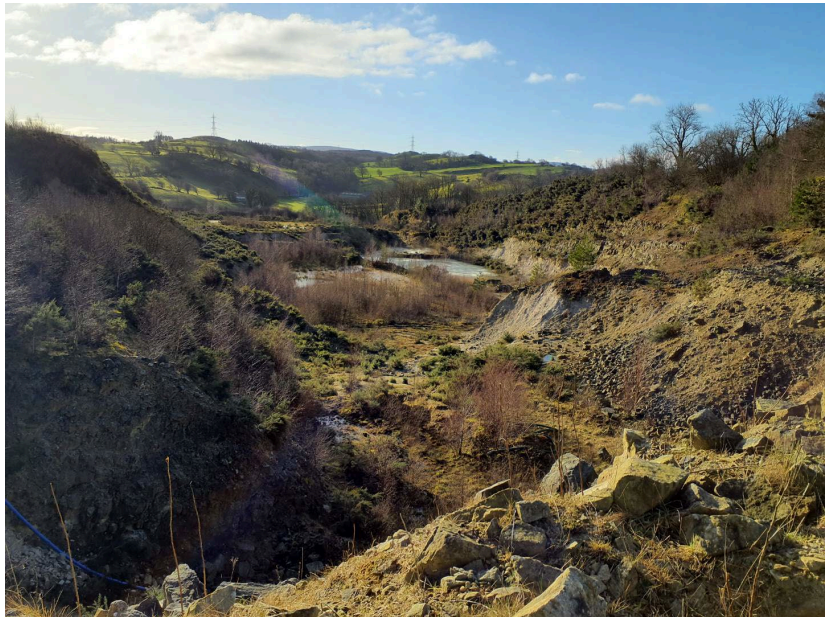
| <b>Photo No.</b><br><br>9 | <b>Date:</b><br><br>30/01/25 | |

| <b>Description:</b><br><br>Main quarried area south-east of sheds.<br><br>View: south | | |

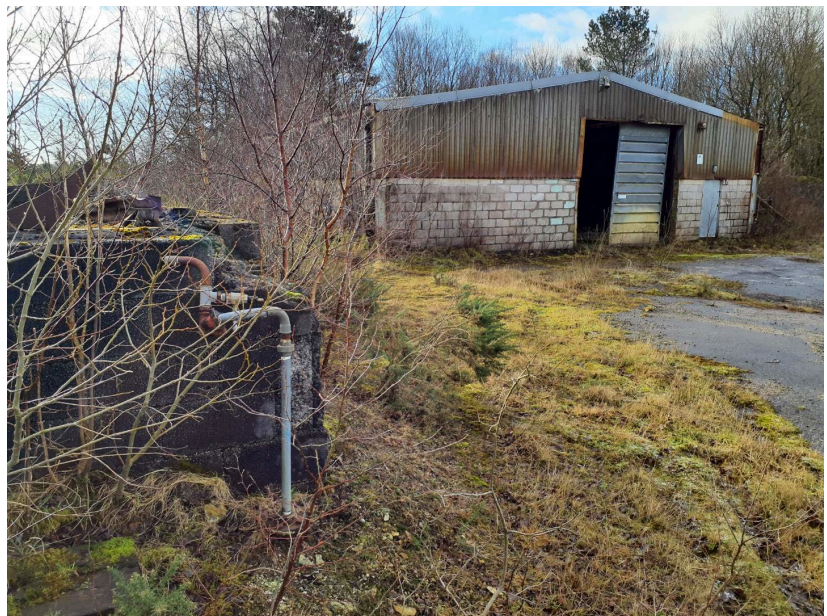
| <b>Photo No.</b><br>10 | <b>Date:</b><br>30/01/25 | |

| <b>Description:</b><br><br>Protruding pipe beside concrete structure with brackets. Potential second previous AST.<br><br>View: south-west | | |

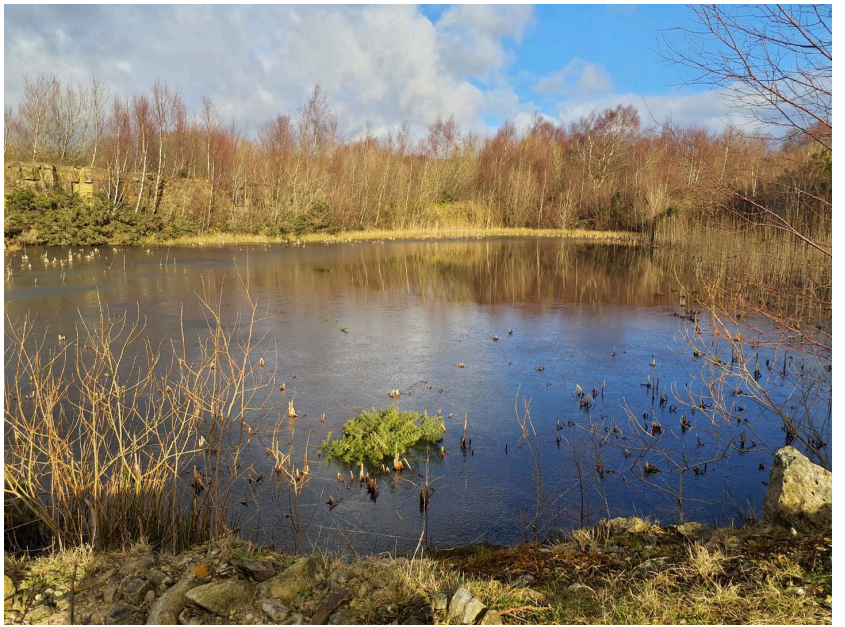
| <b>Photo No.</b><br><br>11 | <b>Date:</b><br><br>30/01/25 | |

| <b>Description:</b><br><br>Largest settling pond. Client rep stated approximately 3-4 m of silt.<br><br>View: north | | |

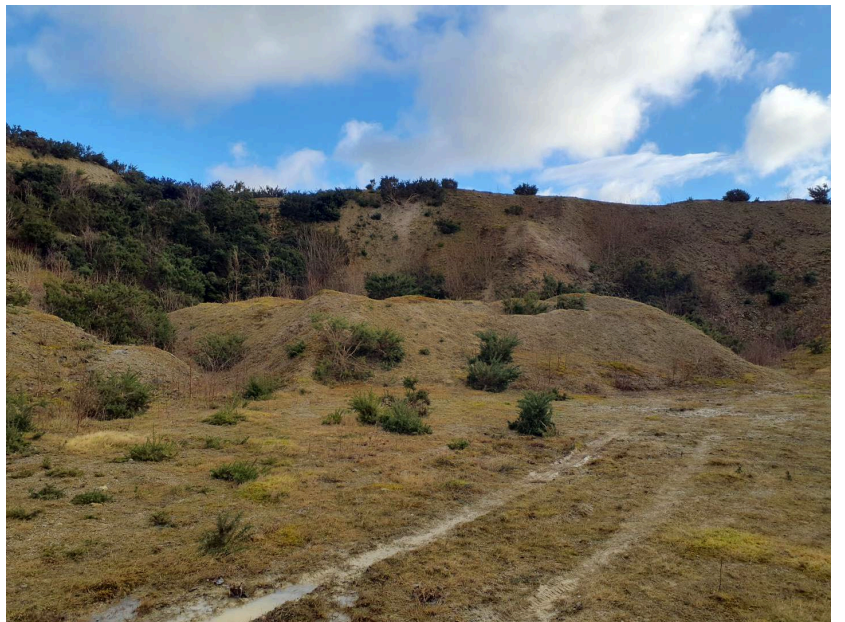
| <b>Photo No.</b><br><br>12 | <b>Date:</b><br><br>30/01/25 | |

| <b>Description:</b><br>North-eastern quarried area.<br>View: east | | |

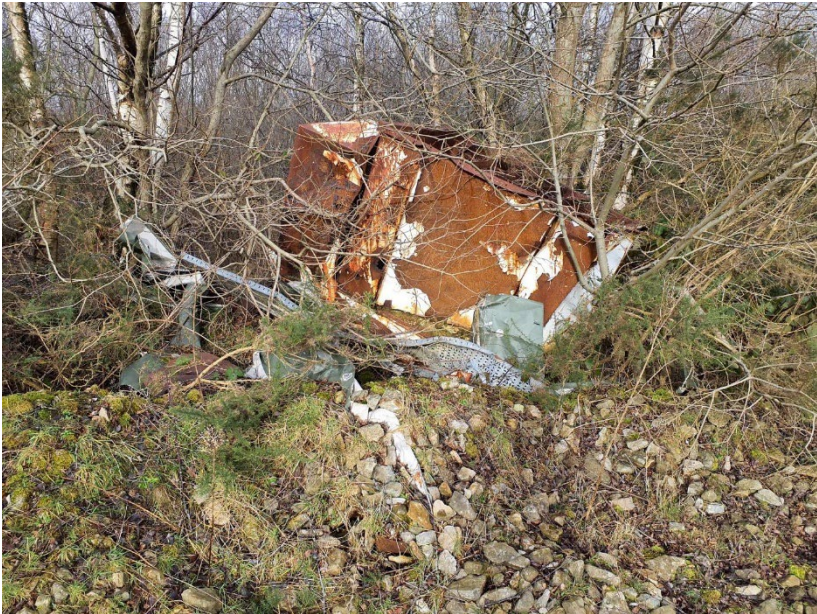
| <b>Photo No.</b><br><br>13 | <b>Date:</b><br><br>30/01/25 | |

| <b>Description:</b><br><br>Metal structure dumped north east of the settling ponds.<br><br>View: north-west | | |

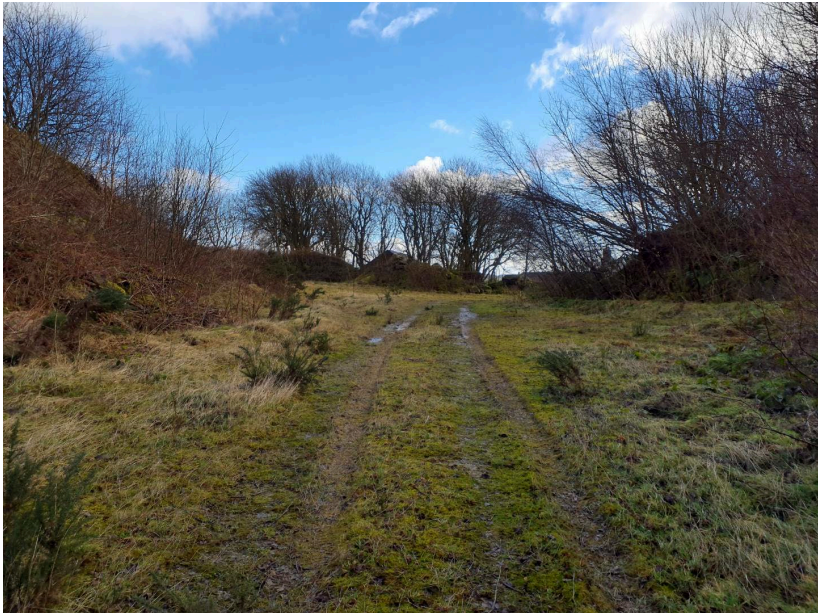
| <b>Photo No.</b><br><b>14</b> | <b>Date:</b><br><b>30/01/25</b> | |

| <b>Description:</b><br>Track toward central east of the southern sector.<br>View: east | | |

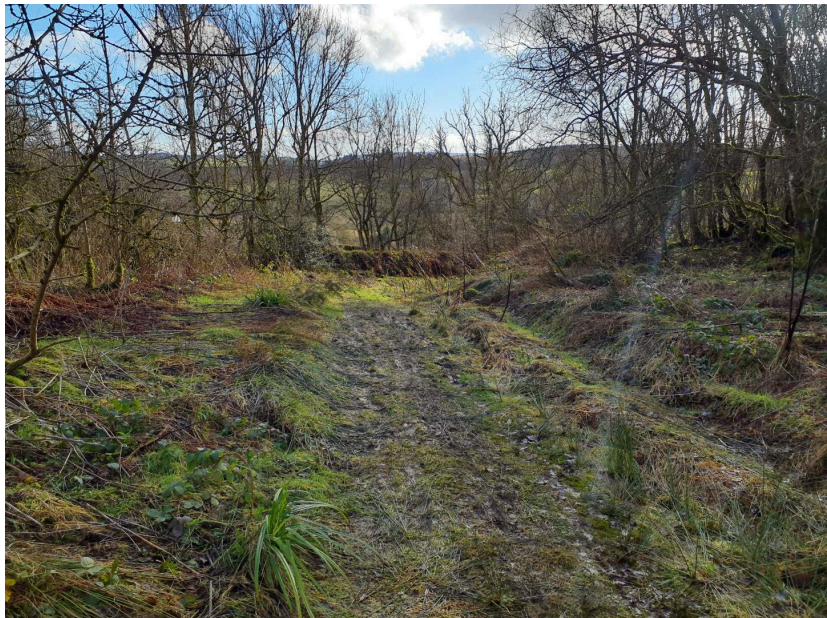
| <b>Photo No.</b><br><b>15</b> | <b>Date:</b><br><b>30/01/25</b> | |

| <b>Description:</b><br>Less defined muddy track down eastern boundary within southern sector.<br><br>View: south-east | | |

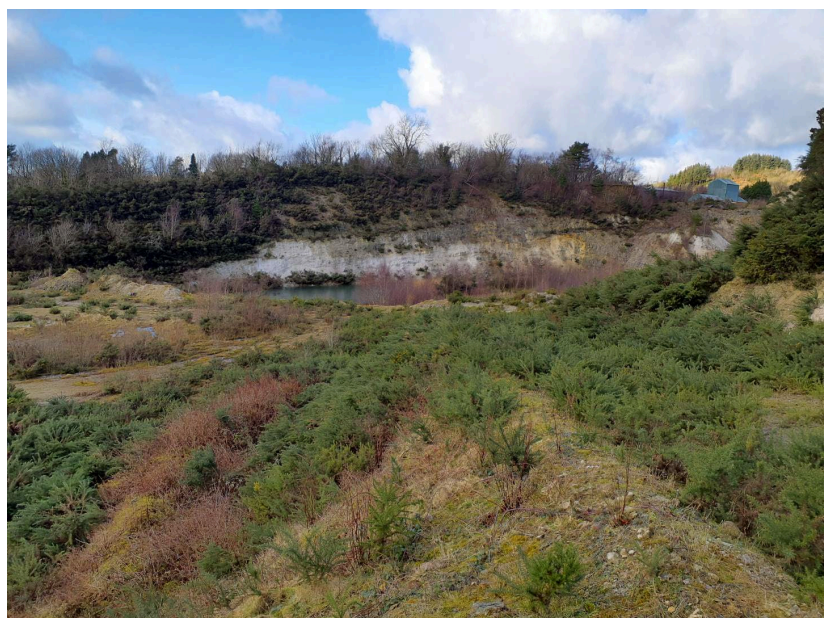
| <b>Photo No.</b><br><b>16</b> | <b>Date:</b><br><b>30/01/25</b> | |

| <b>Description:</b><br>Main quarried area and vegetation.<br><br>View: north-west | | |

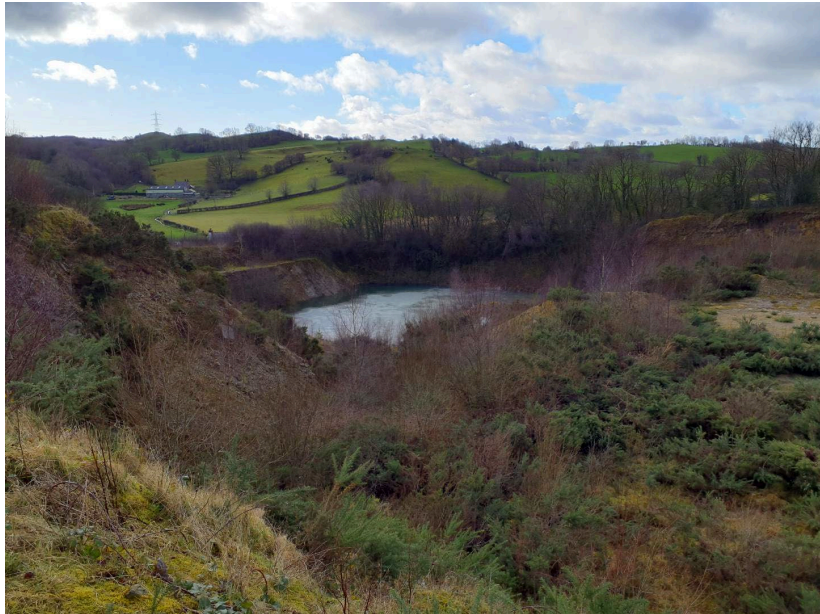
| <b>Photo No.</b><br><br>17 | <b>Date:</b><br><br>30/01/25 | |

| <b>Description:</b><br><br>View toward southern boundary and southern extent of main quarried area with pond.<br><br>View: south | | |

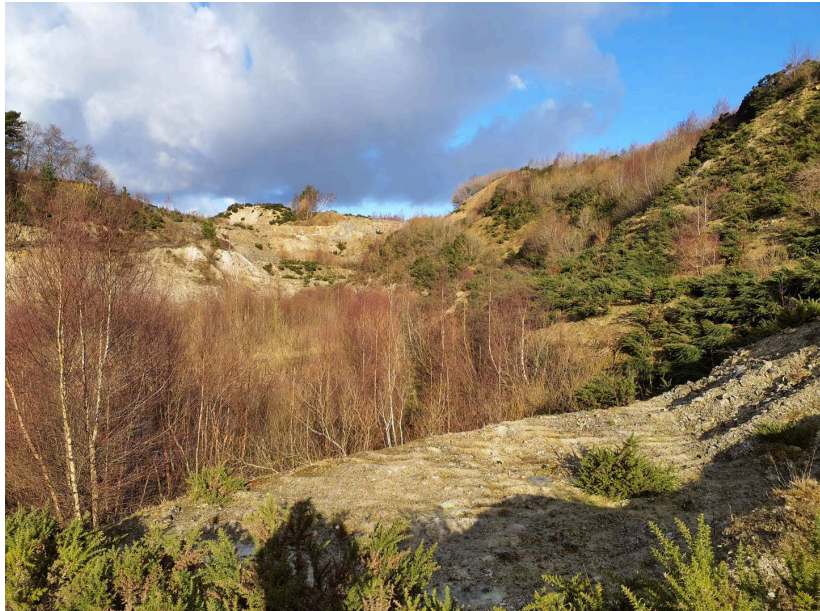
| <b>Photo No.</b><br><b>18</b> | <b>Date:</b><br><b>30/01/25</b> | |

| <b>Description:</b><br>Northern view through quarried area.<br>View: north | | |

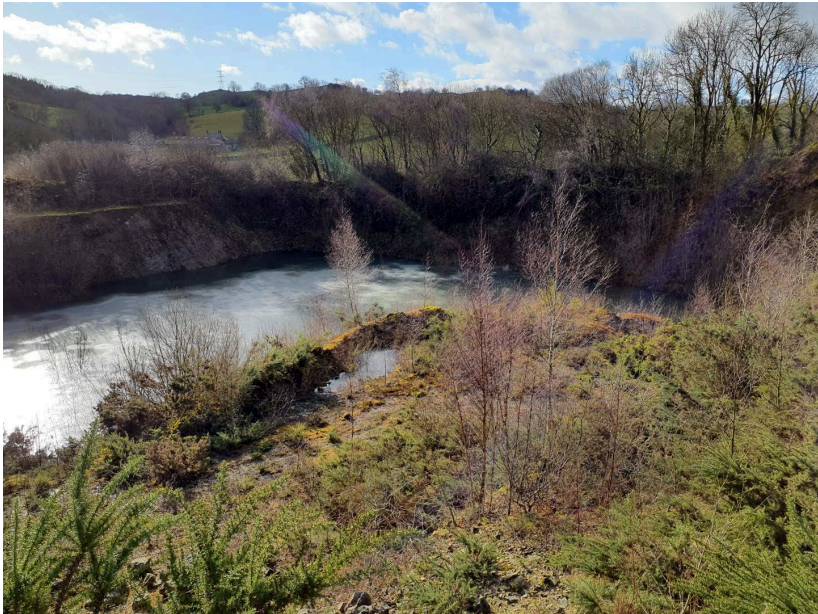
| <b>Photo No.</b><br><b>19</b> | <b>Date:</b><br><b>30/01/25</b> | |

| <b>Description:</b><br>Southern extent of main quarried area and pond.<br>Southern boundary.<br>View: south-west | | |

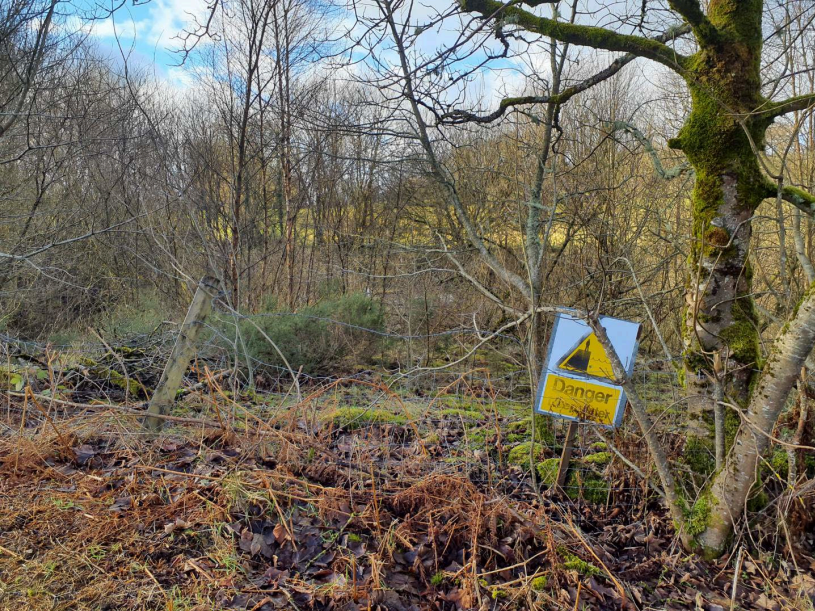
| <b>Photo No.</b><br><b>20</b> | <b>Date:</b><br><b>30/01/25</b> | |

| <b>Description:</b><br>Ponds located immediately west of site boundary.<br>View: west | | |

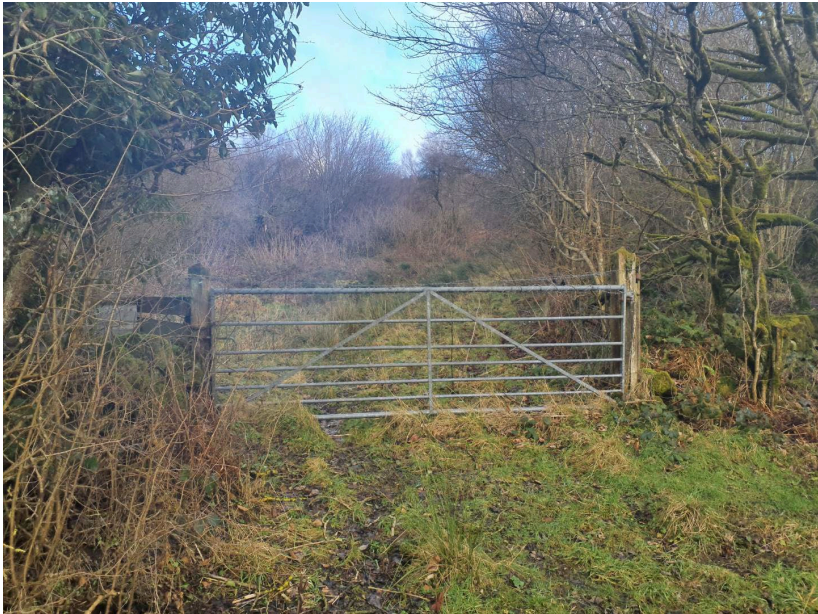
| <b>Photo No.</b><br><b>21</b> | <b>Date:</b><br><b>30/01/25</b> | |

| <b>Description:</b><br>Gate from bridleway into northern sector.<br>View: north | | |

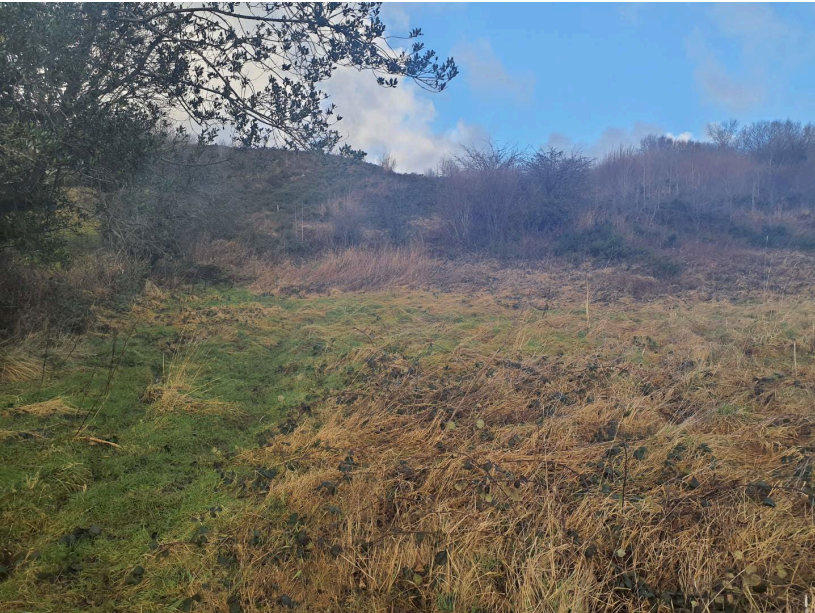
| <b>Photo No.</b><br><b>22</b> | <b>Date:</b><br><b>30/01/25</b> | |

| <b>Description:</b><br>Footpath into northern sector.<br>View: north | | |

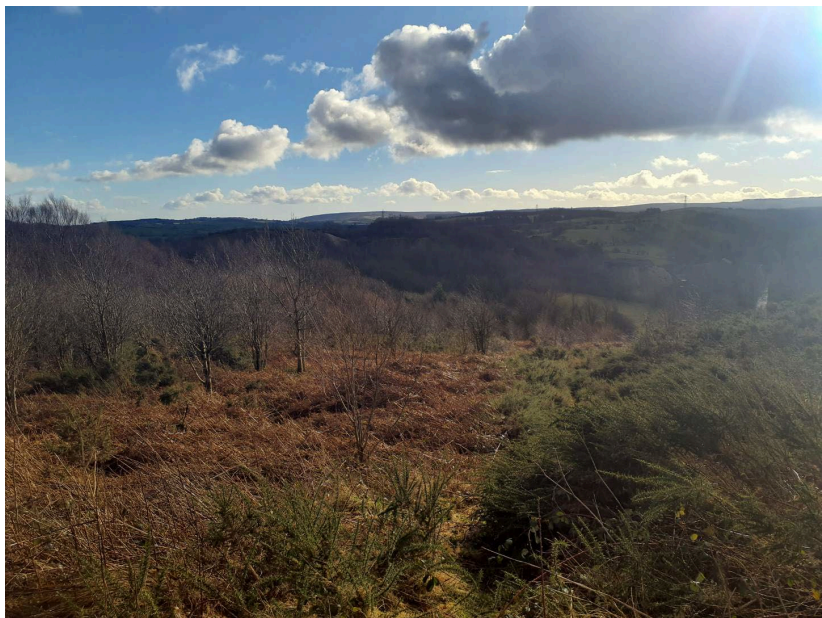
| <b>Photo No.</b><br><br>23 | <b>Date:</b><br><br>30/01/25 | |

| <b>Description:</b><br><br>Northern sector vegetation comprising small trees, brambles, bracken and gorse.<br><br>View: south | | |

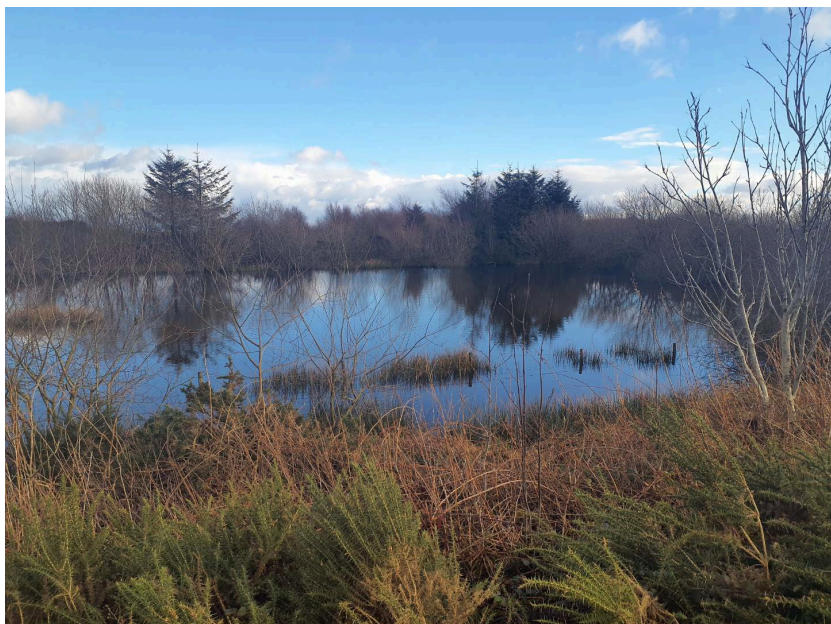
| <b>Photo No.</b><br><b>24</b> | <b>Date:</b><br><b>30/01/25</b> | |

| <b>Description:</b><br>Largest northern sector pond.<br>View: east | | |

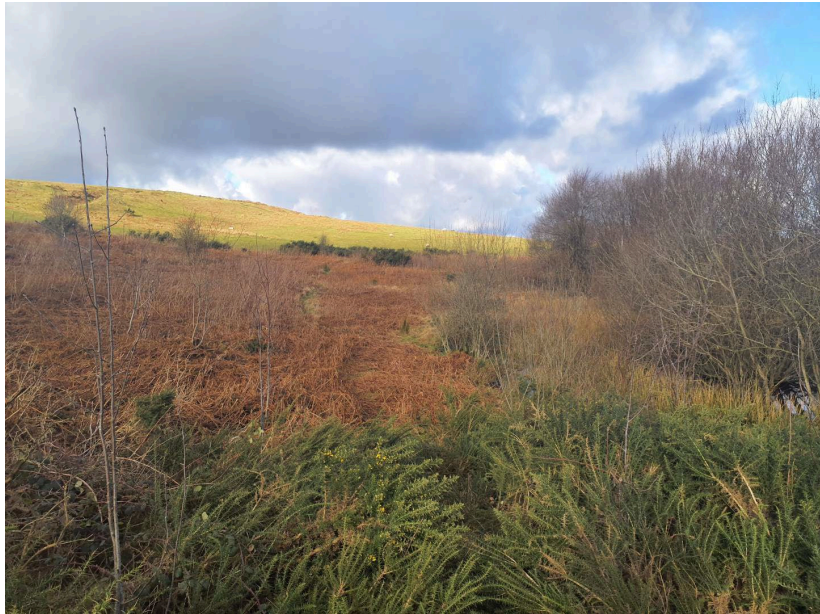
| <b>Photo No.</b><br><b>25</b> | <b>Date:</b><br><b>30/01/25</b> | |

| <b>Description:</b><br>View north through the northern sector.<br>View: north | | |

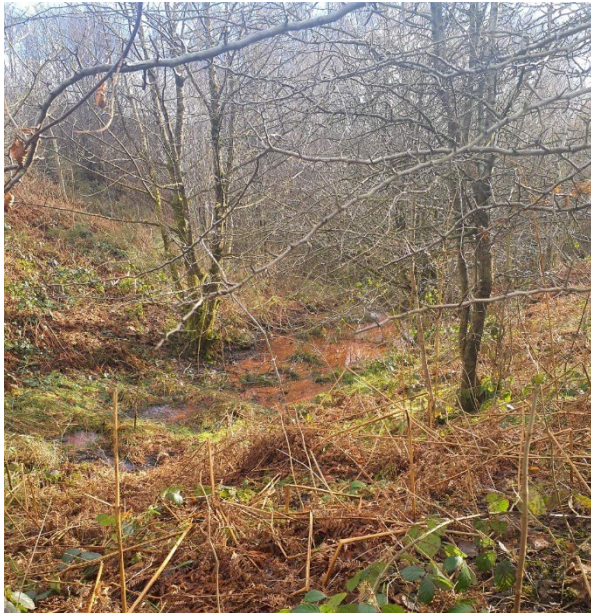
| <b>Photo No.</b><br><b>26</b> | <b>Date:</b><br><b>30/01/25</b> | |

| <b>Description:</b><br>Iron ochre leaching from below largest northern sector pond.<br>View: south-east | | |

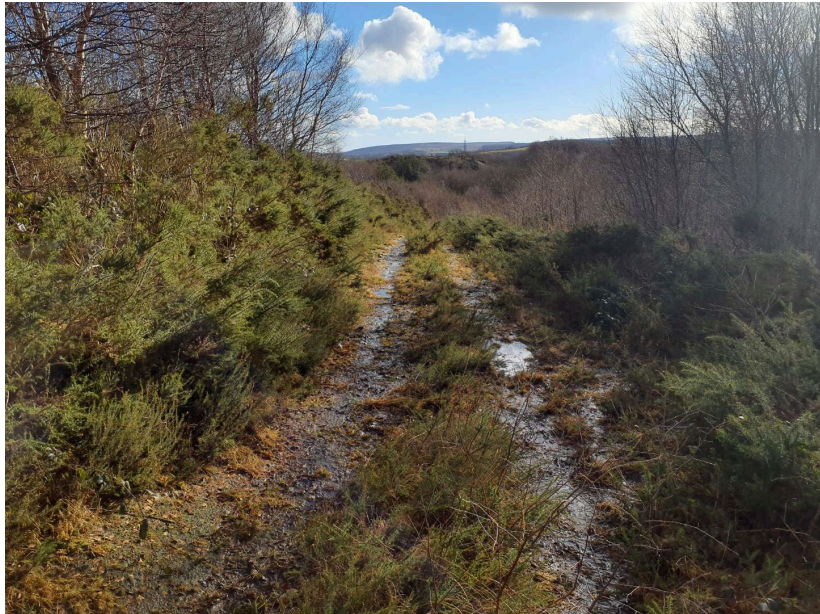
| <b>Photo No.</b><br><b>27</b> | <b>Date:</b><br><b>30/01/25</b> | |

| <b>Description:</b><br>Track into northern sector.<br>View: south | | |

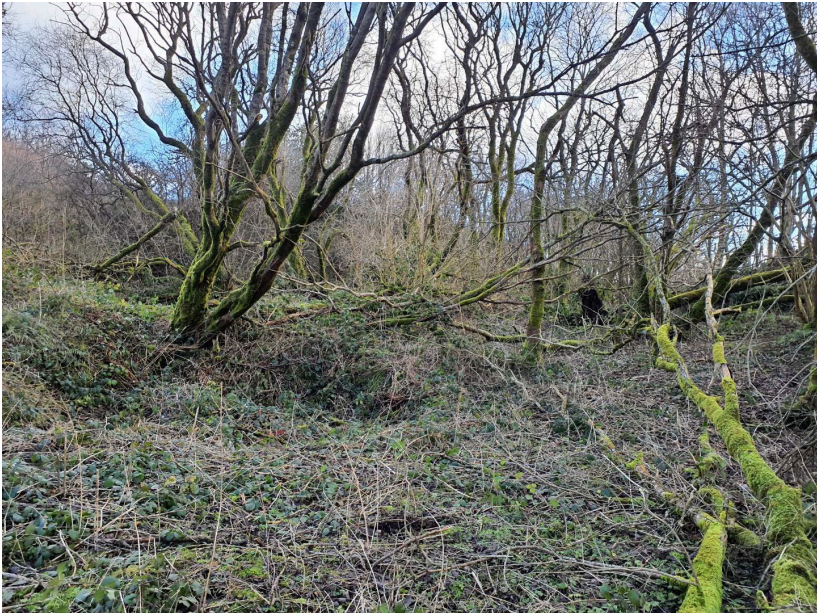
| <b>Photo No.</b><br>28 | <b>Date:</b><br>30/01/25 | |

| <b>Description:</b><br>General overview of the presumed location of the eastern shaft within woodland.<br><br>View: east | | |

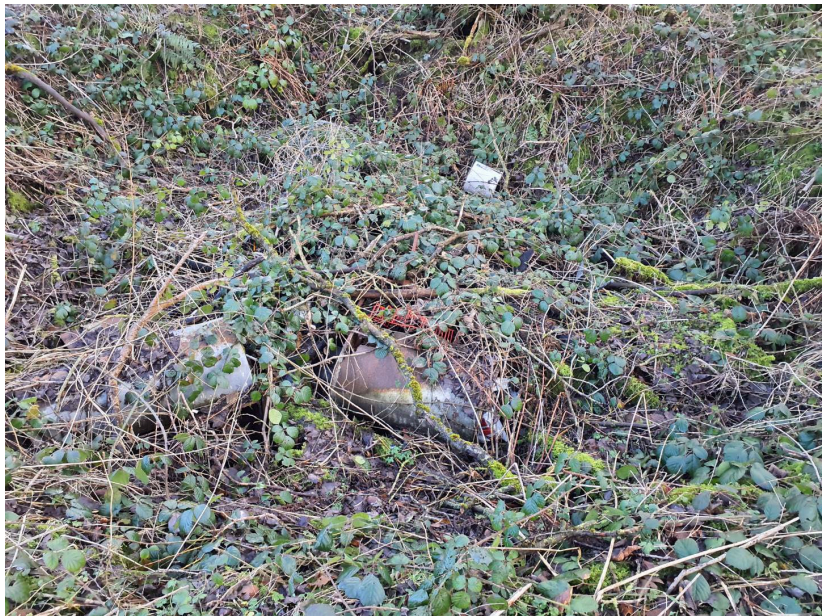
| <b>Photo No.</b><br><br>29 | <b>Date:</b><br><br>30/01/25 | |

| <b>Description:</b><br><br>Presumed location of eastern shaft comprising a hollow with fly tipped waste.<br><br>View: north | | |

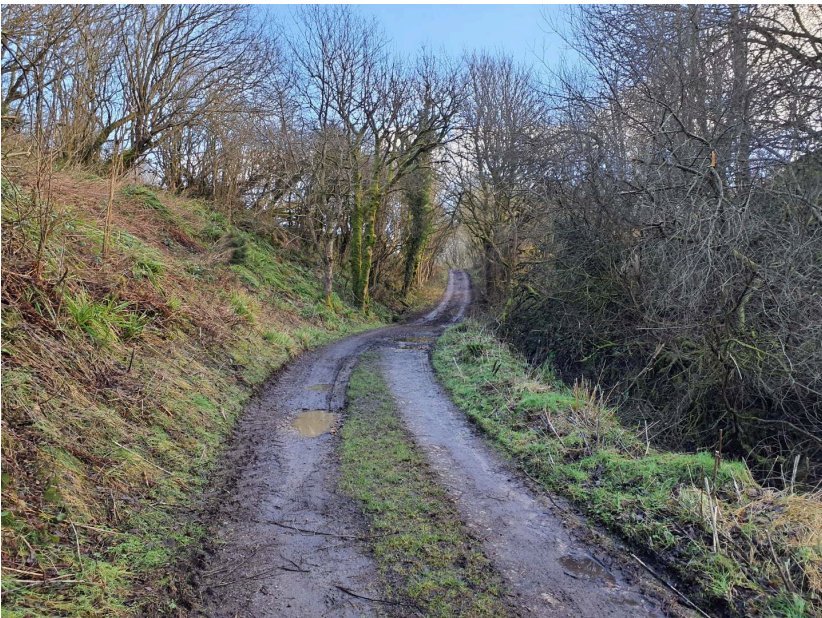
| <b>Photo No.</b><br>30 | <b>Date:</b><br>30/01/25 | |

| <b>Description:</b><br>Bridleway separating the northern and southern sectors.<br><br>View: east. | | |
