RHONDDA
GEOTECHNICAL
SERVICES

GEOTECHNICAL HISTORY
OF
PARC EIRIN/ WILFRIED WAY
TONYREFAIL
WITH REFERENCE TO SITE REMODELLING
AND PREVIOUS LOSS OF ECOLOGICAL HABITATS

14/12/2023

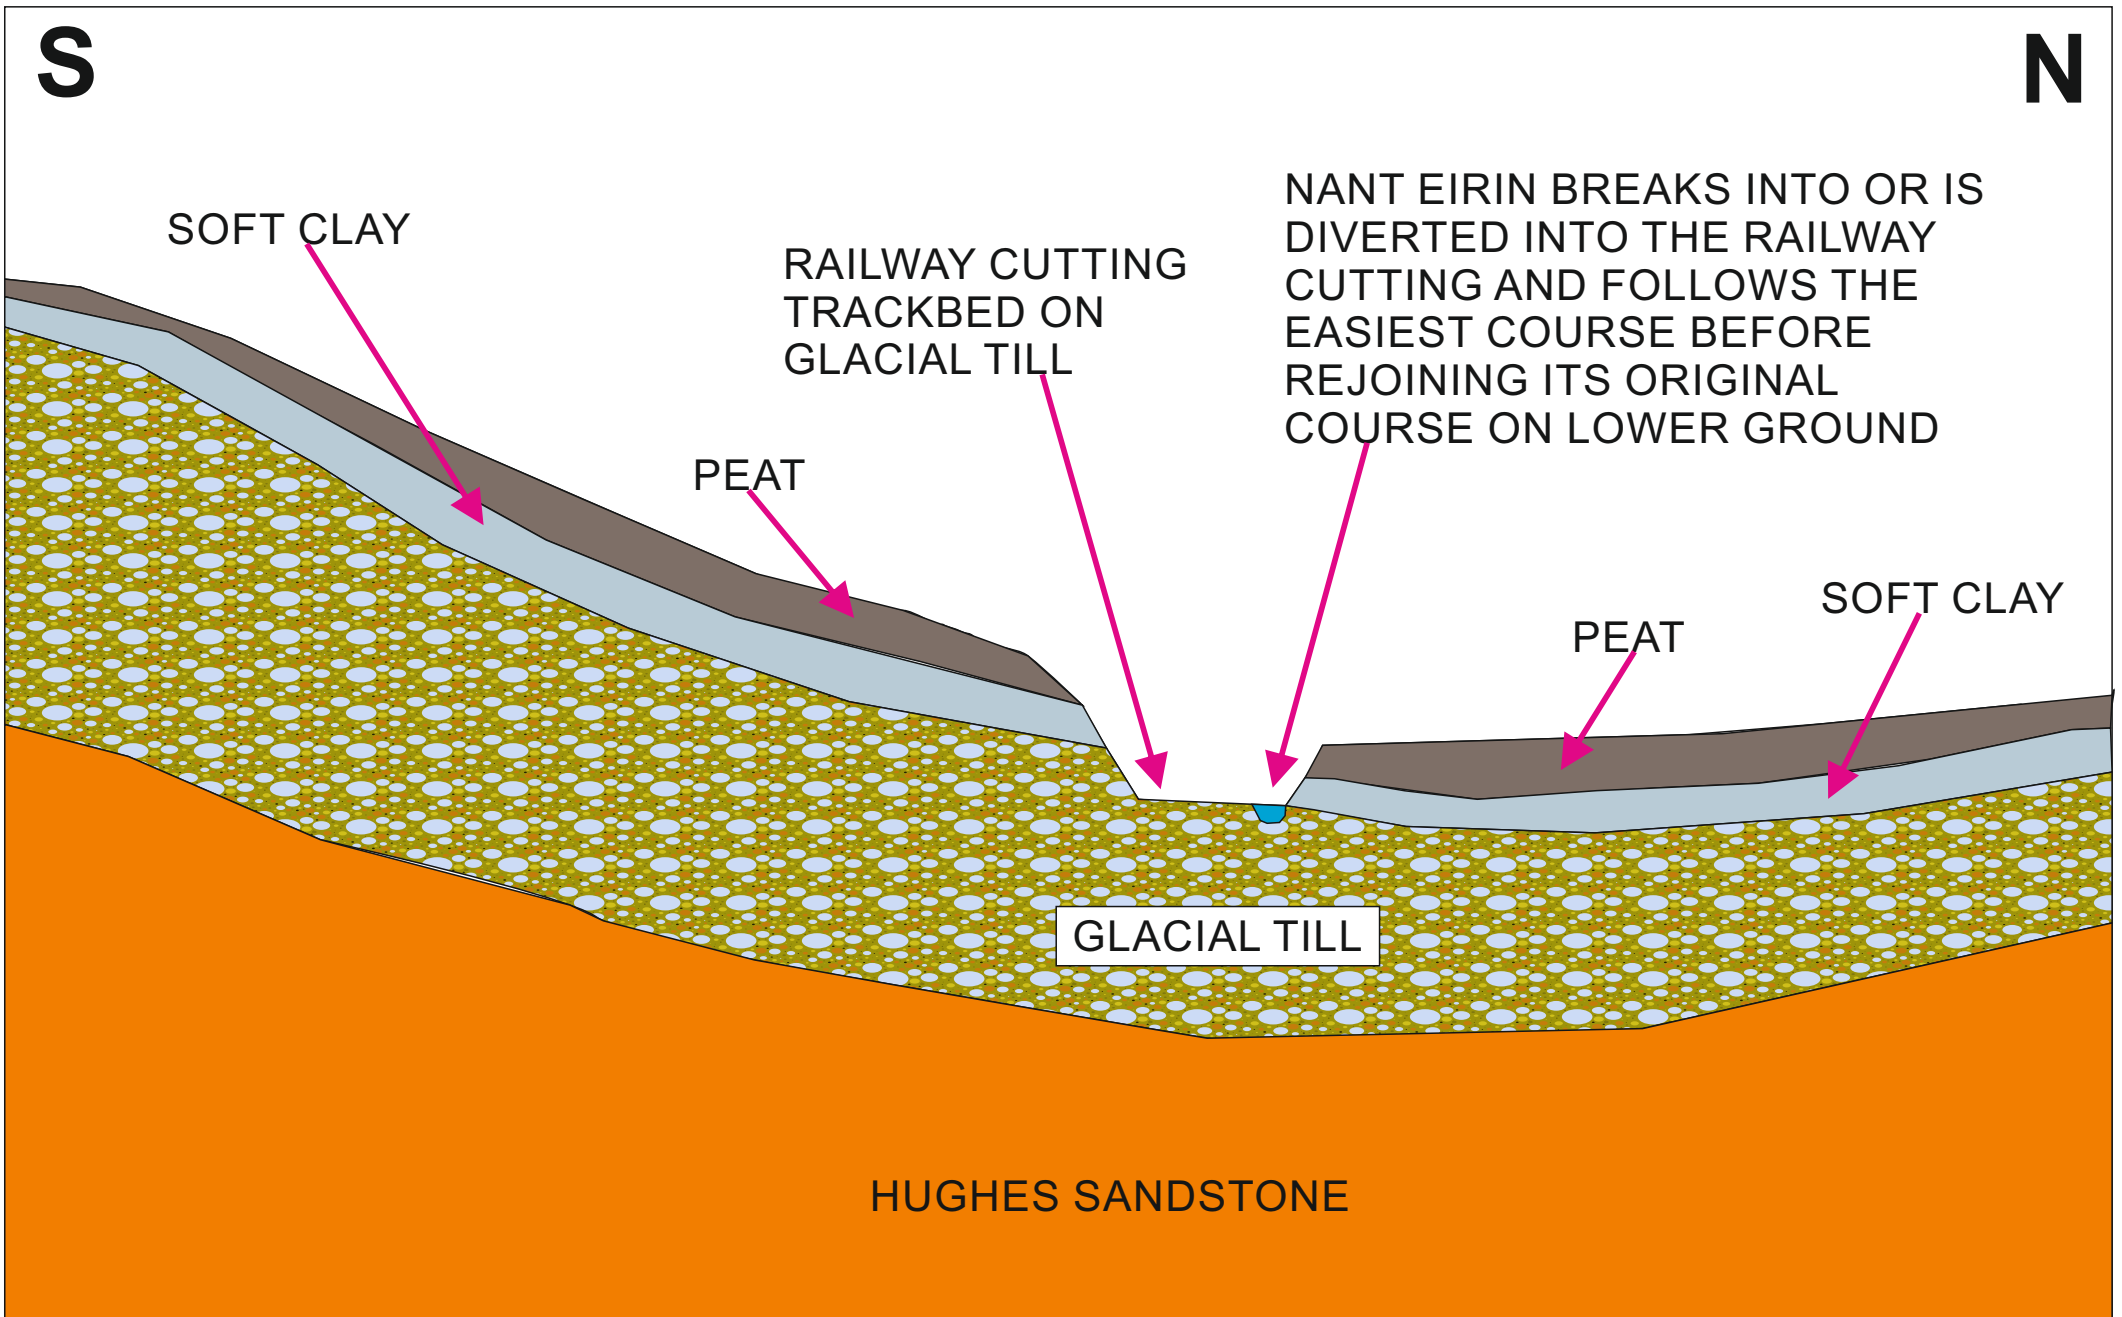
SECTION A

SOUTH-NORTH CROSS SECTION OF THE SITE PRIOR TO THE W.D.A. REDEVELOPMENT

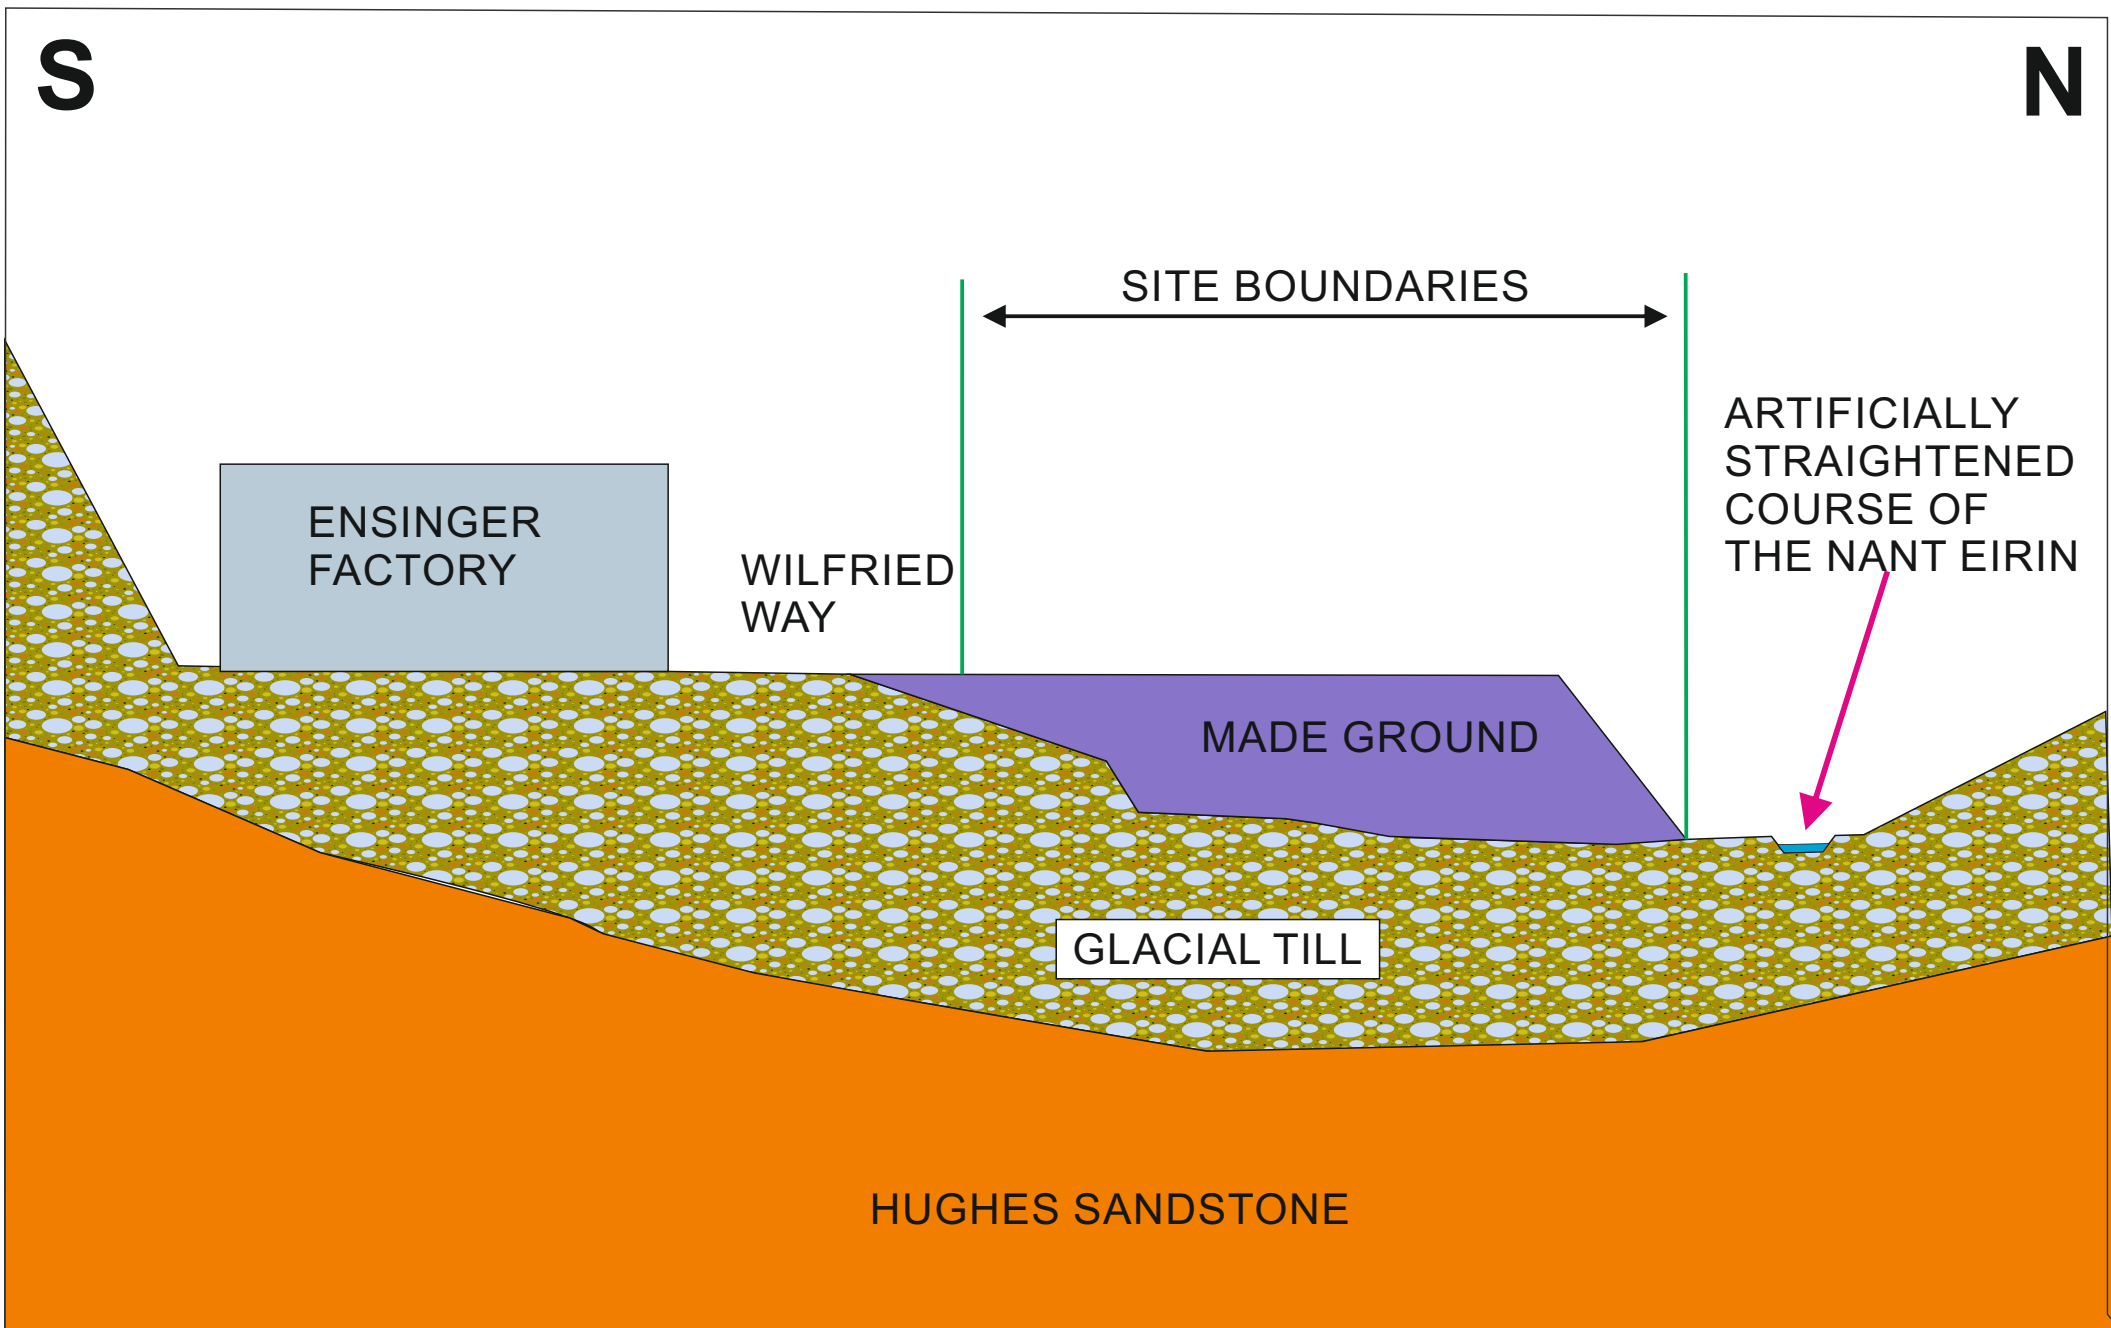
SECTION B

SOUTH-NORTH CROSS SECTION OF THE SITE AFTER TO THE W.D.A. REDEVELOPMENT

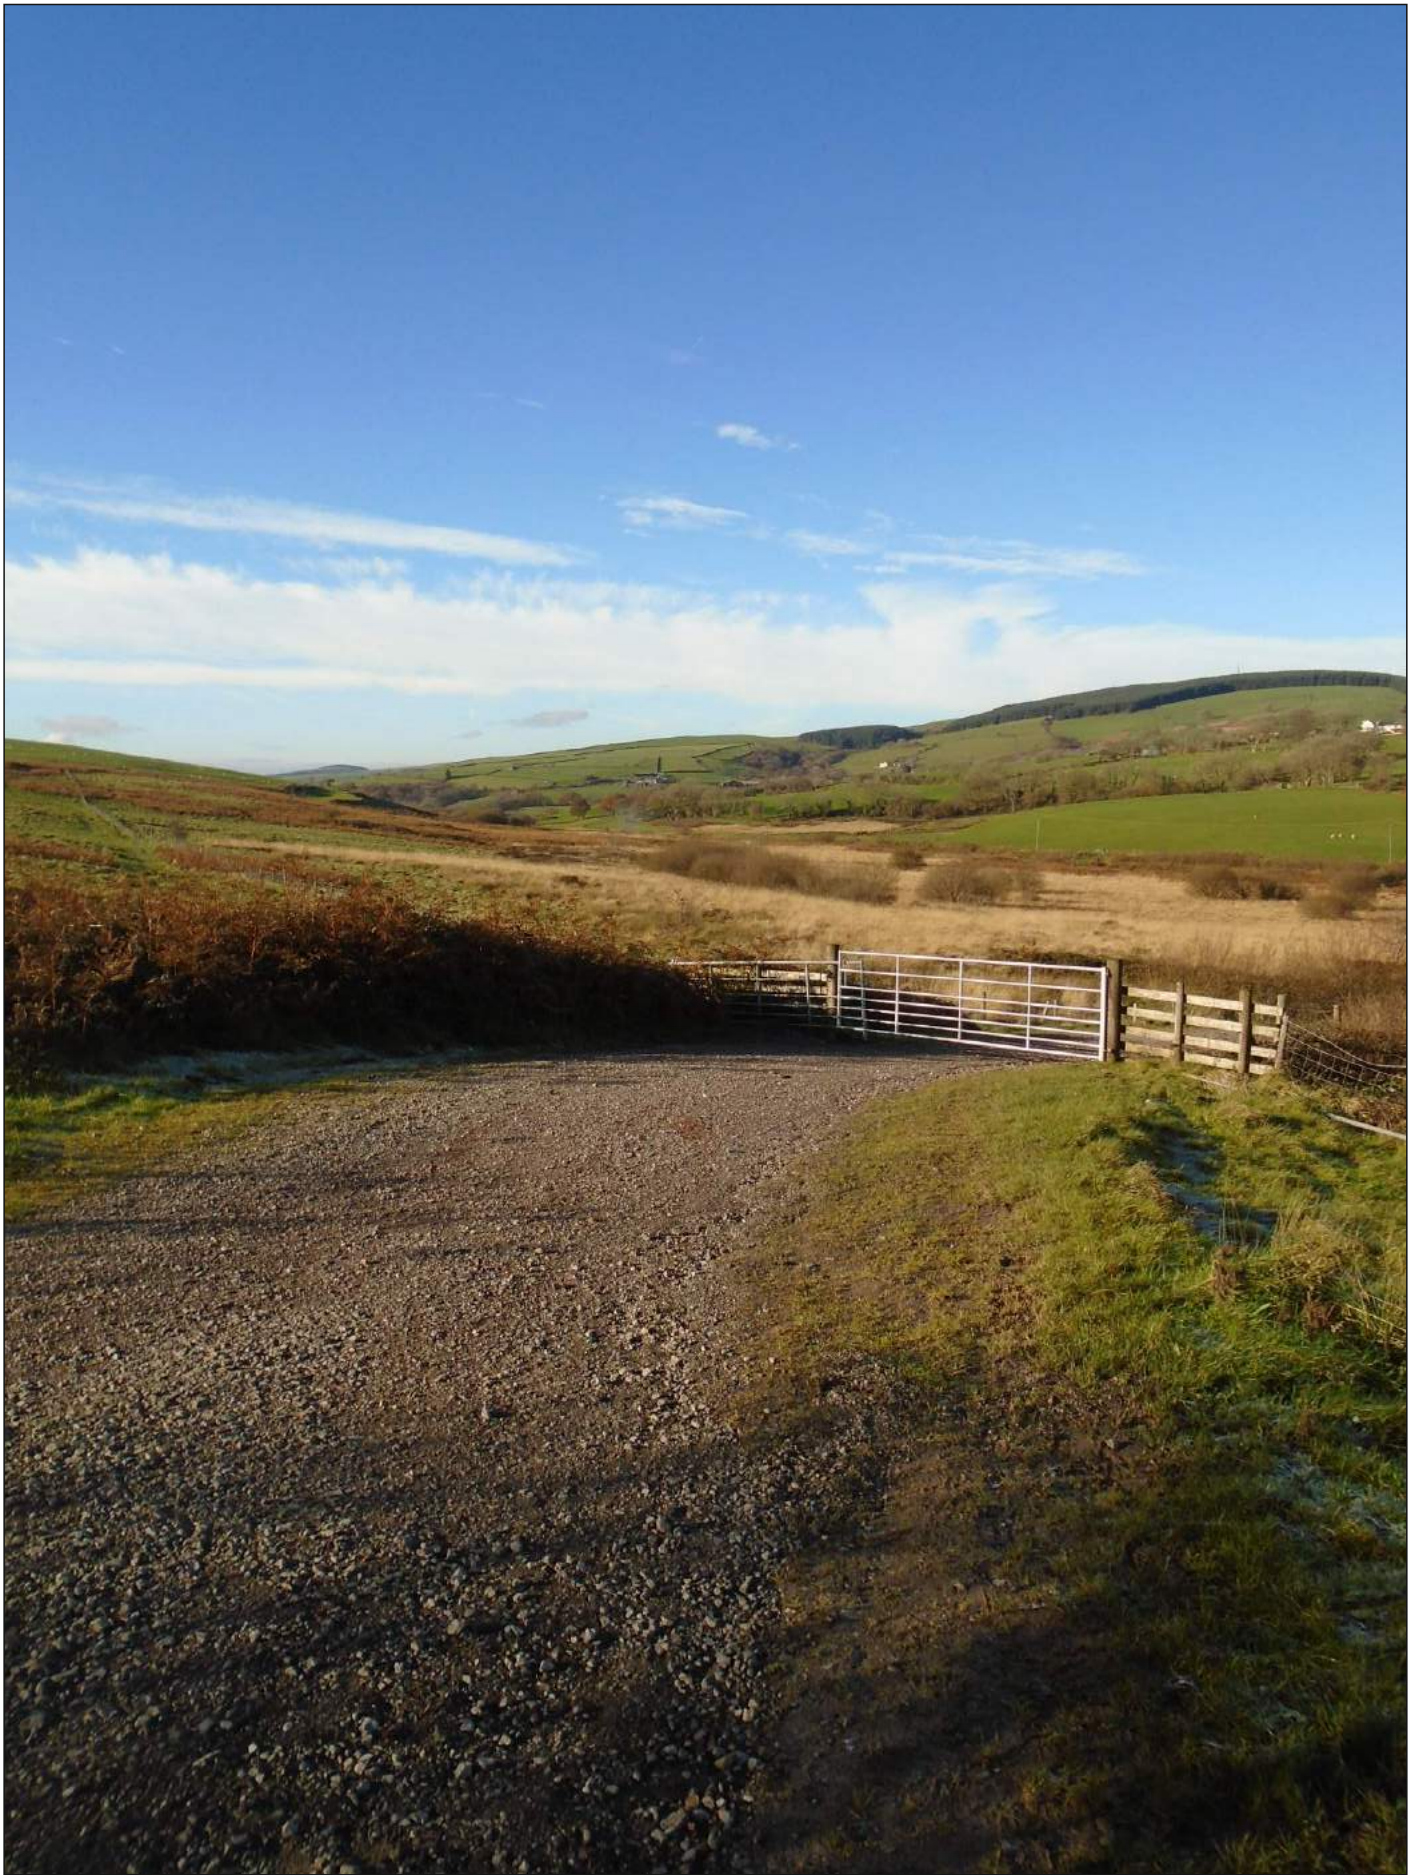
Both sites can be contrasted with the undisturbed peat bog to the west of the site. The water retention capacity of Peat is huge. The thickness of the accumulated peat and its location in a natural valley bottom mean it could never dry out, and can be considered a true permanent wetland.

FIGURE 6
UNDISTURBED PEAT BOG AT THE REAR OF THE
GRIFFIN INN VIEWED FROM THE HAUL ROAD

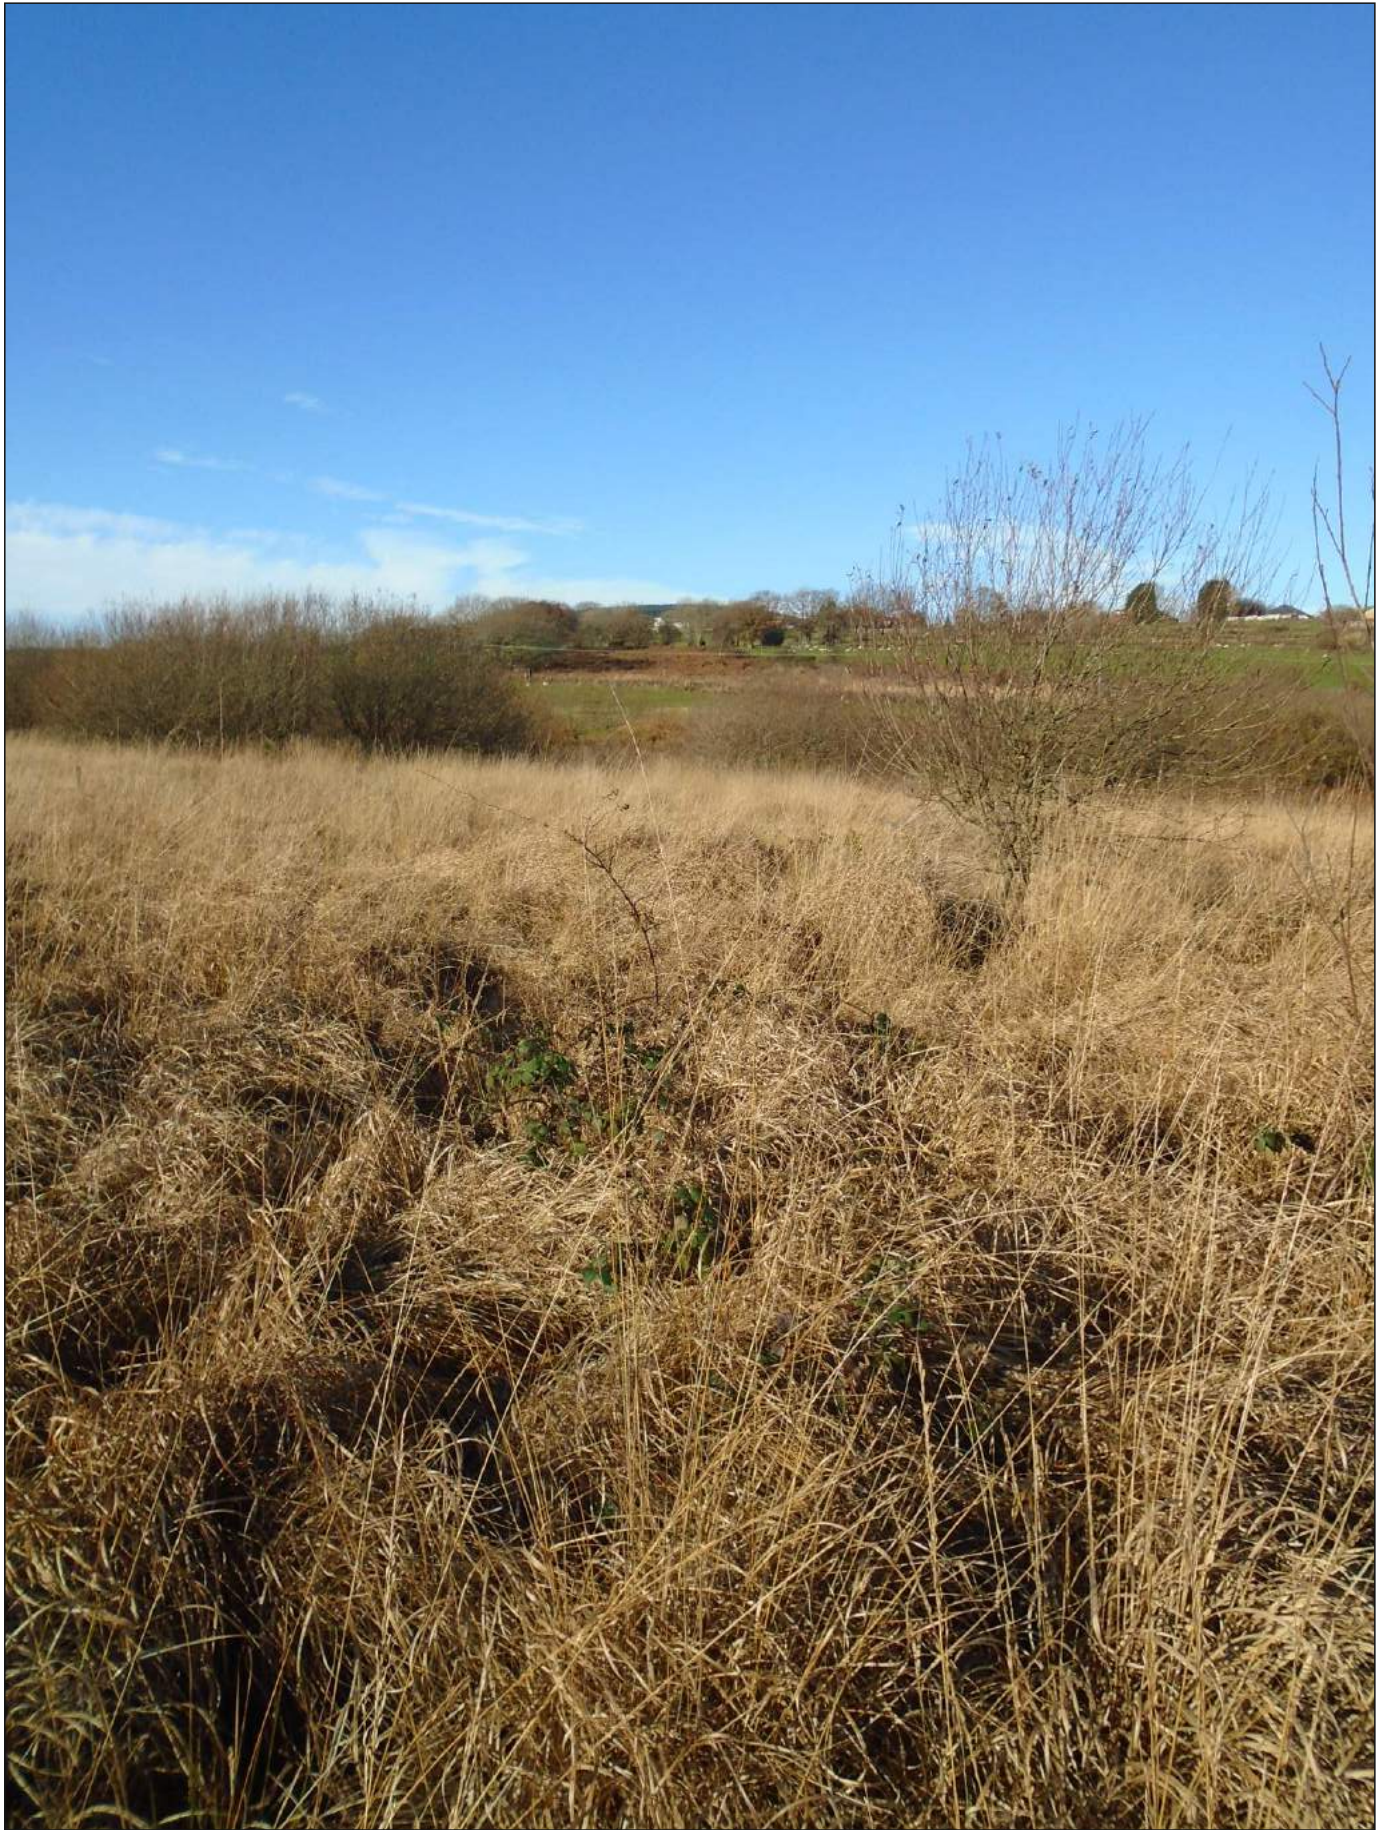
FIGURE 7

CLOSE UP VIEW OF THE VEGETATION BEHIND THE GRIFFIN INN.

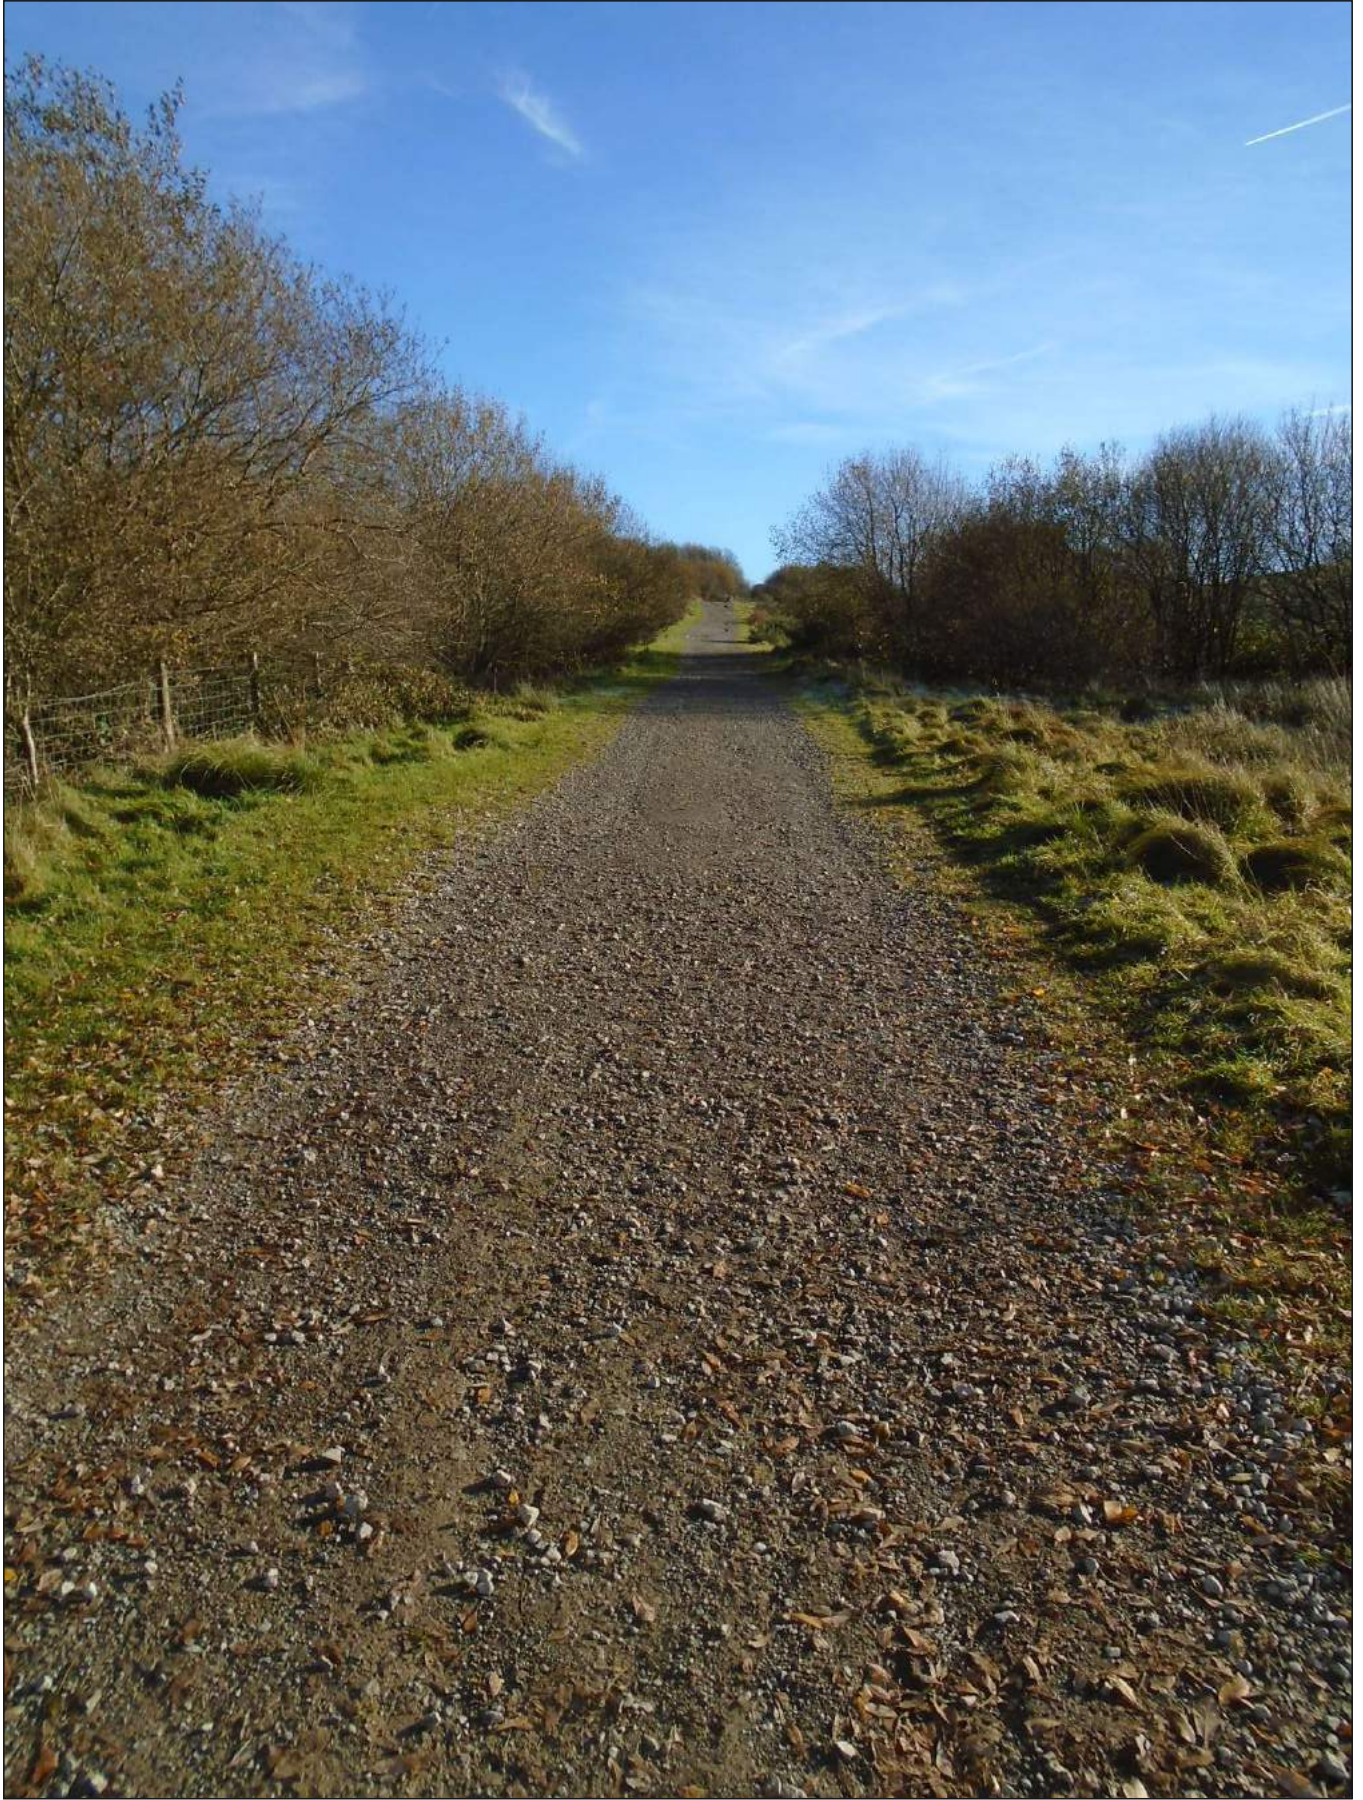
FIGURE 8
HAUL ROAD LEADING TO GELLI'R HAIDD UCHAF.

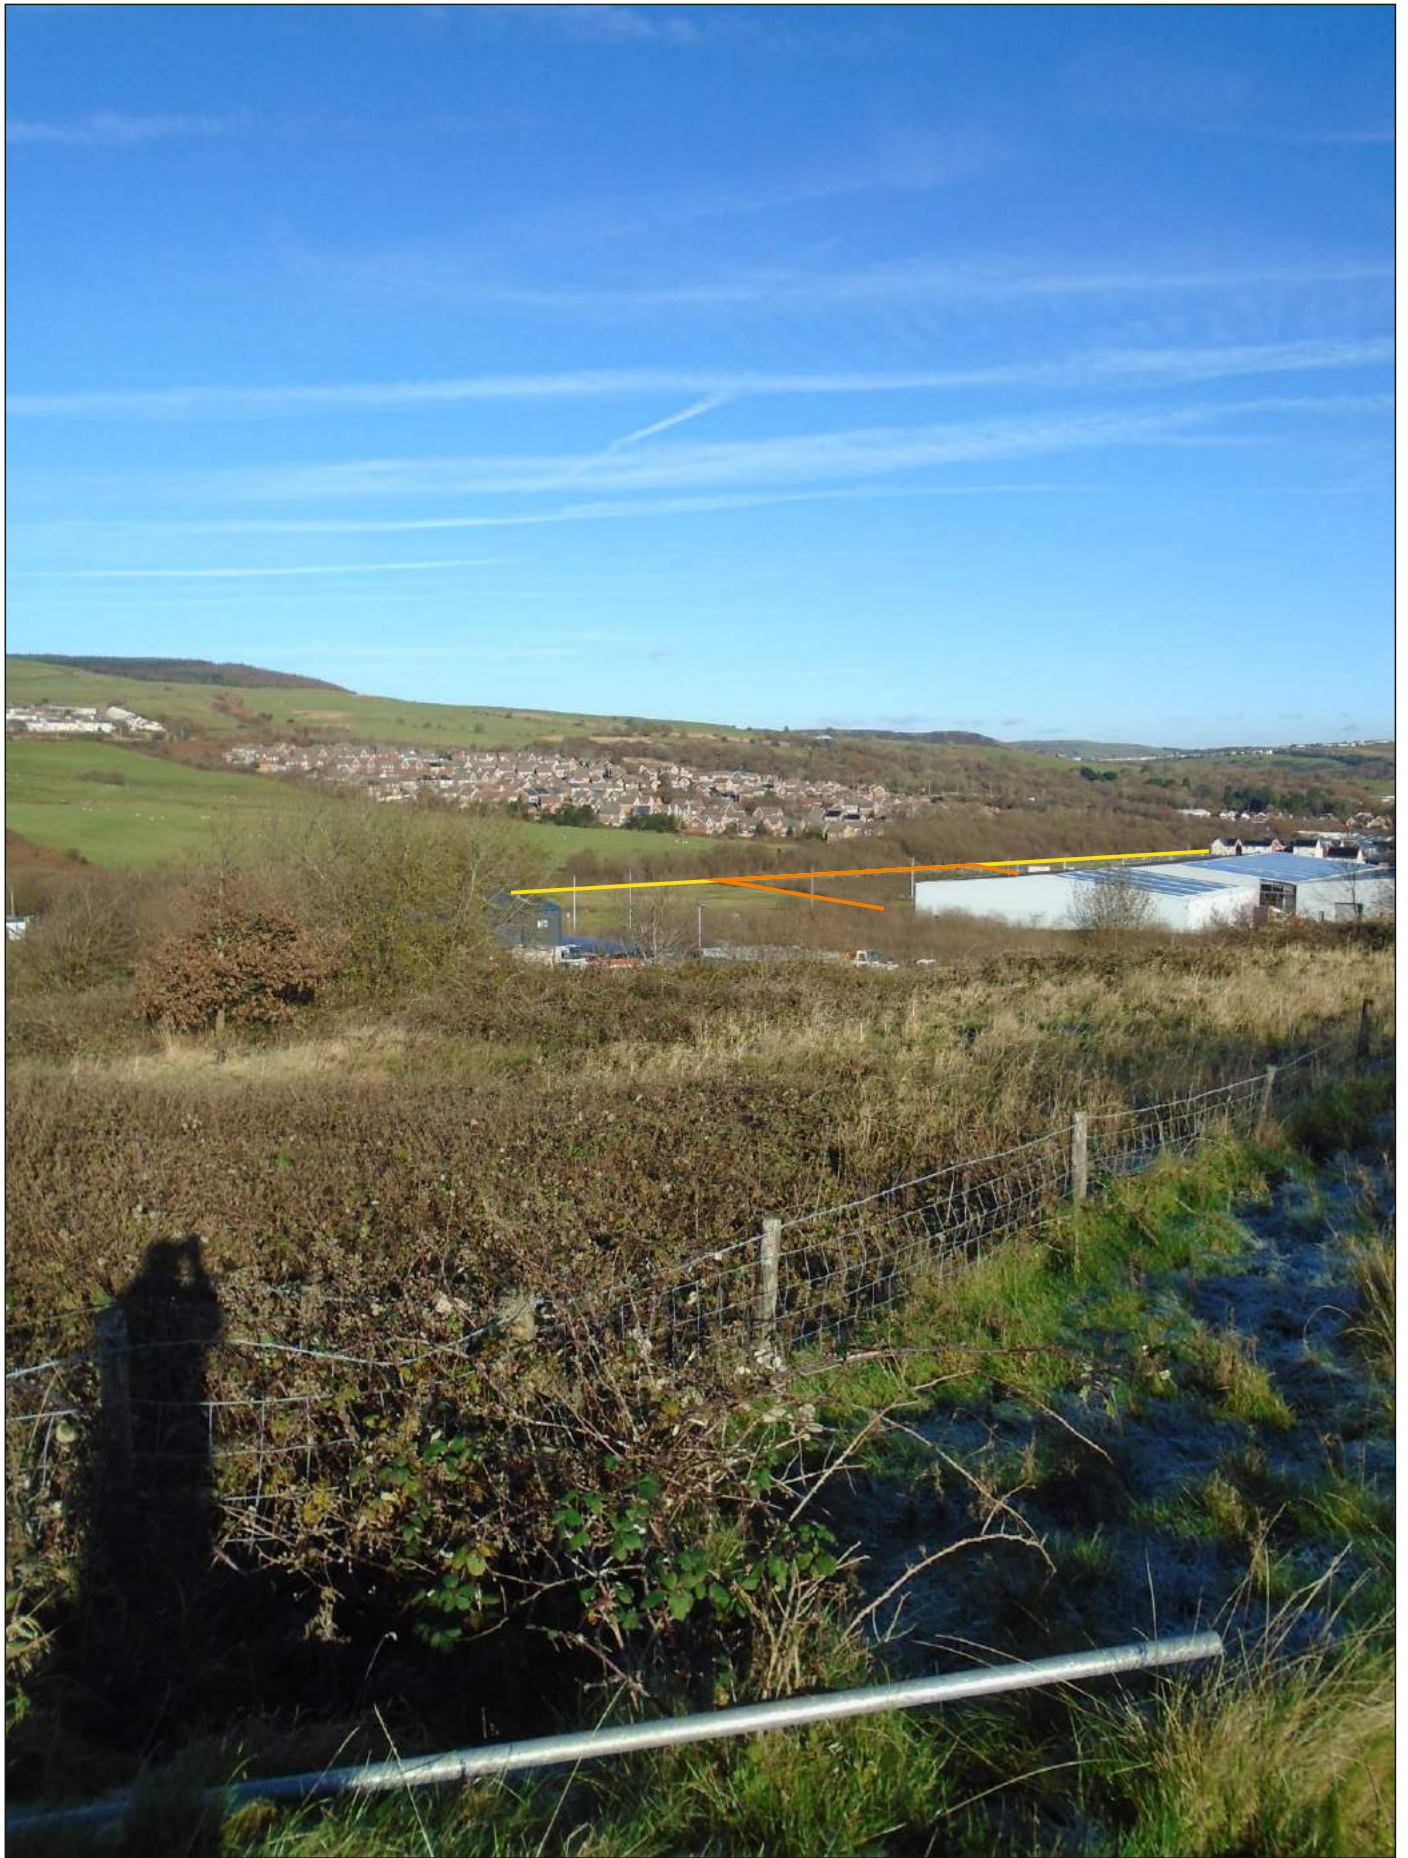
FIGURE 9

VIEW OF THE PLATEAU FROM ABOVE. ENSINGER'S FACTORY IS TO THE RIGHT. THE YELLOW LINE MARKS THE BACKLINE OF THE PLATEAU. THE DEVELOPMENT PLOT IS HIGHLIGHTED ORANGE

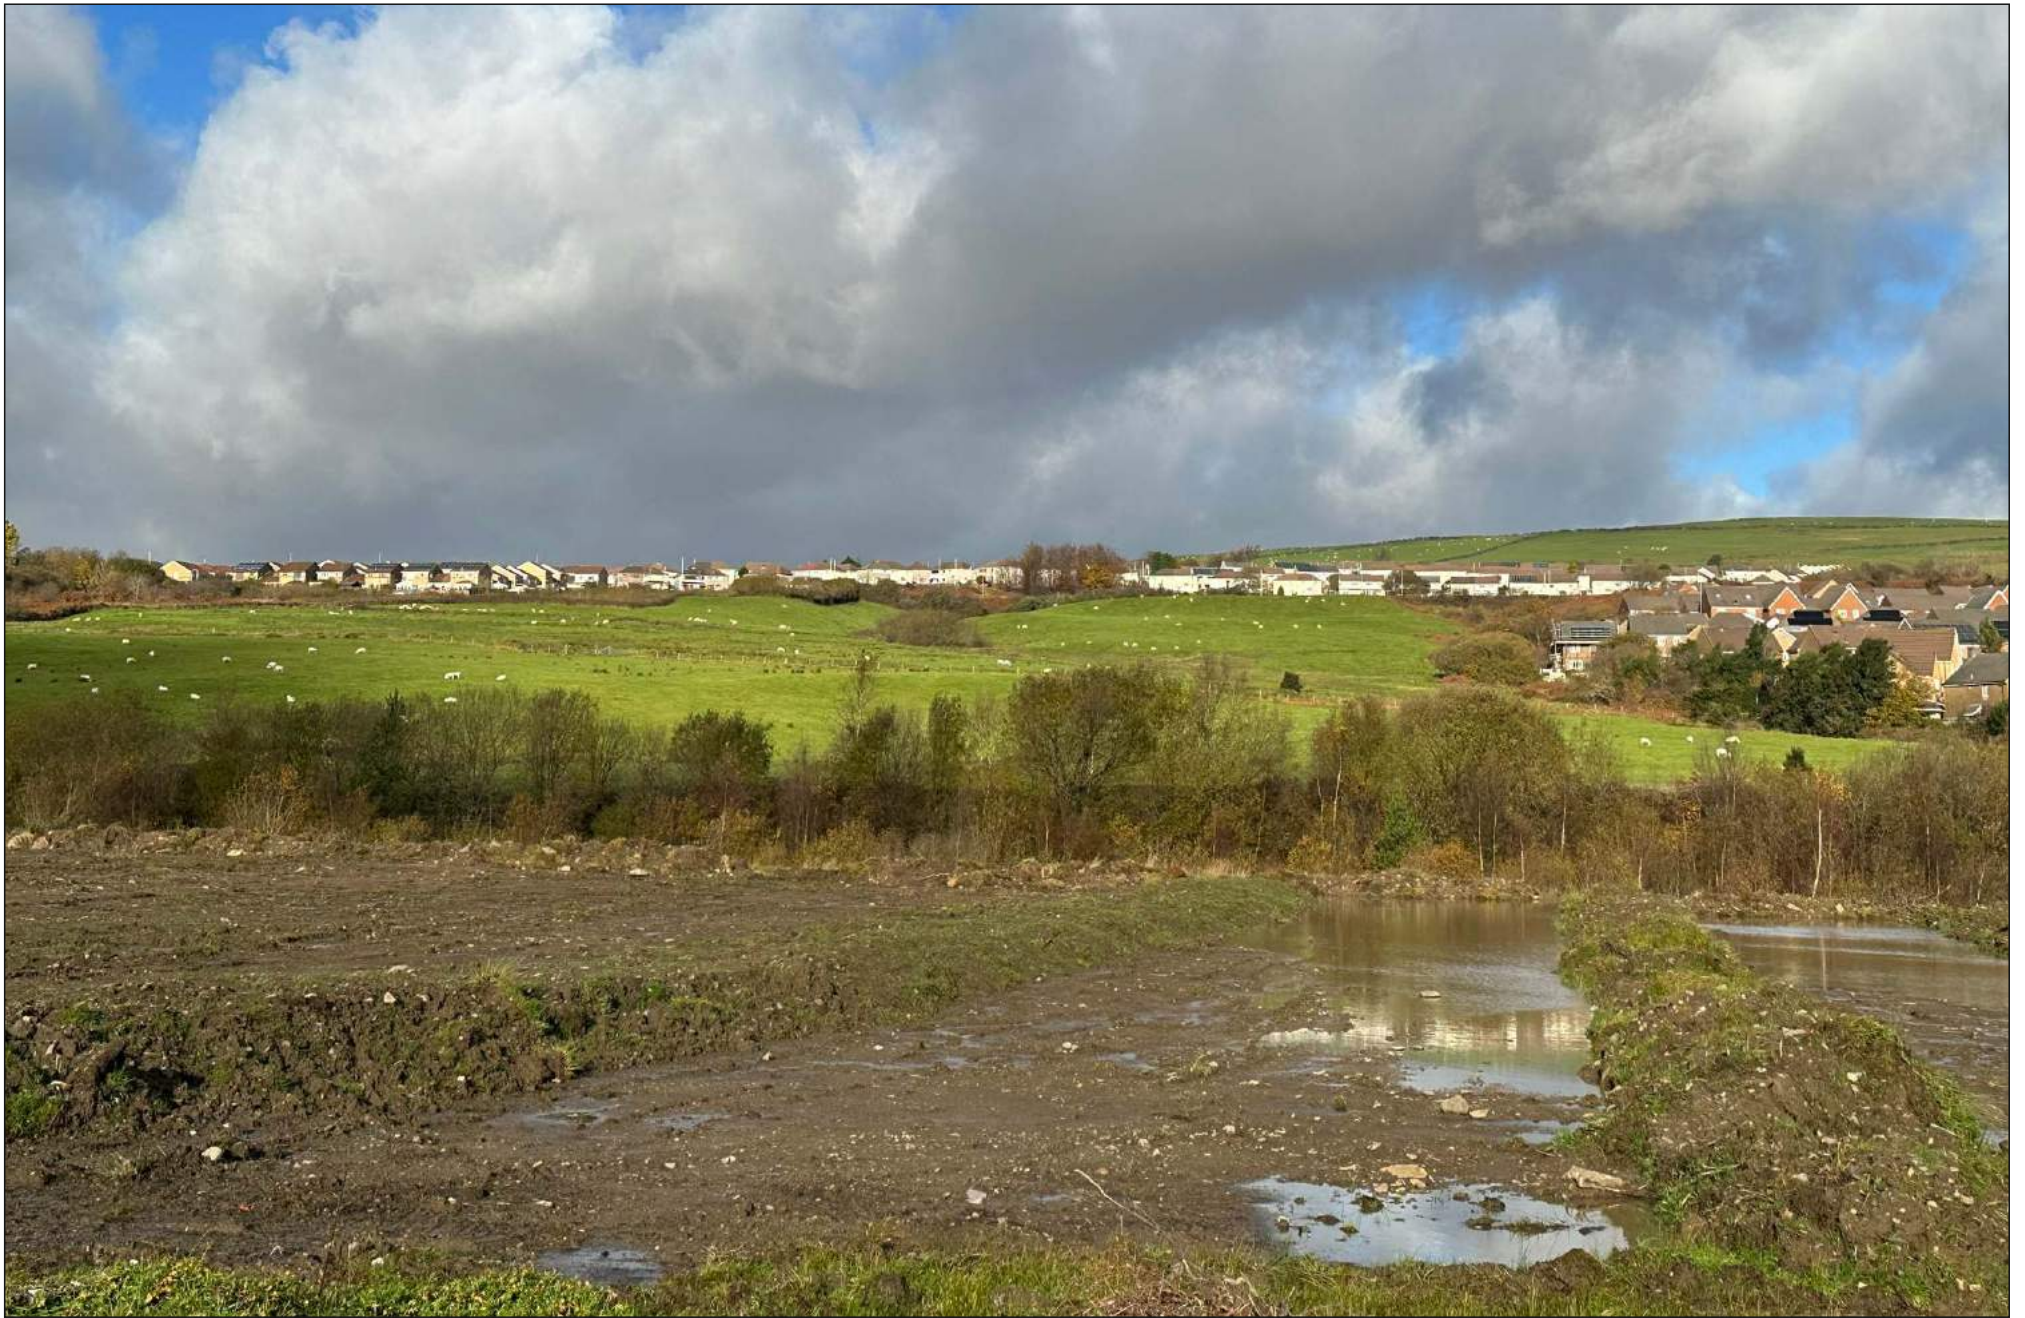
potential to be a true wetland. During warm or windy weather, the ground would dry out completely due to the shallow granular nature of the top substrate. A more appropriate description of the site at the time of the survey would be waterlogged grassland and scrub. No soil or vegetation has been removed from site and everything that was previously growing on the surface is now in the bunds seen in Figure 10. This can be compared with the adjacent plot seen in Figure 11. This has an identical history and underlying soil conditions to the application site. The only difference is that the site has been managed. It is regularly mown by contractors with a tractor. It is not known who is paying for this, or why this is being done.

FIGURE 10 THE SITE AT PRESENT. WATER IS HOLDING ON THE SURFACE

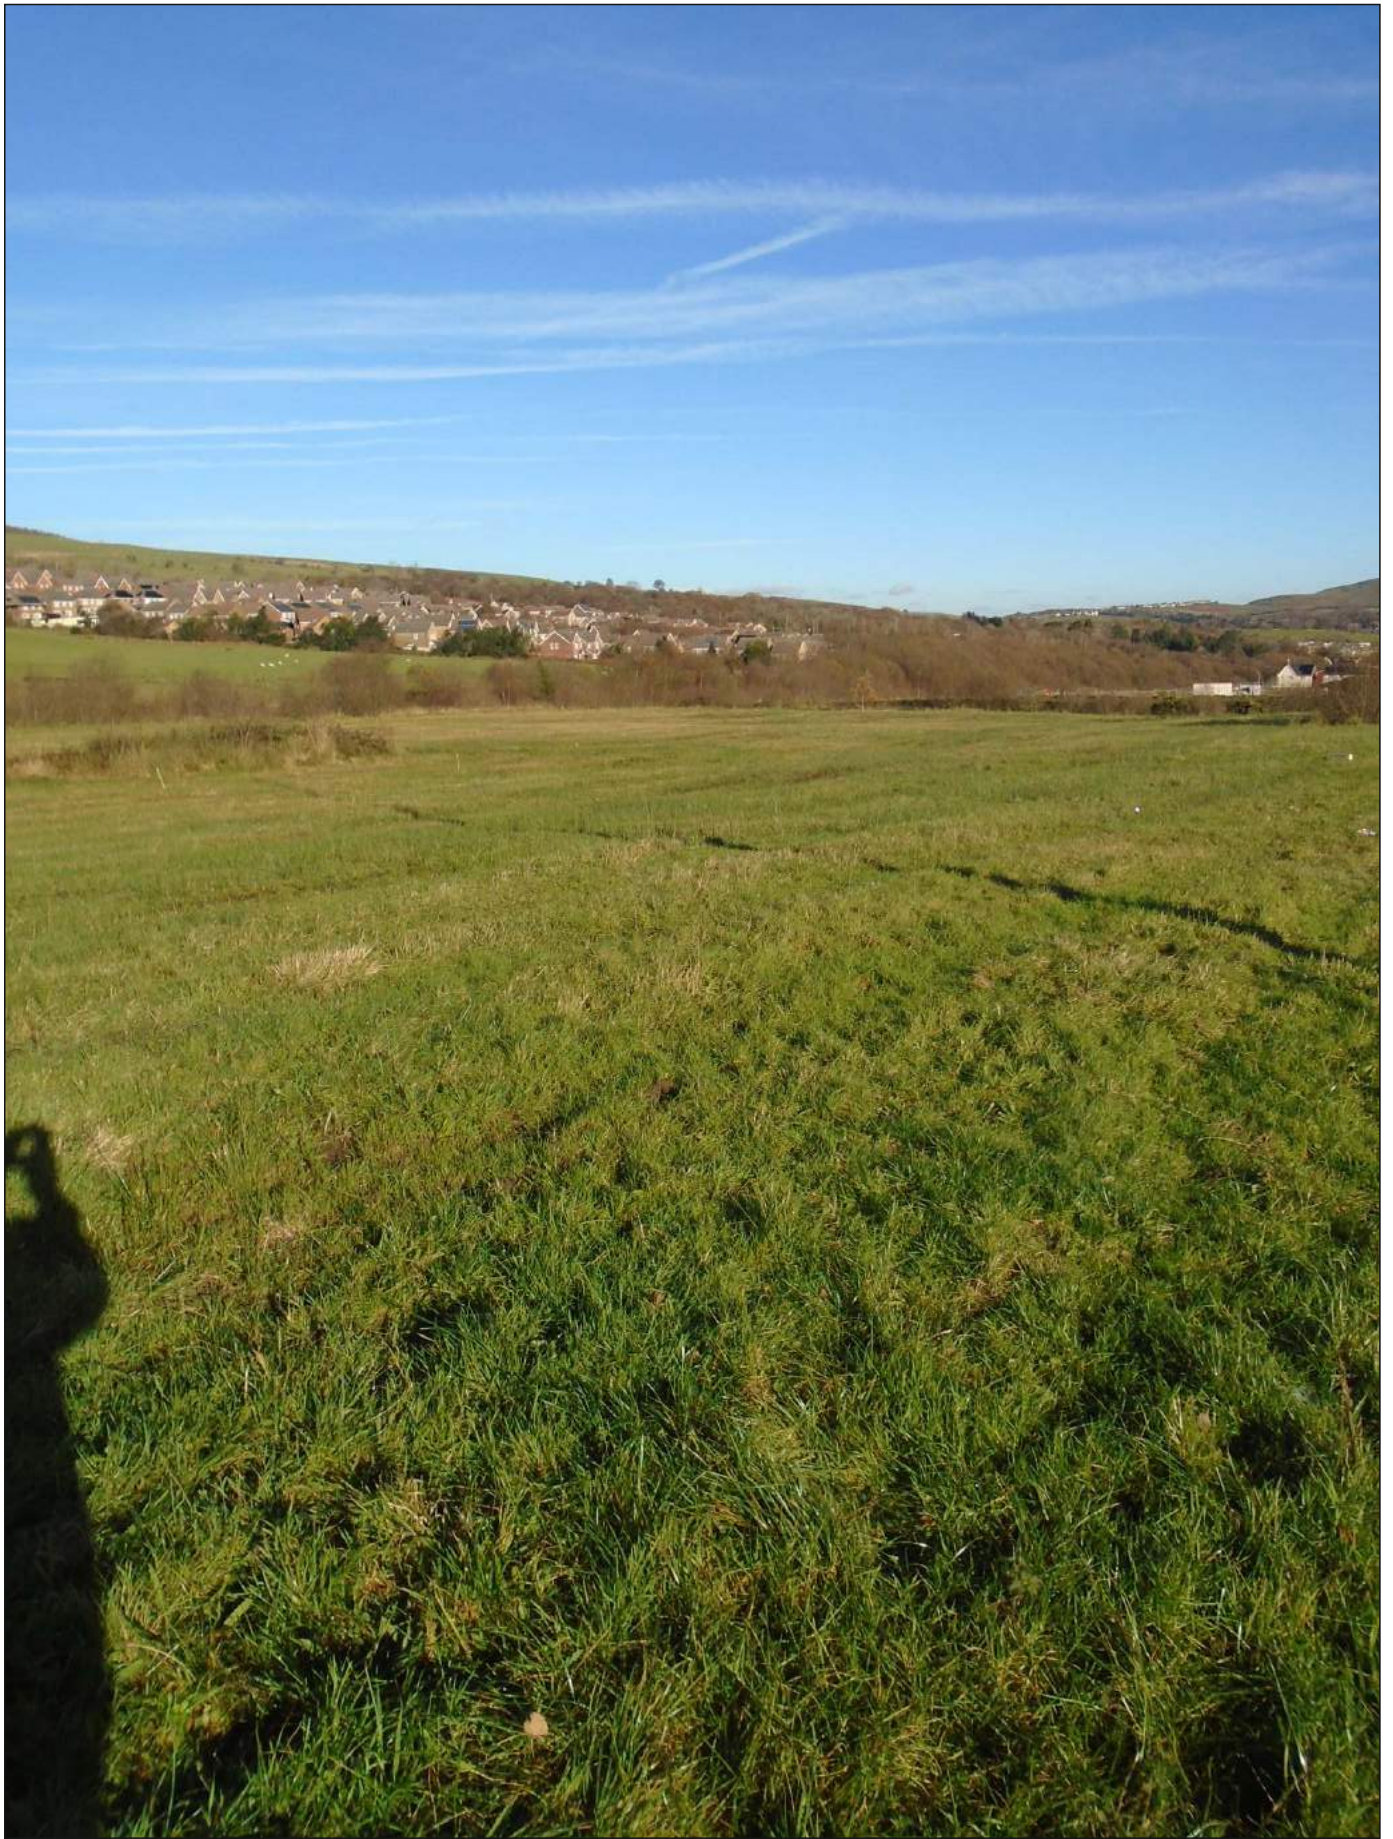
FIGURE 11
THE ADJACENT PLOT. THIS IS MAINTAINED BY LANDSCAPE CONTRACTORS BUT THERE IS NO PHYSICAL DIFFERENCE FROM THE DEVELOPMENT PLOT BELOW GROUND LEVEL
