## **Marlas Farm, Pyle, Bridgend**

# **Bat Emergence Survey Report**

*A report by MPS Ecology*

Project:	Marlas Farm, Pyle, Bridgend
Report:	Bat Survey Report
Date:	4 <sup>th</sup> October 2022
Issue:	FINAL
Prepared By:	Dr Mike Shewring CEcol, MCIEEM
Checked By:	N/A

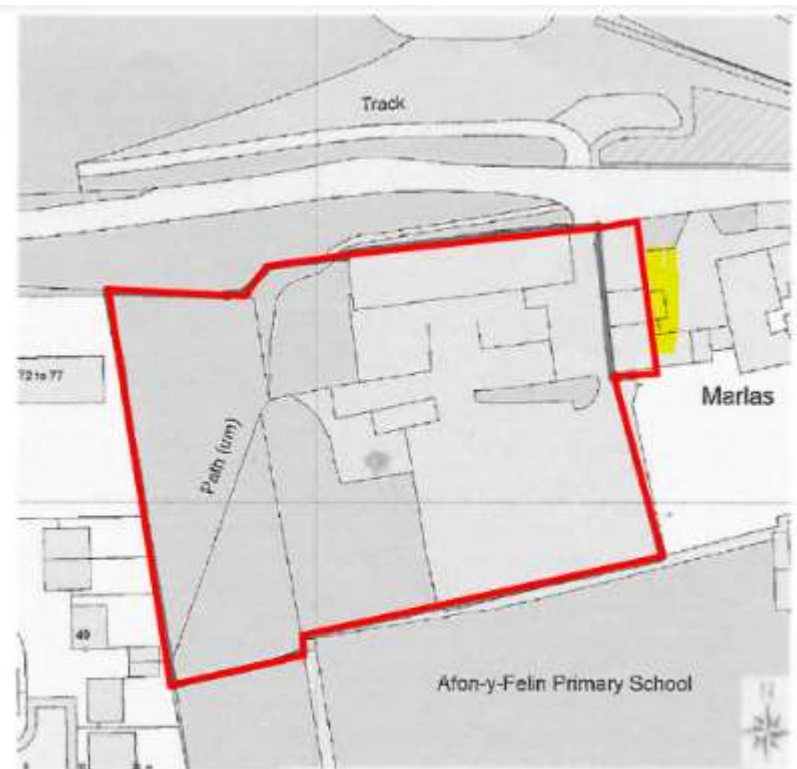
Figure 2 – Area of restricted visual coverage

Again no external access and thus complete visual coverage was available to the eastern elevation of the far eastern building/ barn due to its abutment to a residential property. See Figure 2 below showing area of restricted visual coverage (highlighted in yellow).

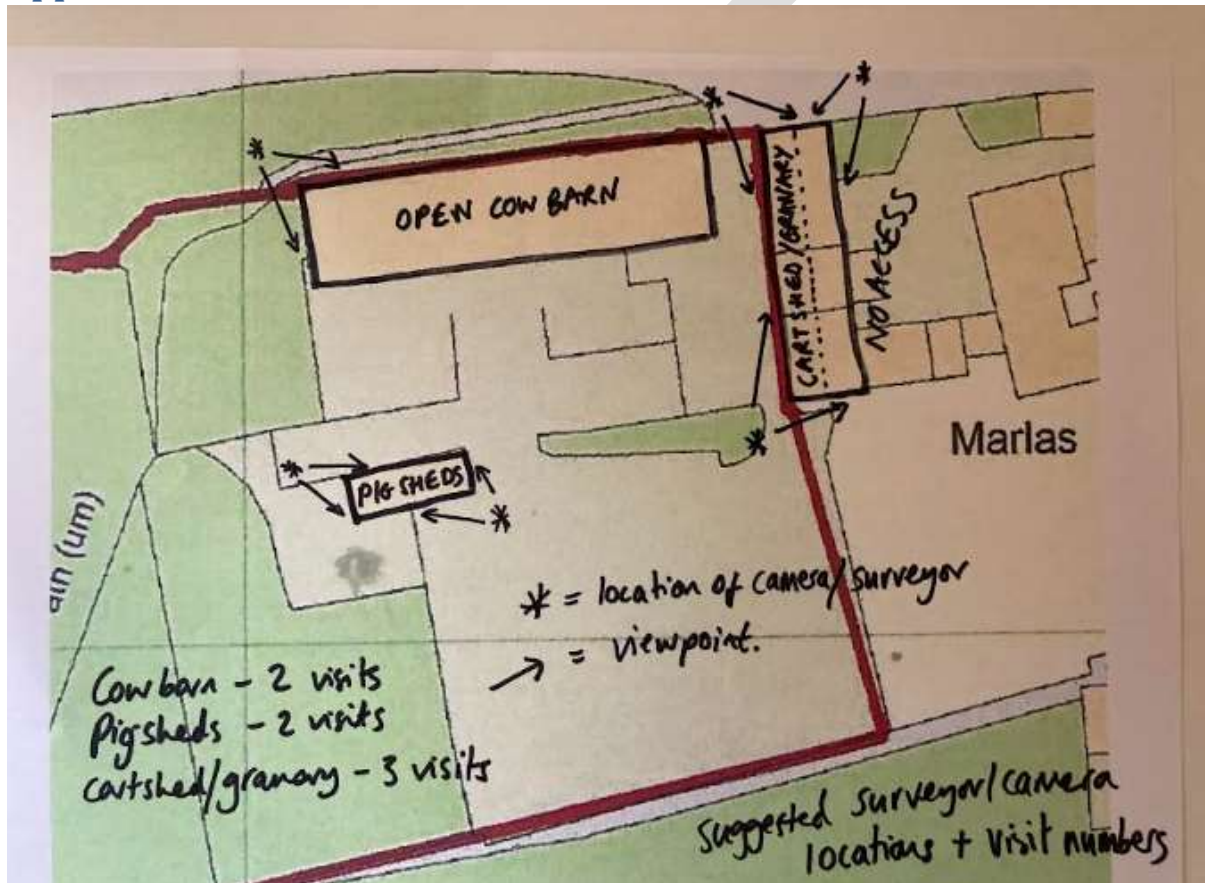
## Appendix A

Surveyors were located as suggested by Koru Ecology Associates<sup>3</sup> (See Appendix A) with three surveyors focused on the granary/ cart shed during the surveys on the 11<sup>th</sup> July, 1<sup>st</sup> August and 31<sup>st</sup> August. Whilst two surveyors focused on the Pig Shed on the 11<sup>th</sup> July and 1<sup>st</sup> August and two surveyors focusing on the Cow Shed on the 31<sup>st</sup> August. An additional visit by a single surveyor focused on the western elevation of the cow shed was also undertaken on the 9<sup>th</sup> September.
