RHONDDA  
GEOTECHNICAL  
SERVICES

COAL MINING RISK ASSESSMENT  
PLANNING APP. 17/5068/41  
LAND ADJACENT TO  
LLANTRISANT BUSINESS PARK  
LLANTRISANT  
R.C.T.

8/03/2018

## COAL MINING RISK ASSESSMENT

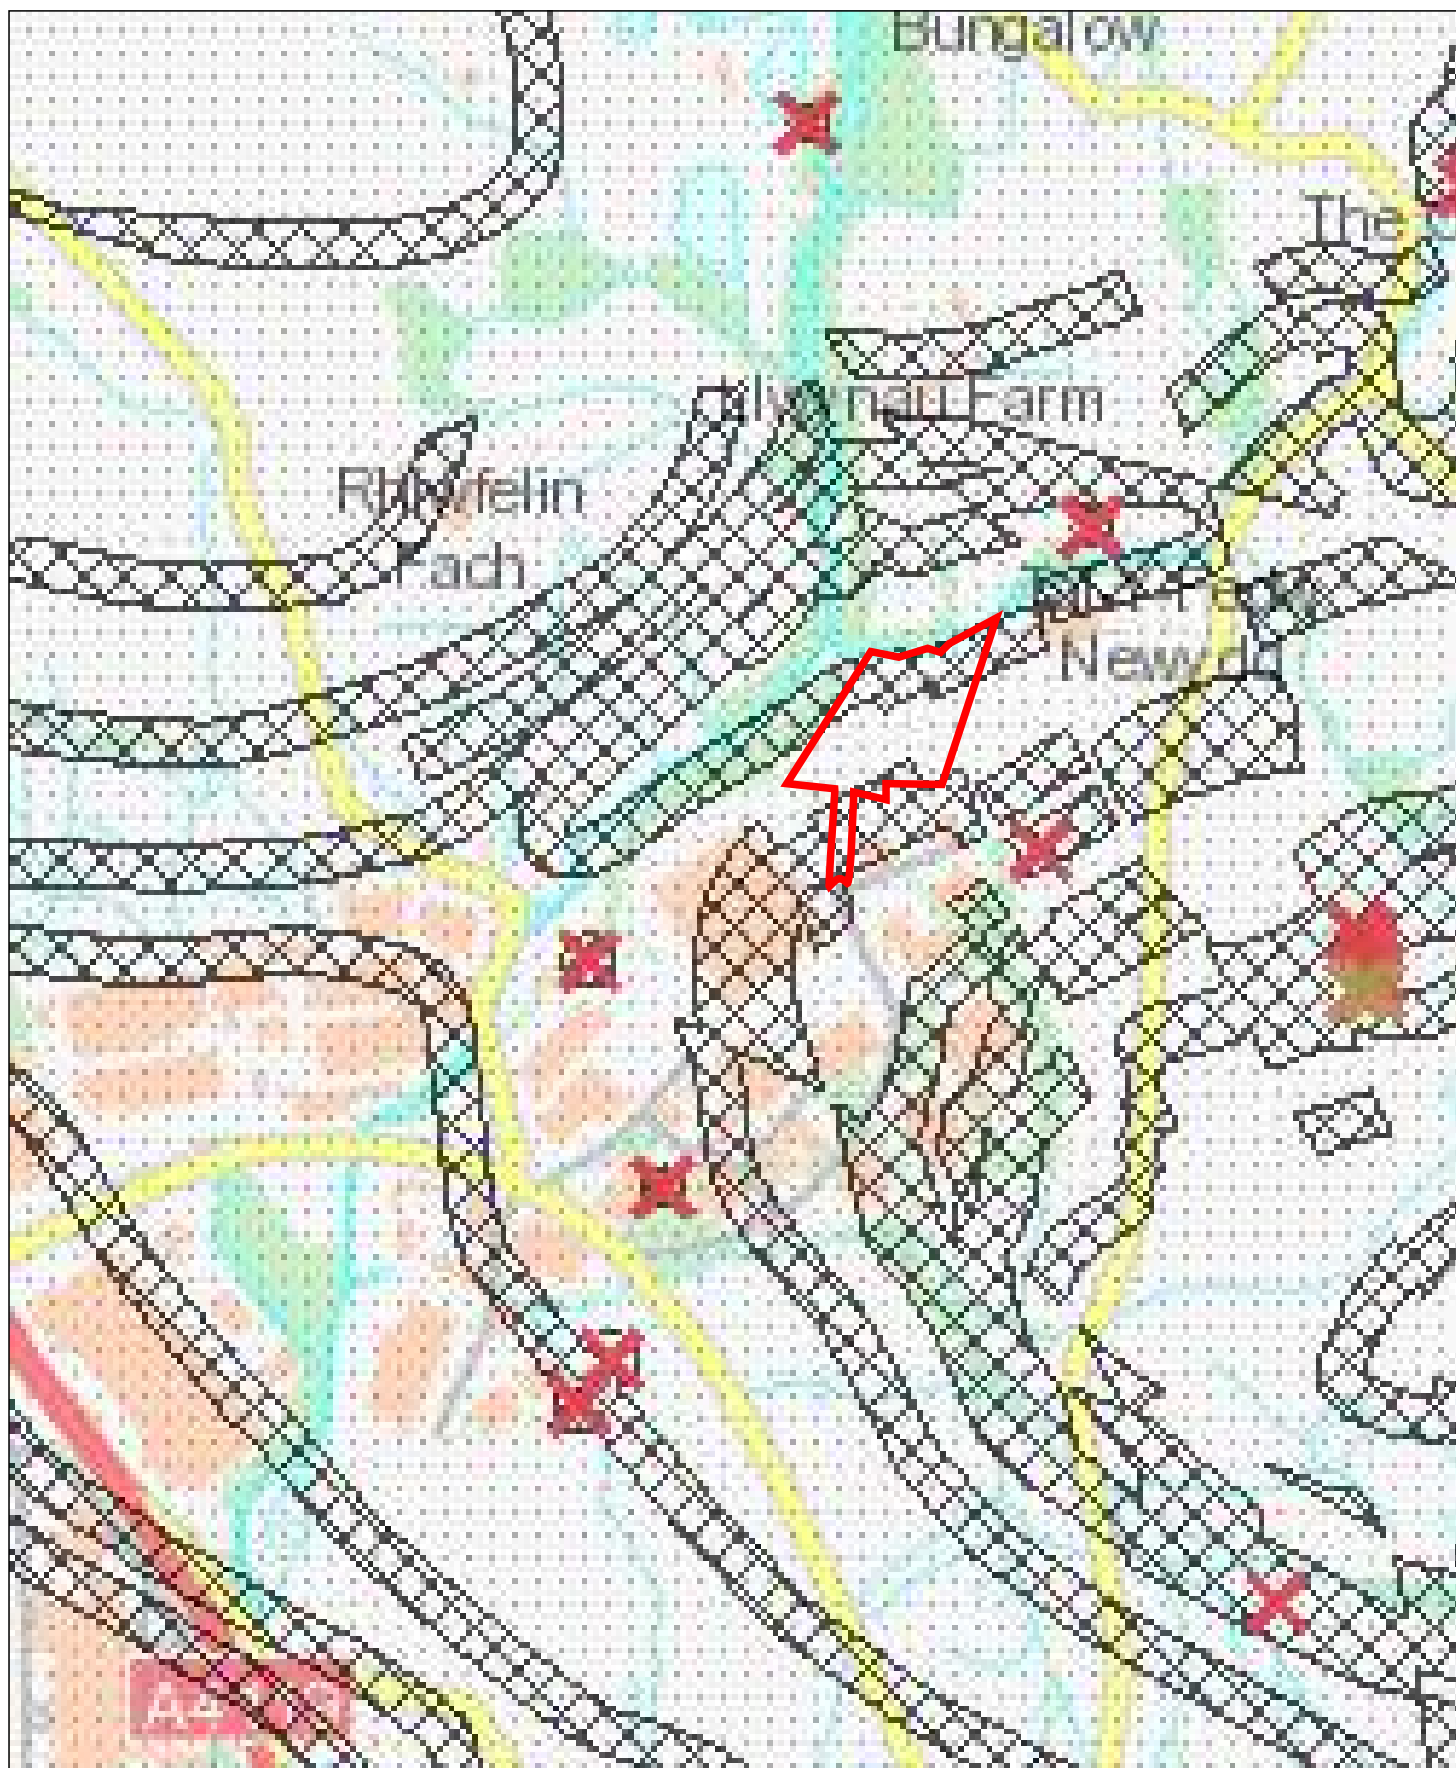
FIGURE 3A

SCREENSHOT FROM THE C.A. INTERACTIVE VIEWER SHOWING THE APPROXIMATE SITE BOUNDARY WITH DEVELOPMENT HIGH RISK AREAS HATCHED AND MINE ENTRIES MARKED (SHAFTS IN RED, ADITS IN BROWN)

2b) The C.A. interactive viewer contains a vast amount of information from various sources. Figure 3A overleaf is a screenshot of the planning window with the site highlighted. The site can be seen to straddle two areas of Development High Risk. The surrounding area has several shafts marked, although as stated in the report, none are within 100m. (One is just outside this limit and the relevance of this will be discussed later). The mining data window is far superior to the planning window as it is possible to zoom in to a greater magnification. However the seam outcrops shown seem totally alien to the outcrop pattern shown on other sources of information. Figure 3B shows the relevant section with the C.A. seam codes added and explained below the map. The author is in correspondence with the C.A. about this, but the matter is unlikely to be resolved prior to this risk assessment being submitted.

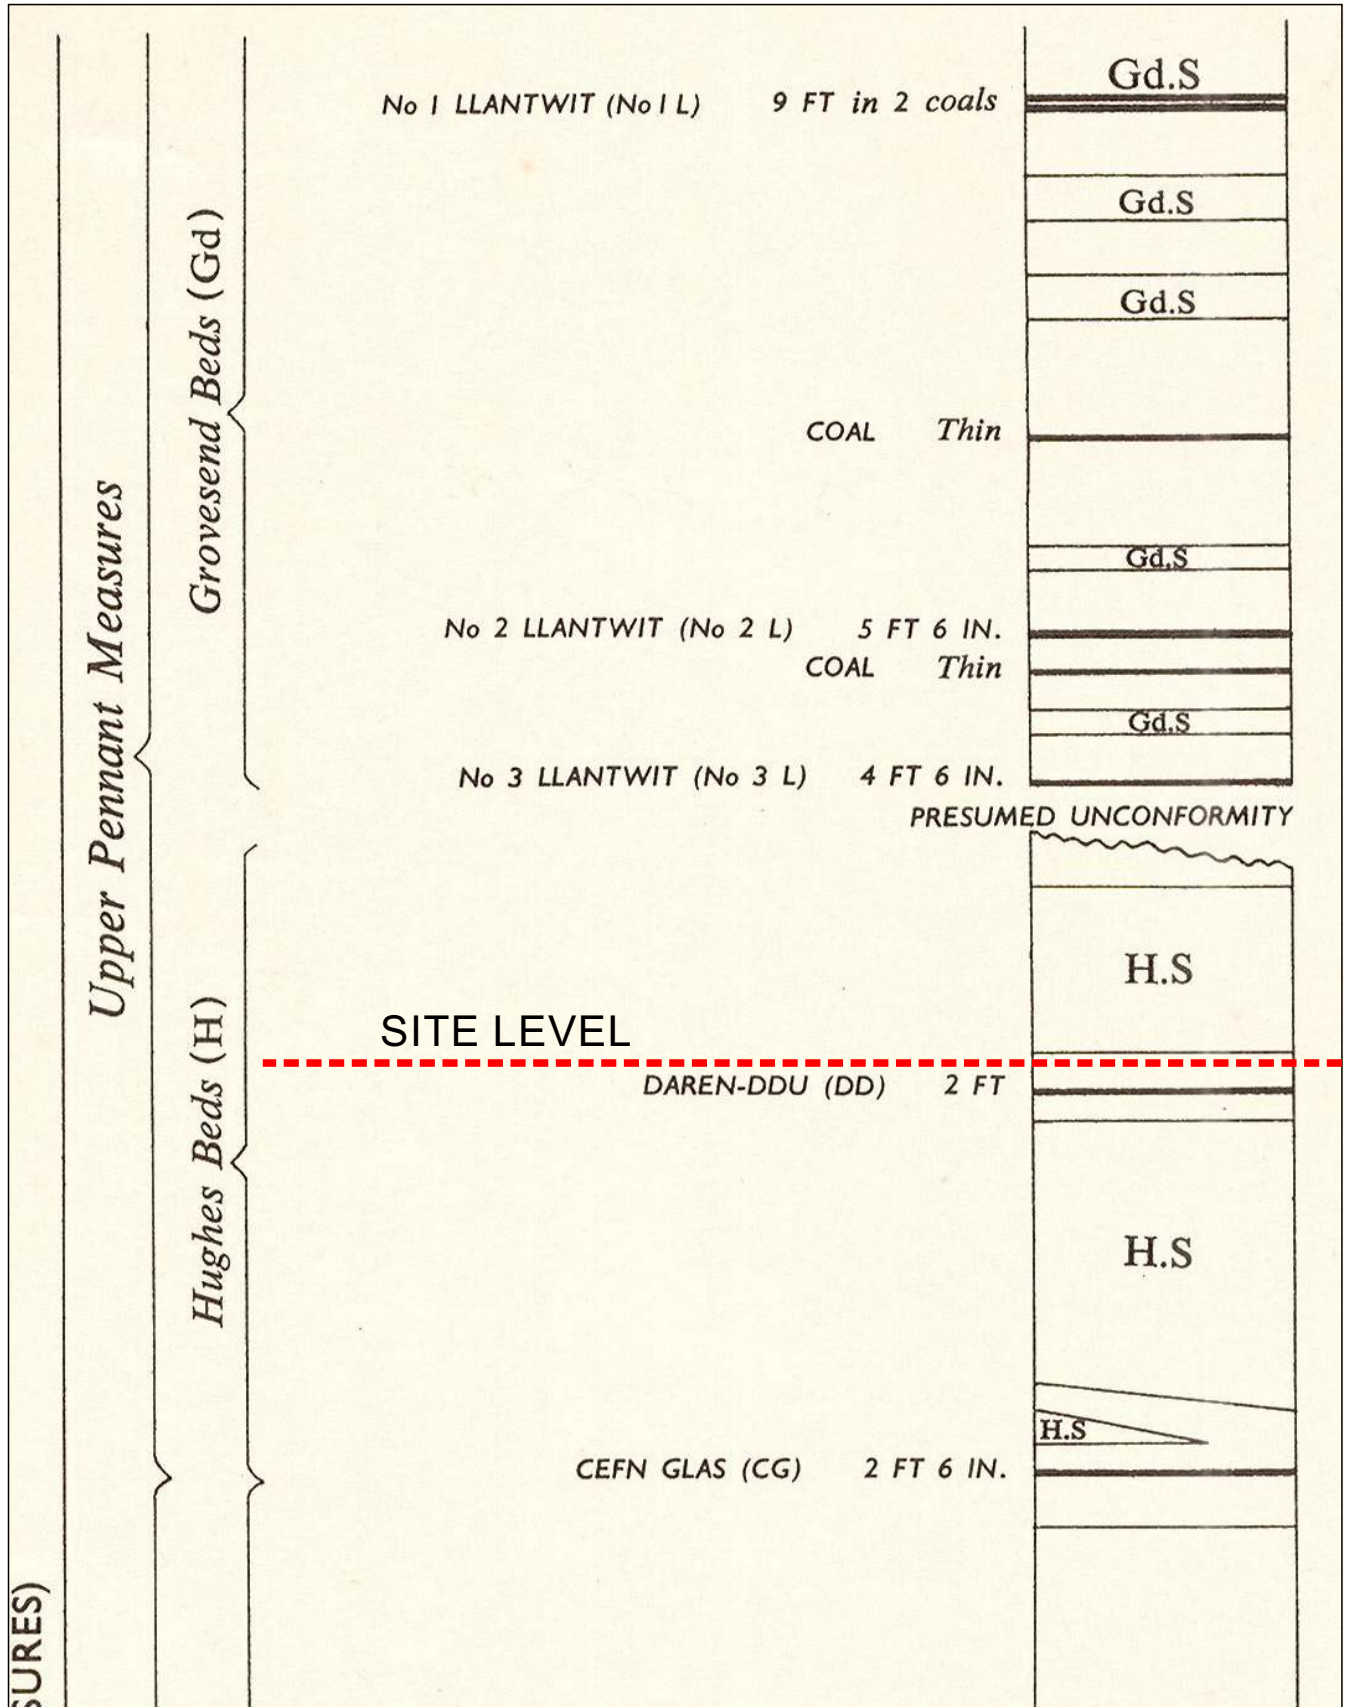
FIGURE 5  
SECTION OF STRATIGRAPHIC COLUMN FROM SHEET 36 NW

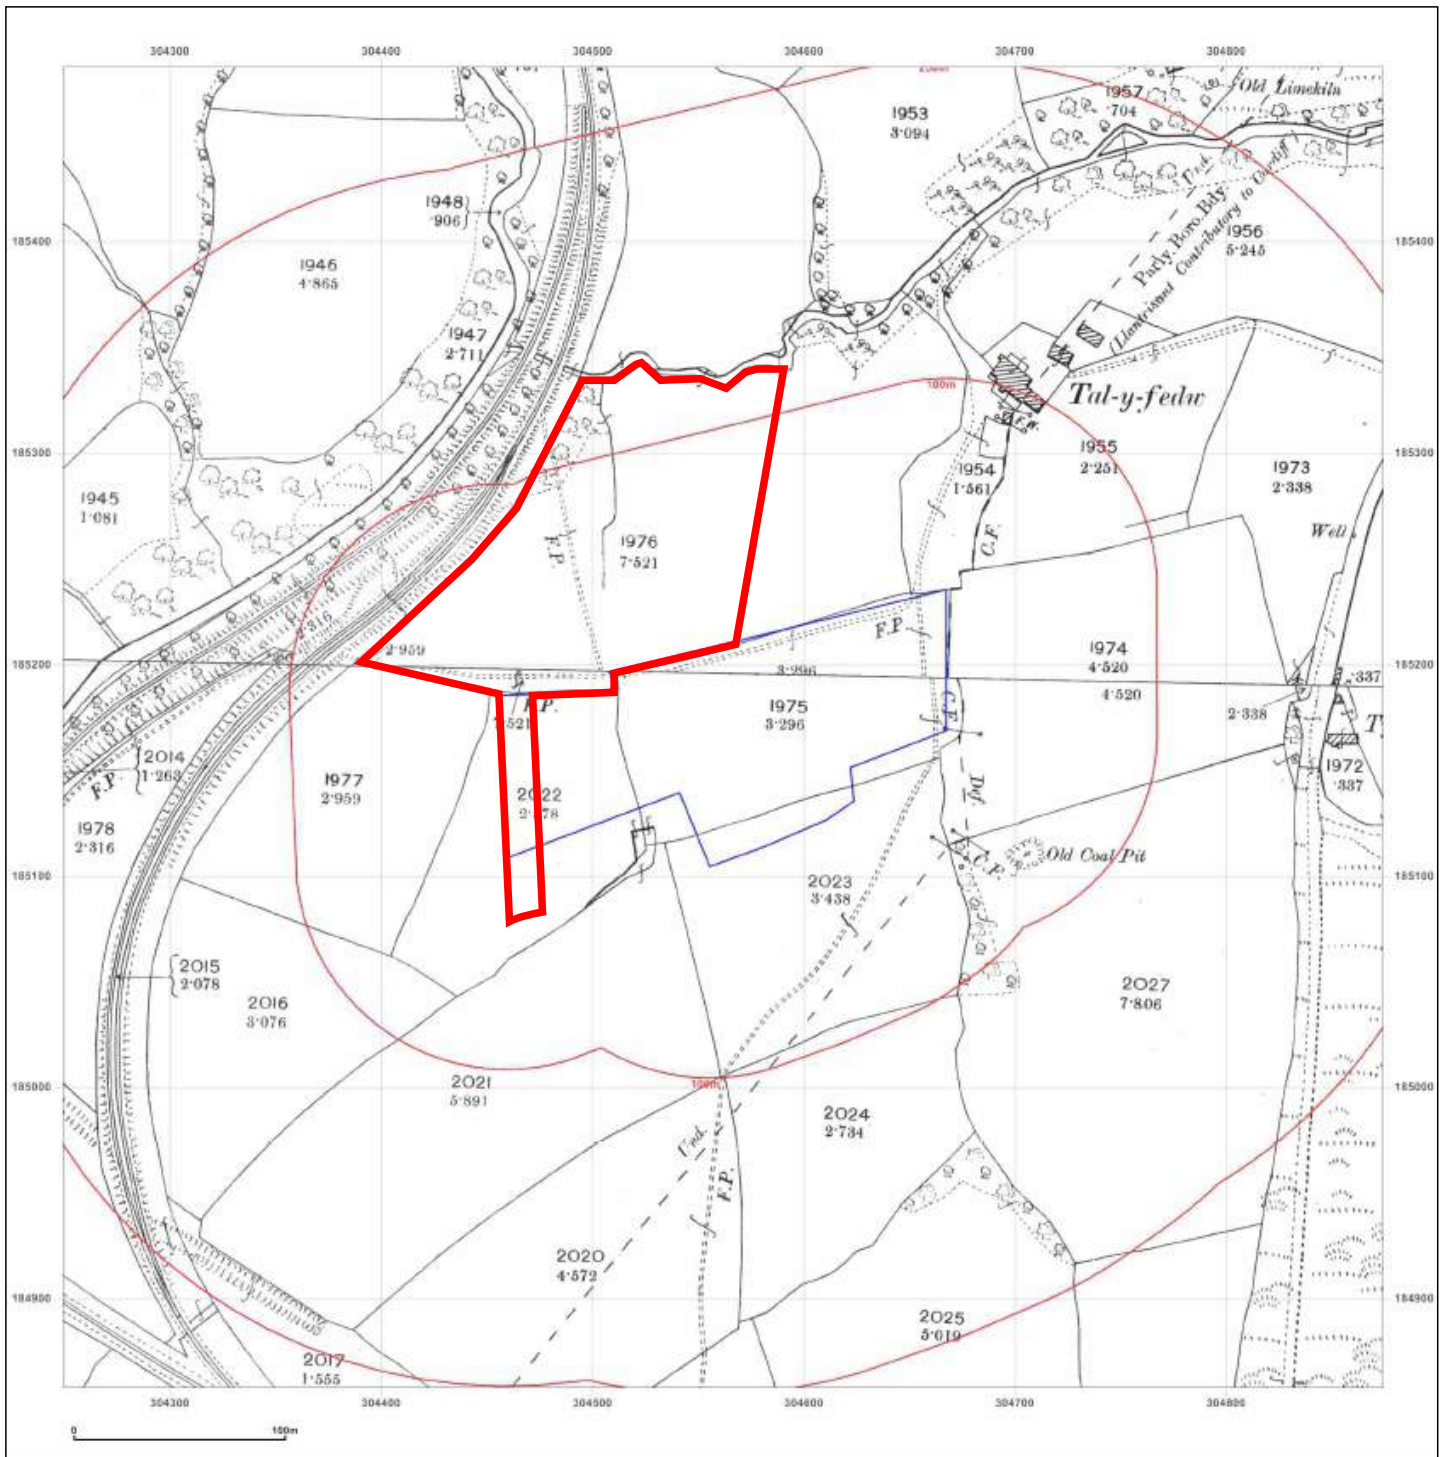
FIGURE 8  
THE SITE IN 1900

Moving on to Figure 8, which is the 1900 map the obvious difference is the development of the Treferig branch of the Taff Vale Railway which forms the western boundary of the site. This served the Glyn Colliery and several smaller levels several kilometres north of the site in Tonyrefail. Aside from that the site remains completely rural in aspect. The “old shaft” is still visible.

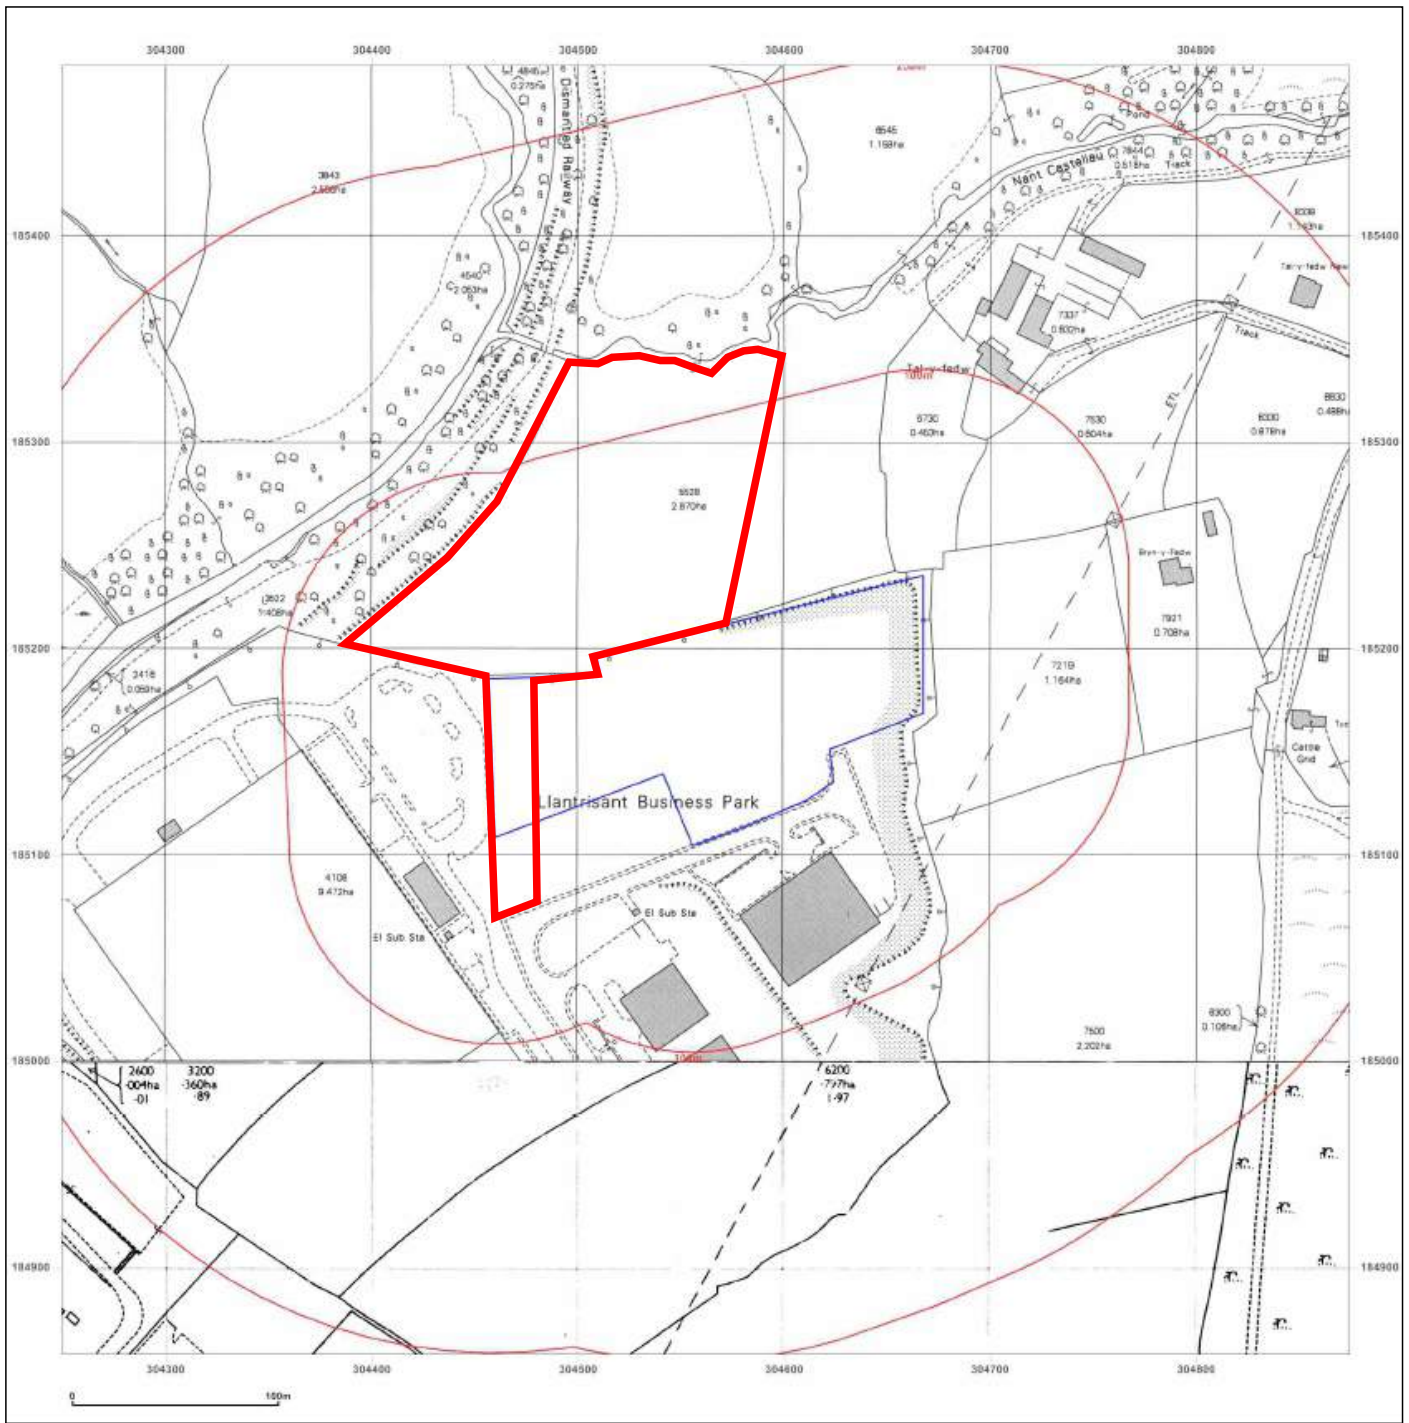
FIGURE 9  
THE SITE IN 1990

All other available 1:2500 maps were examined but none are reproduced here until the 1990 revision (Figure 9). The reason for this being there is absolutely no change in the site and surrounding areas. The only exception to this is the closure of the railway sometime between the 1919 and 1940 revisions. Even the field boundaries are unchanged. In Figure 9 Llantrisant Business Park has been developed nearly up as far as the site since its inception in 1969. To complete things almost up to the present day a 2014 aerial photograph is included as Figure 10. The common feature between all these maps is that there is absolutely no trace, over a period of nearly 140 years, of any activity near the

outcrop of the Daren-Ddu. Field boundaries remain intact, no spoil or annotated mining features are shown, in marked contrast to the surrounding area.

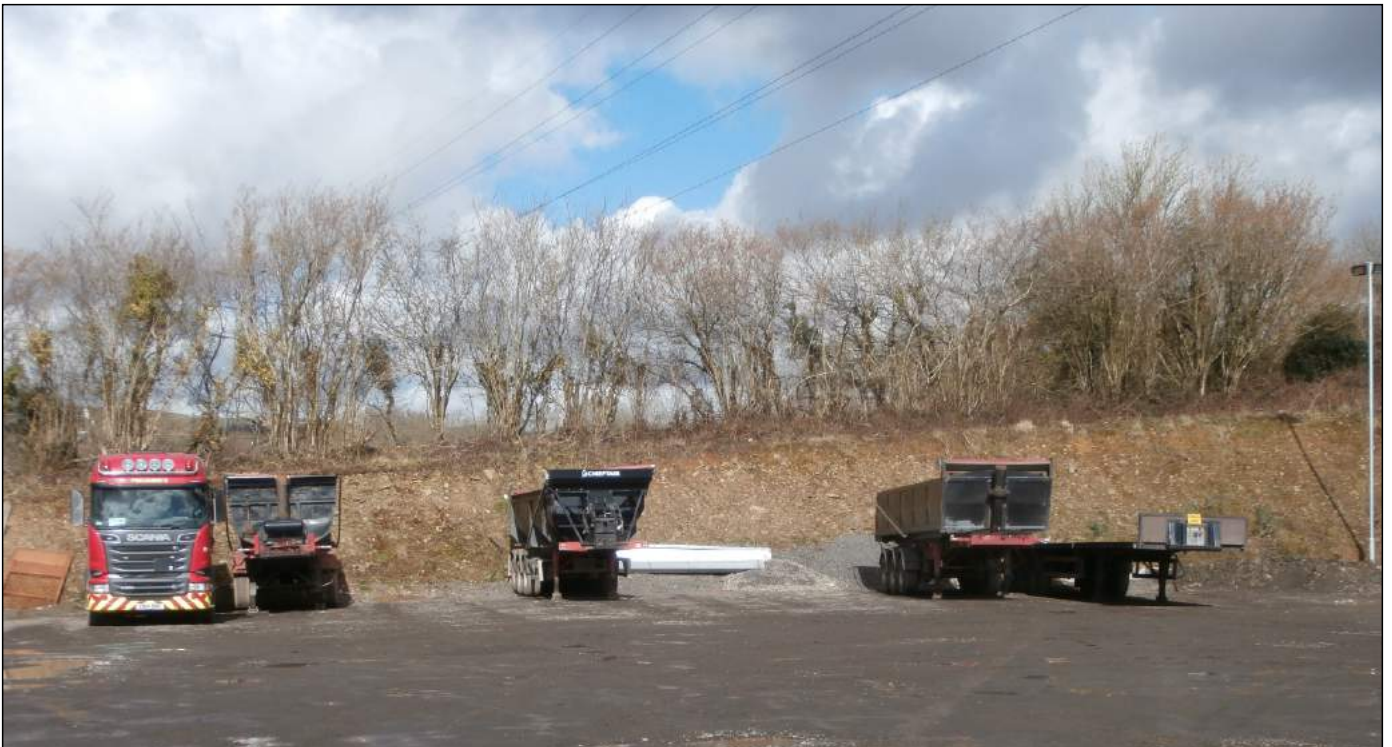
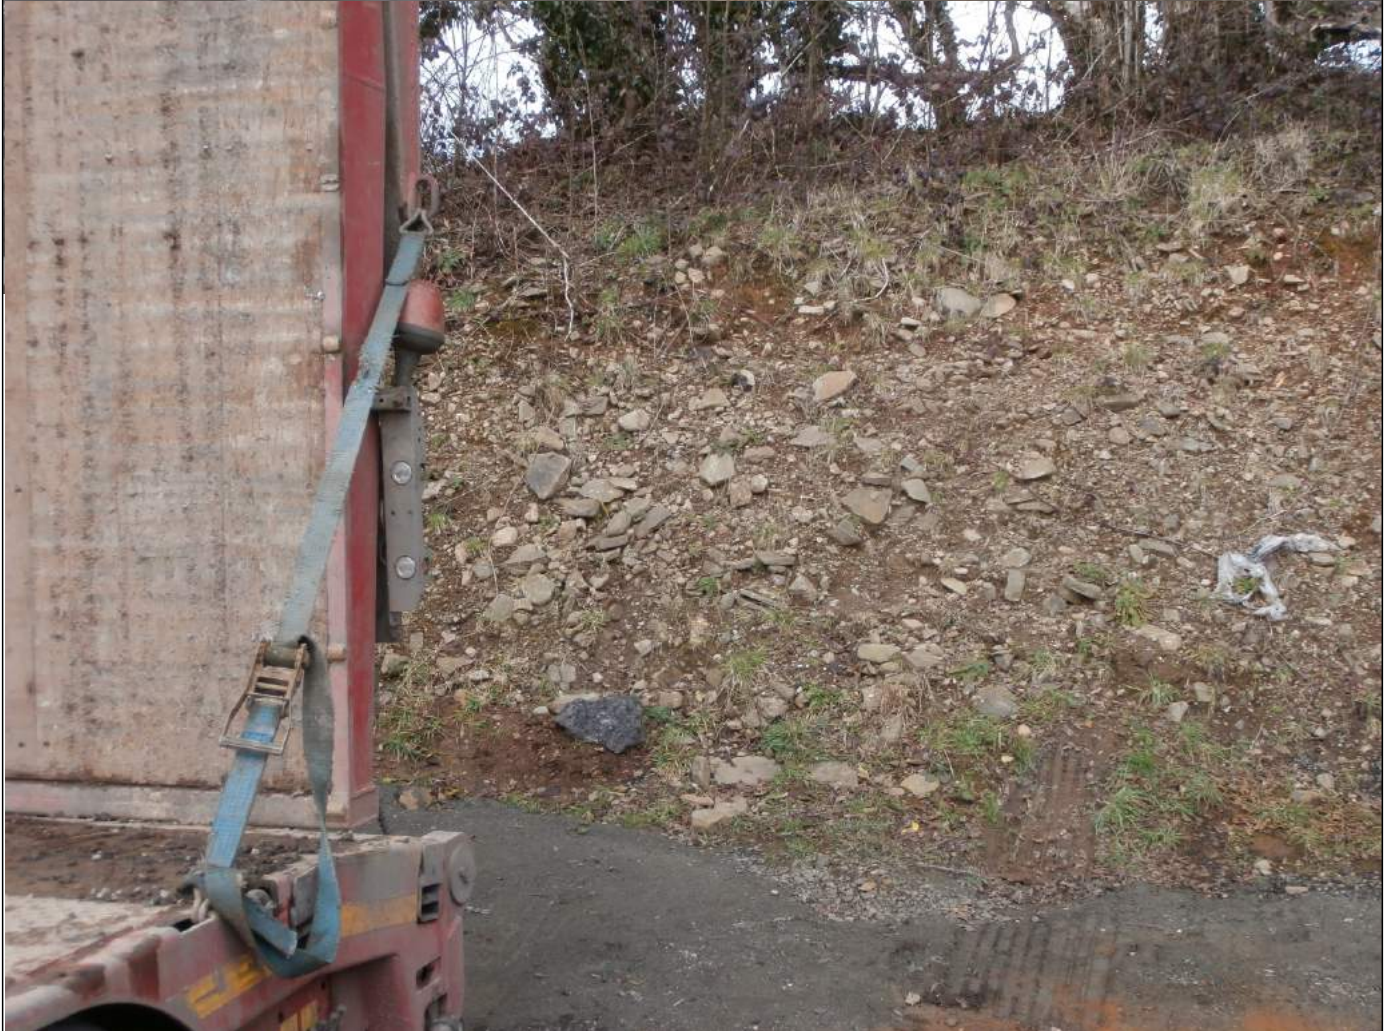
FIGURE 11 (TOP)  
CUT IN GLACIAL TILL IMMEDIATELY SOUTH EAST OF THE SITE  
FIGURE 12 (BELOW)  
CLOSE UP OF MATERIAL SHOWING LARGE, ANGULAR  
PENNANT SANDSTONE COBBLES AND BOULDERS

The site is adjacent to another that has been modified by a cut and fill operation. This enabled an exposure of the superficial material to be examined and photographed. Figures 11 and 12 show the cut and a close up of the material. This is a strong Glacial Till (formerly Boulder Clay). This forms a raised plateau on the site roughly five metres higher than the course of the Nant Mychydd. Figure 13 is a view of the site from the extreme north east corner of the boundary showing this plateau. It should be noted that this would be the ideal location to drive a level into the seam from a position above the river. The entire embankment was examined and there was absolutely no trace of it ever having been disturbed. Any level would have been easy to spot to the trained eye, on what was clearly virgin ground.

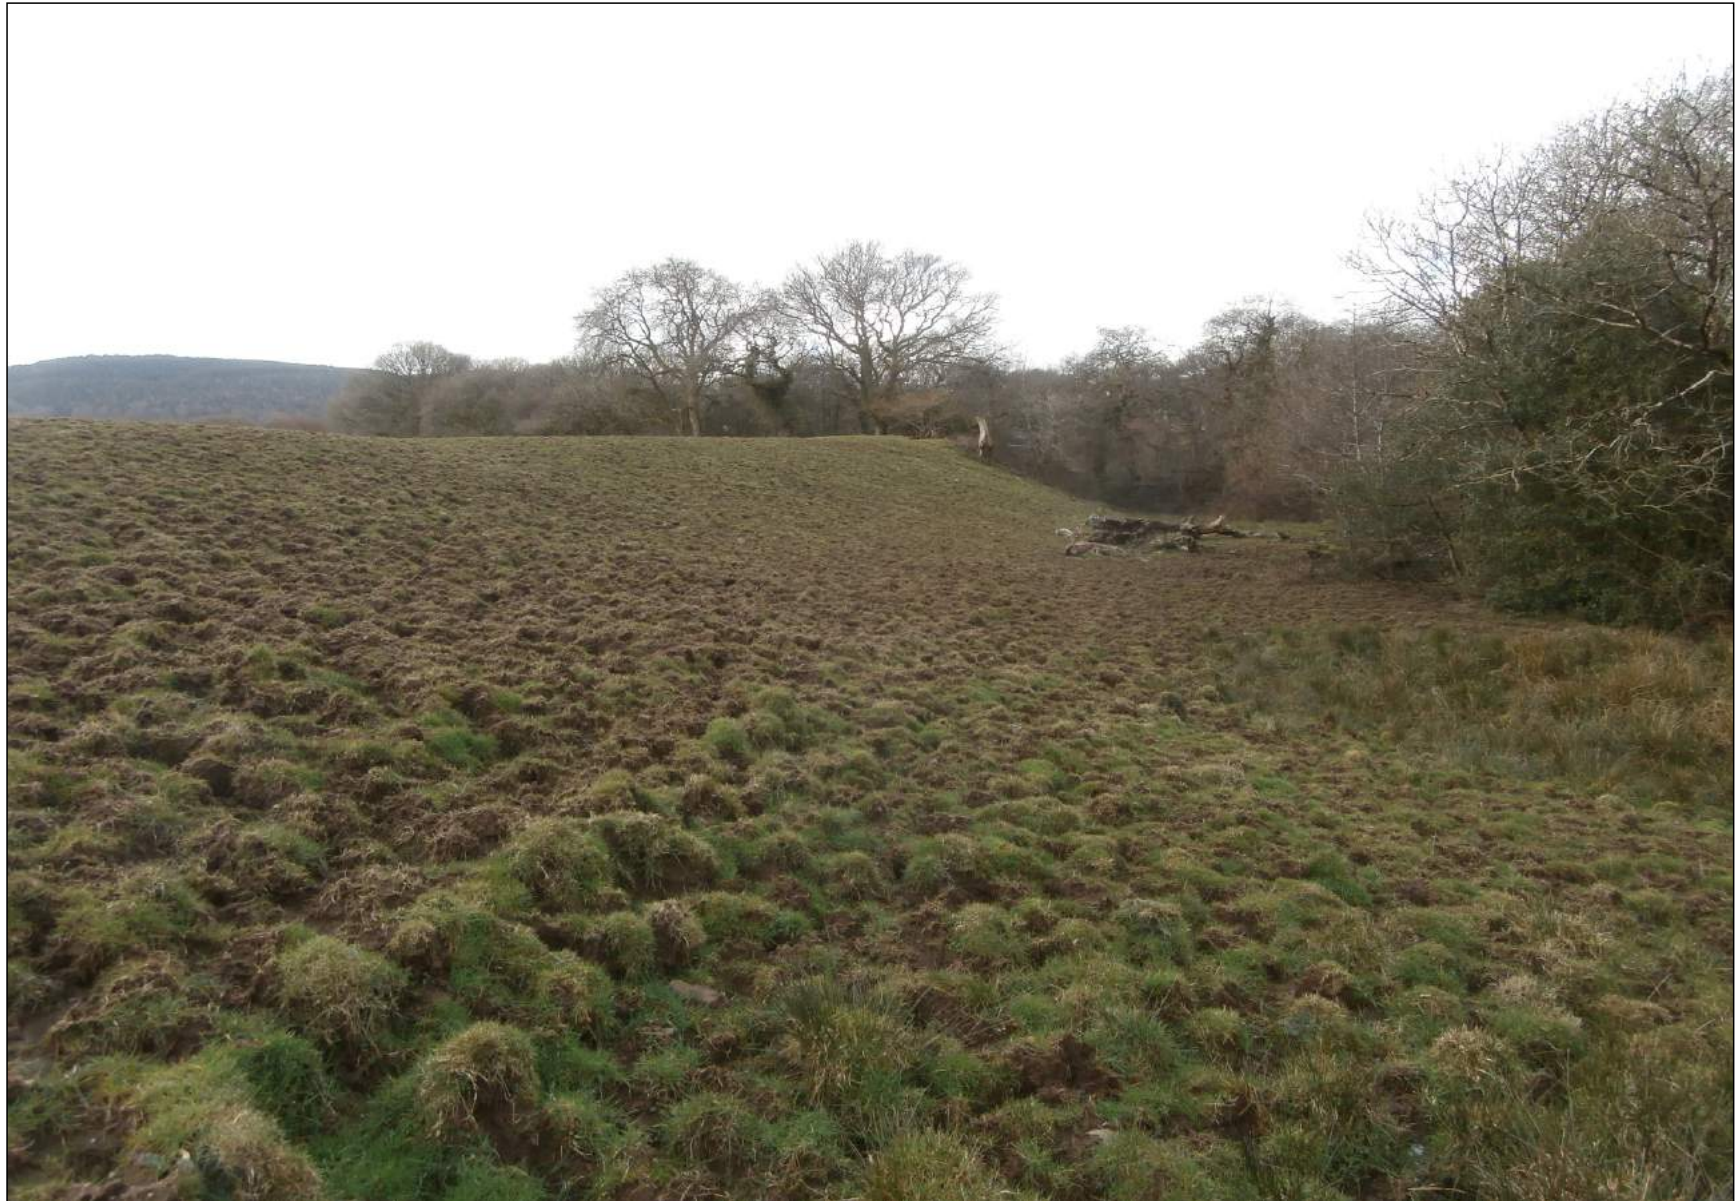
FIGURE 13

VIEW OF THE NORTHERN BOUNDARY OF THE SITE, LOOKING WEST FROM THE NORTH EAST CORNER OF THE BOUNDARY SHOWING PLATEAU OF GLACIAL TILL

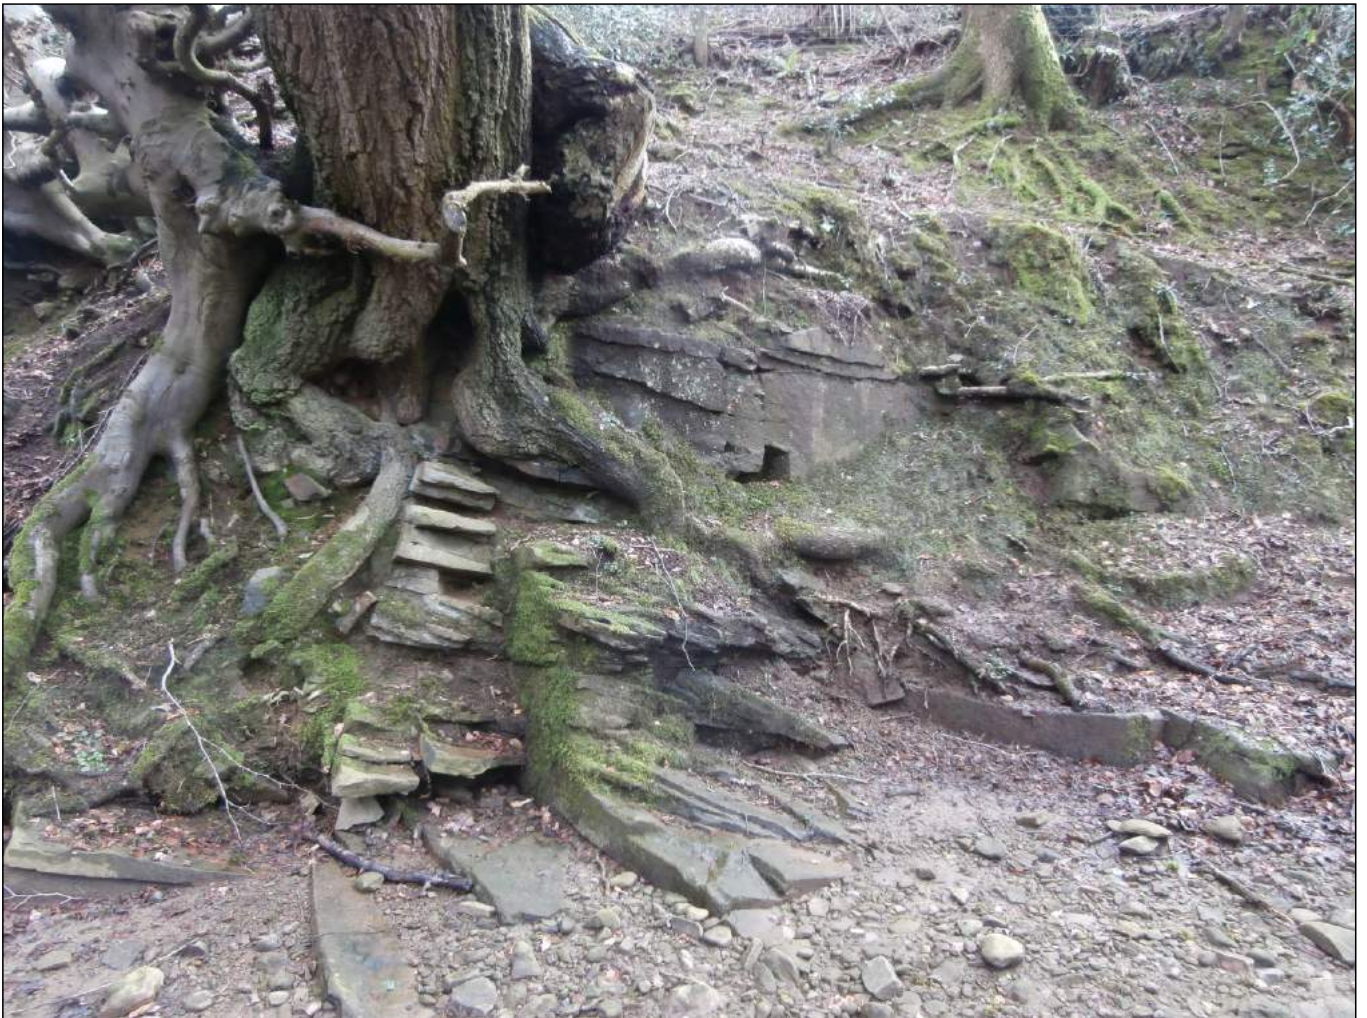
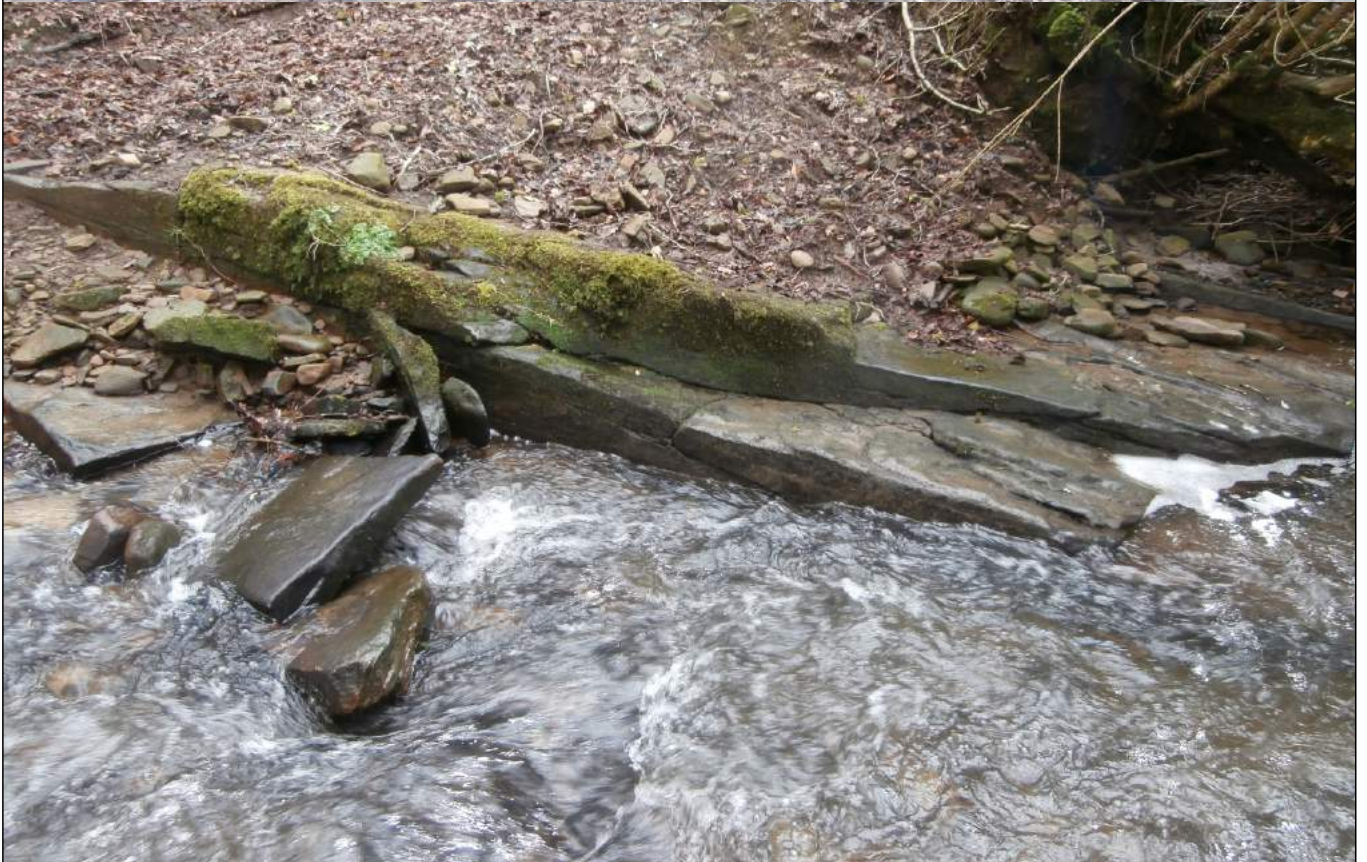
**FIGURES 14 AND 15**  
**OUTCROPS OF THE SANDSTONE ABOVE THE DAREN-DDU SEAM**  
**IN THE BED OF THE NANT MYCHYDD NORTH EAST OF THE SITE**

The author then travelled up the course of the small river to locate the exposed sandstone. This is presumably the sandstone that lies above the Daren-Ddu seam in the mining records. Since the dip is indeed 10°-15° to the south (Figures 14 and 15), this places the subcrop exactly where the Geological Survey have it. This is north of the site boundary, not on site as in the Coal Authority data. Nonetheless, unless it has been gouged out by glacial erosion, the seam will still underlie the site at shallow depth. Since topographic levels do not vary much from the site to the mining records to the south, rockhead must deepen southwards. The direction of dip coincides with the direction of local ice travel. This means the bedding and jointing of the sandstone would have facilitated deep erosion by the ice, but the bedrock profile under the site is unknown as there are no records of intrusive works in the area. Before leaving, the Llwynau shaft was located and photographed (Figure 16, C.A. ref 304185-011). As can be seen in the photograph the C.A. have recently remediated the shaft. It has been infilled with limestone cobbles and boulders. The standard C.A. stockproof fence has been upgraded by the farmer since the author's last visit.

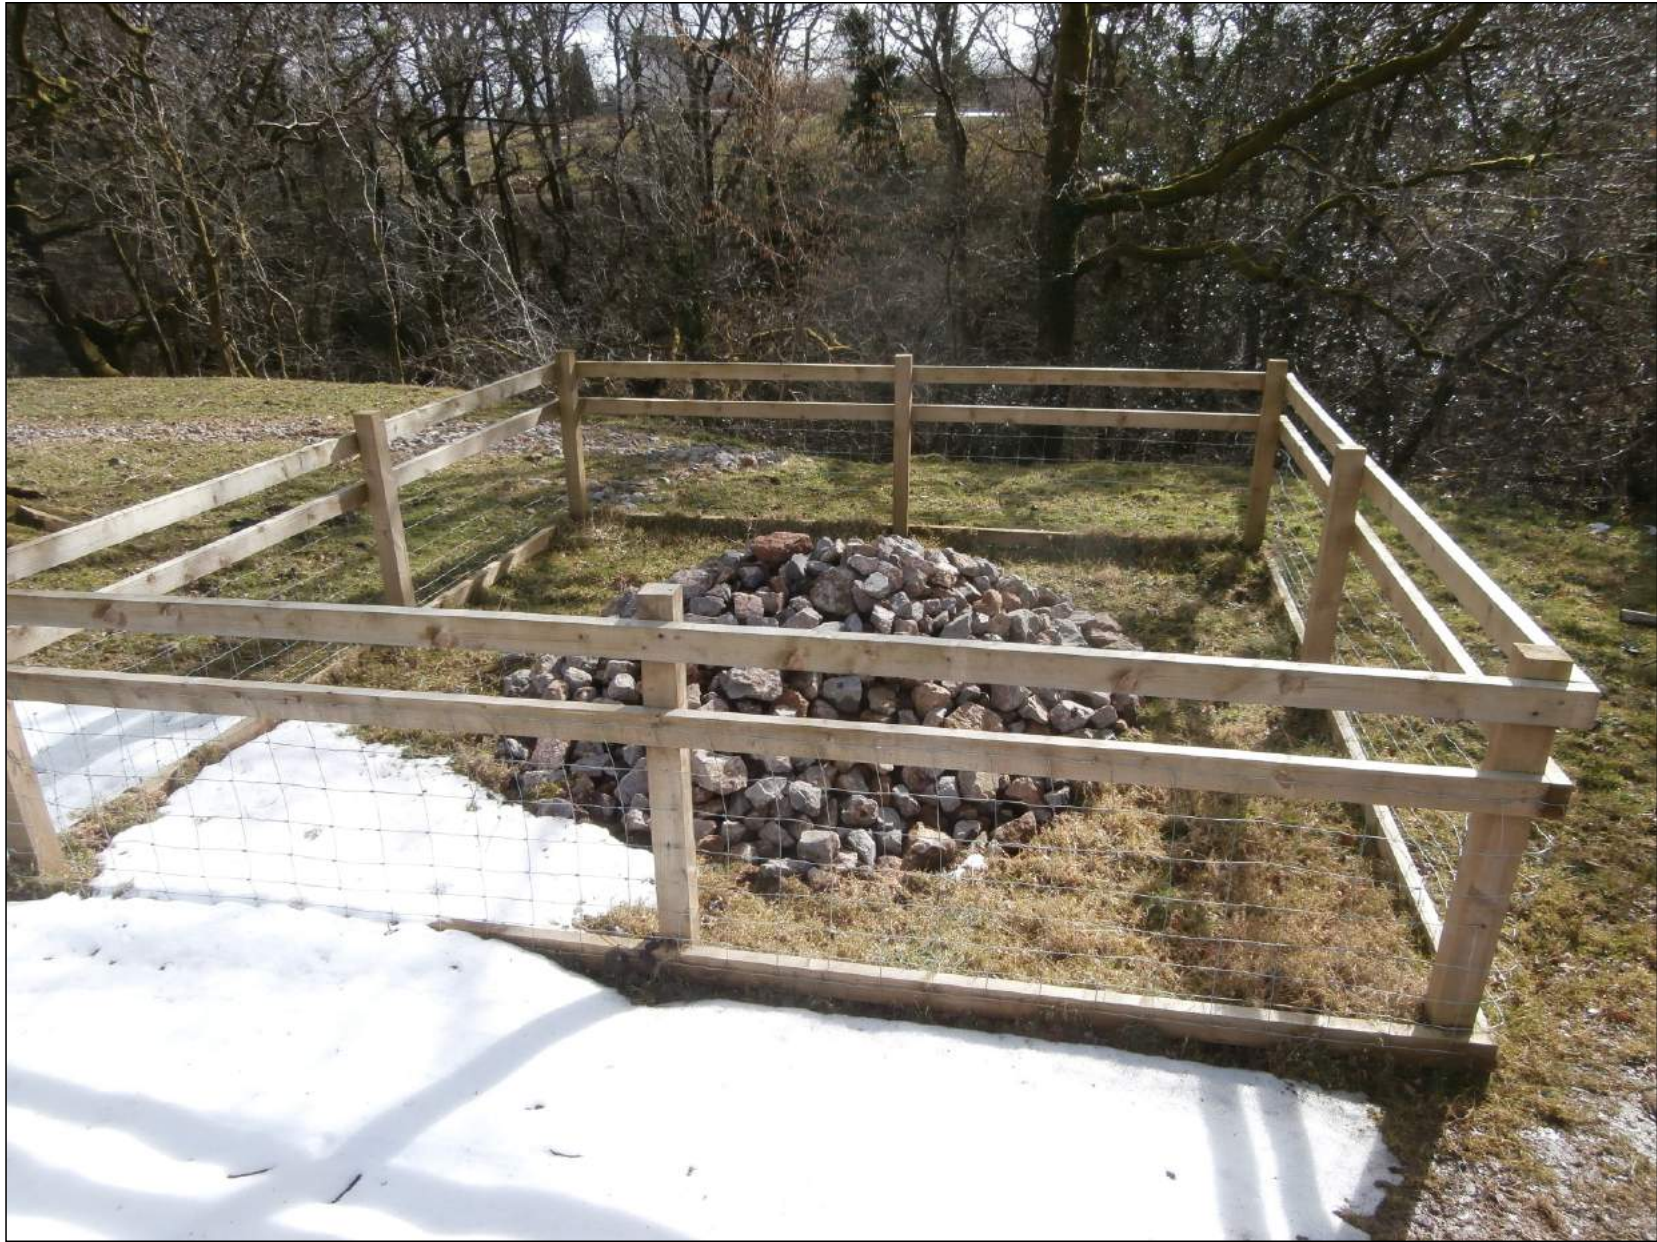
FIGURE 16  
TREATED LLWYNAU MINESHAFT (C.A. 304185-011) LOOKING SOUTH WEST.  
TAL-Y-FEDW FARM VISIBLE ACROSS THE VALLEY OF THE NANT MYCHYDD

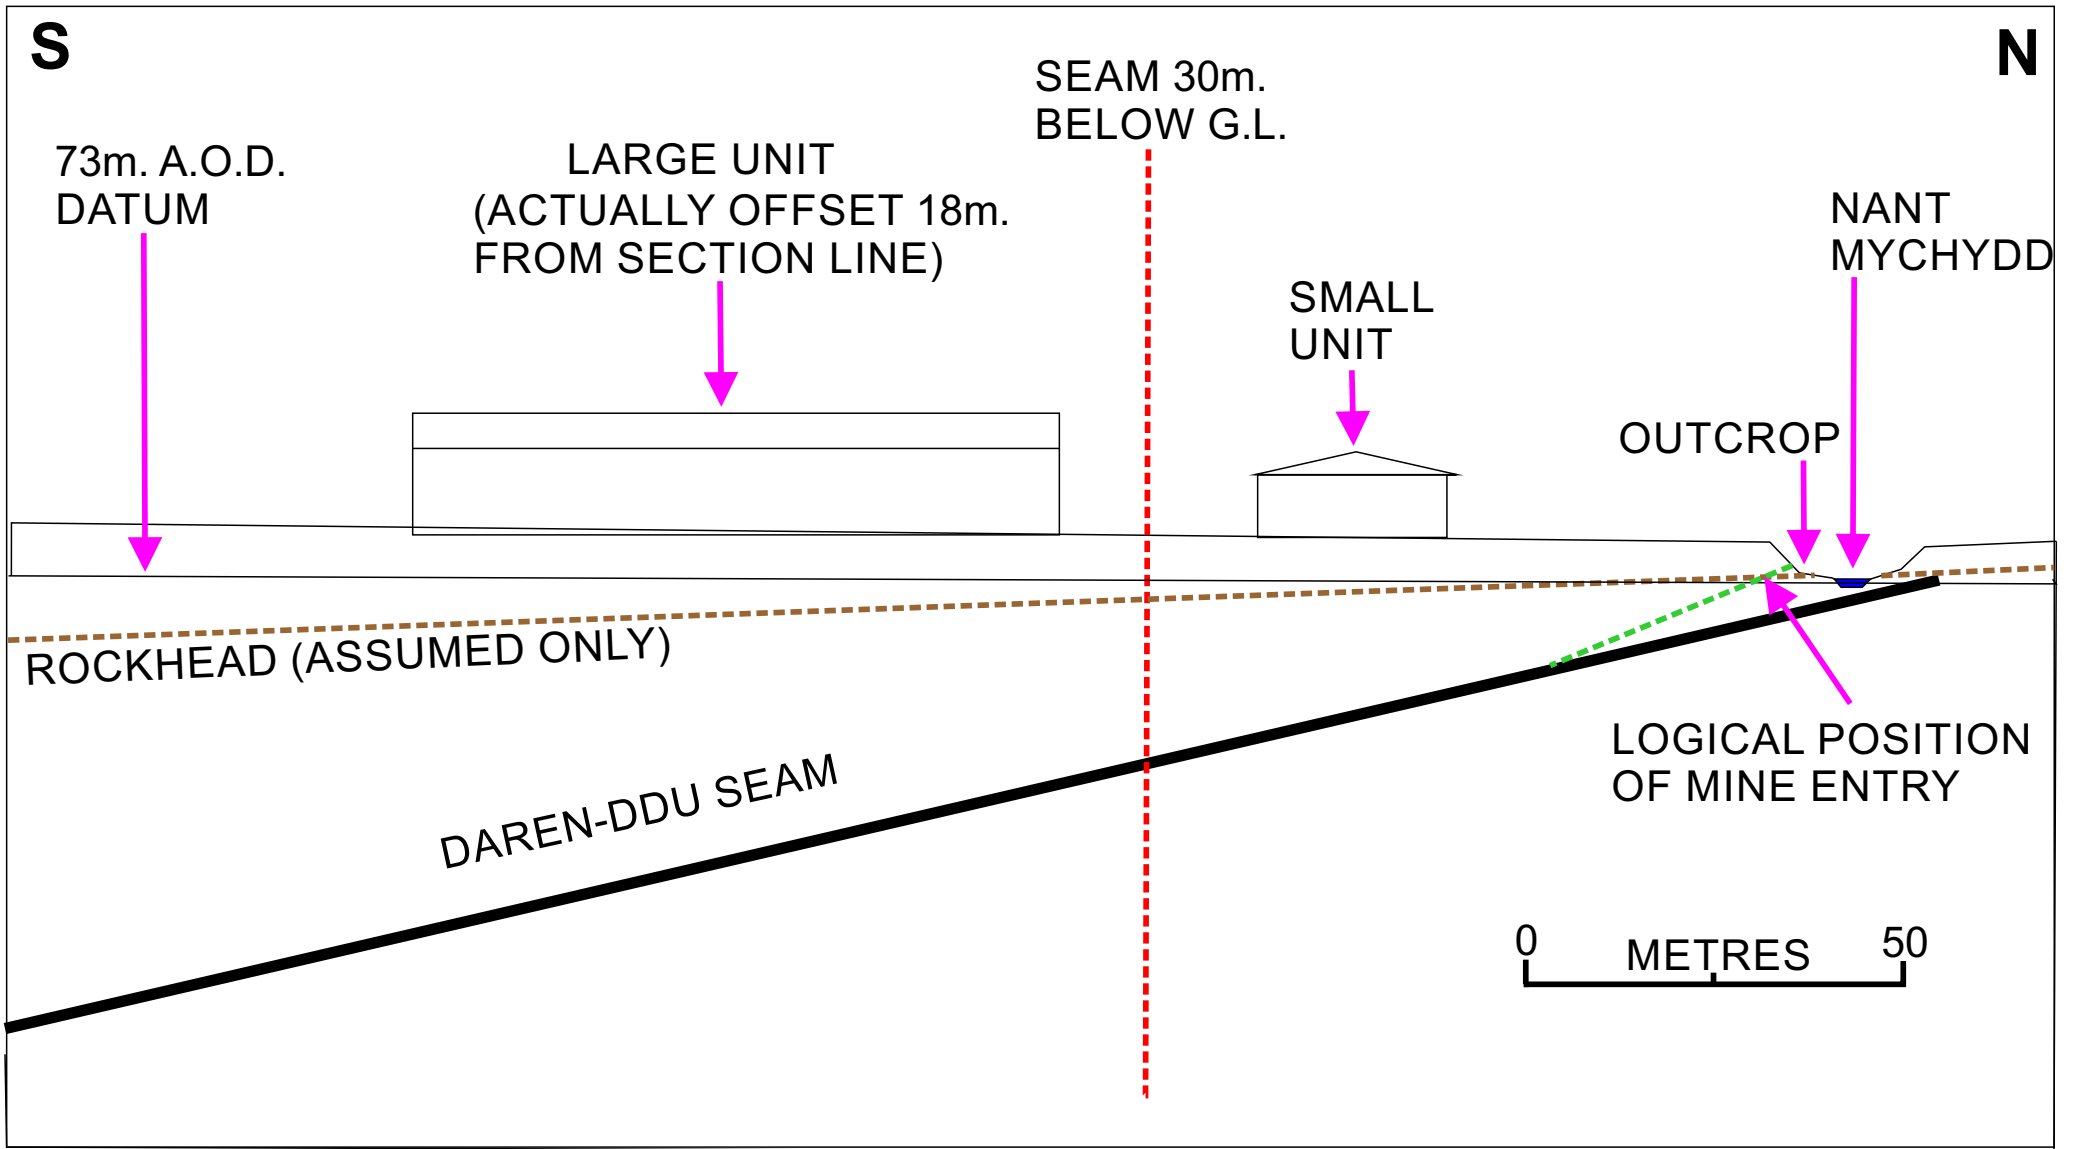
FIGURE 17  
 N-S CONCEPTUAL SECTION OF LLANTRISANT SITE  
 VERTICAL AND HORIZONTAL DIMENSIONS TO SCALE  
 (LINE OF SECTION SHOWN IN FIGURE 18)

The geological model to be used in this risk assessment has the Daren-Ddu seam on the northern limb of the Llantwit Syncline. This would mean the seam dipping southwards under the site at 10°-15°. Using the dip and outcrop position in combination with the topography, this would mean that the seam would be present at depths varying from 10m. on the crest of the plateau (land profiles are not being altered significantly, and the low area adjacent to the river will always remain undeveloped as a high flood risk area) to 57m. on the southern boundary of the main land parcel. At the northernmost line of the development the depth would be 20m. This is shown in the conceptual section in Figure 17, with the line of section shown on the site plan in Figure 18. The levels used are from a topographical survey of the site. It is entirely possible the shallowest part of the Daren-Ddu seam has been removed by glacial erosion since depth to rockhead is unknown. For the purposes of this risk assessment however, we shall assume it is still there. If this is the case, then it can definitely be considered “shallow” under a considerable area of the site. This is particularly true considering it is unknown how much of the cover is rock, and how much is Glacial Till.

trial shaft positions, although it was undoubtedly the intended target. Because of the thick drift cover this fact would not have been apparent until the Daren-Ddu was reached by the trial shafts. This was a common occurrence at the time where gaps in the geological knowledge, combined with estate boundary/mineral rights issues meant many sinkings were hit or miss enterprises with many failures. The Daren Ddu seam has a distinctive section, and it is informative to note the shafts went no further. The sinkers would have realised they were beneath the horizon of the No.3 and abandoned the shaft. The Memoirs clearly state that they are *trial shafts* and they record no attempt to exploit the seam, although the depth and seam section are accurately described. The reason for this would be the poor quality of the seam. Not only was the coal highly sulphurous, giving it a low price, but it was also thinner than elsewhere on the coalfield. These facts, combined with the large dirt partings, meant that mining the seam was not a commercial proposition. It is safe to conclude that the seam was never worked under the site from the south “on the rise” i.e. up the dip to allow gravity drainage to the shaft. Neither was it worked from close to outcrop, down dip (“to the deep”). Any adit type entries would have to be on the sharp break of slope up from the river. To attempt to reach it from the other side, driving under the river at very shallow depth would not make engineering sense and would be fraught with practical difficulties. Not least of these would be the inrush of surface water and drowning. This was far from unheard of close to the southern crop of the coalfield. It also seems probable that the river formed the boundary between two separate estates, ruling out accessing mineral reserves under one estate from another. Indeed the main function of mining surveyors at the time was to prevent this happening. The probability that the river was an estate boundary is indicated by the position of the Llwynau shaft. As mentioned in an earlier section, it is known that it was sunk to the Cefn Glas seam. Its position close to the estate boundary meant it could exploit the seam working up dip, allowing gravity drainage back to the shaft.
