FORMER GWALIA BUILDING, KINGSWAY, SWANSEA

BUILDING INSPECTION (PROTECTED SPECIES) & BAT ACTIVITY SURVEY

Document Reference: E24126101 / Doc 01 – November 2024

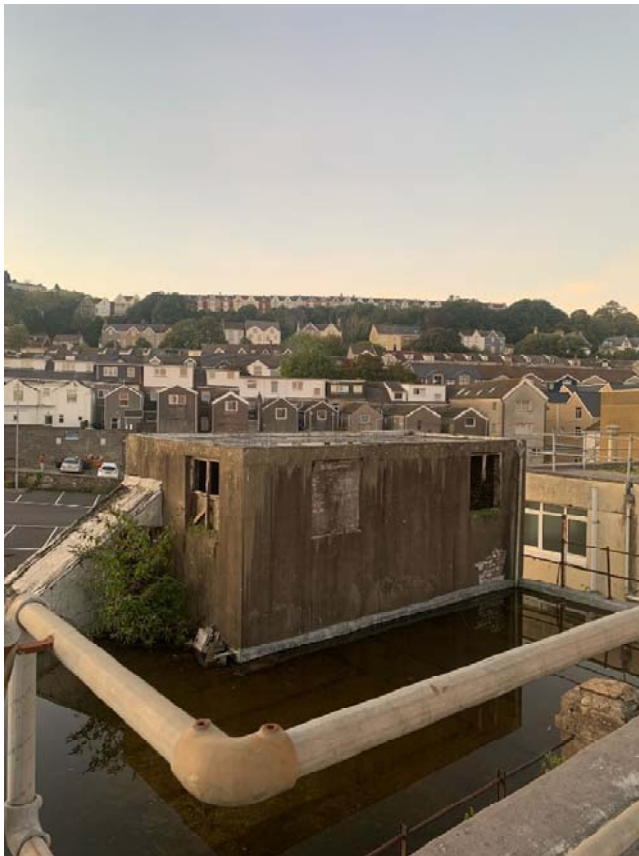
Plate 2 Surveyor View Of Roof-Top Structure To Garage Building

- 3.14 A brick built plant or storage room is present to the roof of the Evan Rees building in the north west of the plot – no direct access into this part of the building was possible (ladder present on the first floor was not considered safe to access although window openings were noted which could provide access for birds or bats – evidence of use by birds was prevalent to first and ground floor rooms (see 3.11 & Appendix III)).

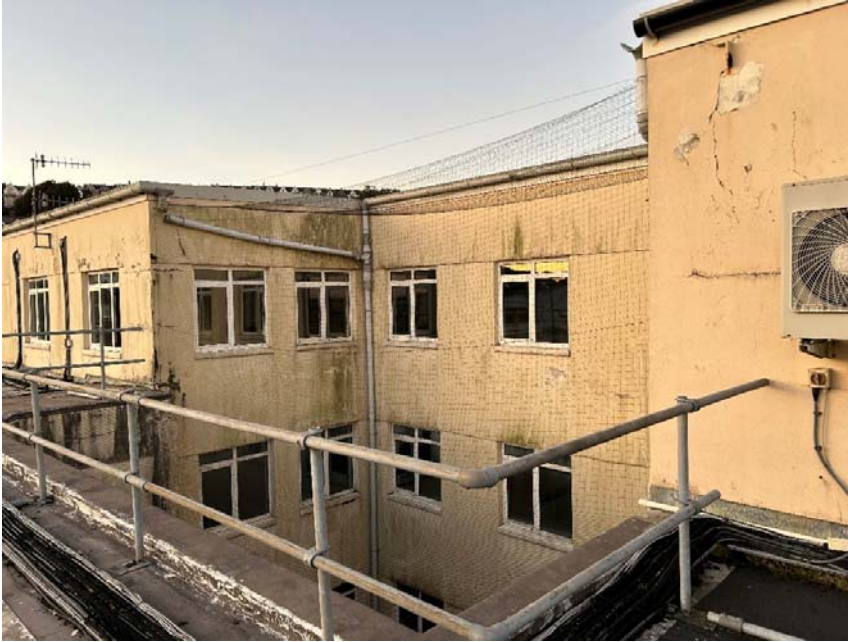
Plate 3 Surveyor View of West Elevation of Four Storey structure

- 3.18 The western side of the four storey structure was covered in netting – presumably as a deterrent to nesting birds and it was considered that this would limit/prevent any access to the building at this location. No obvious bat roost features were identified here (e.g. see Plates 3 & 4) although desk study records (from 2014) identified records of individual bats in this area. Review of the Night Fox camera footage confirmed no observations of emerging bats over the course of the survey.

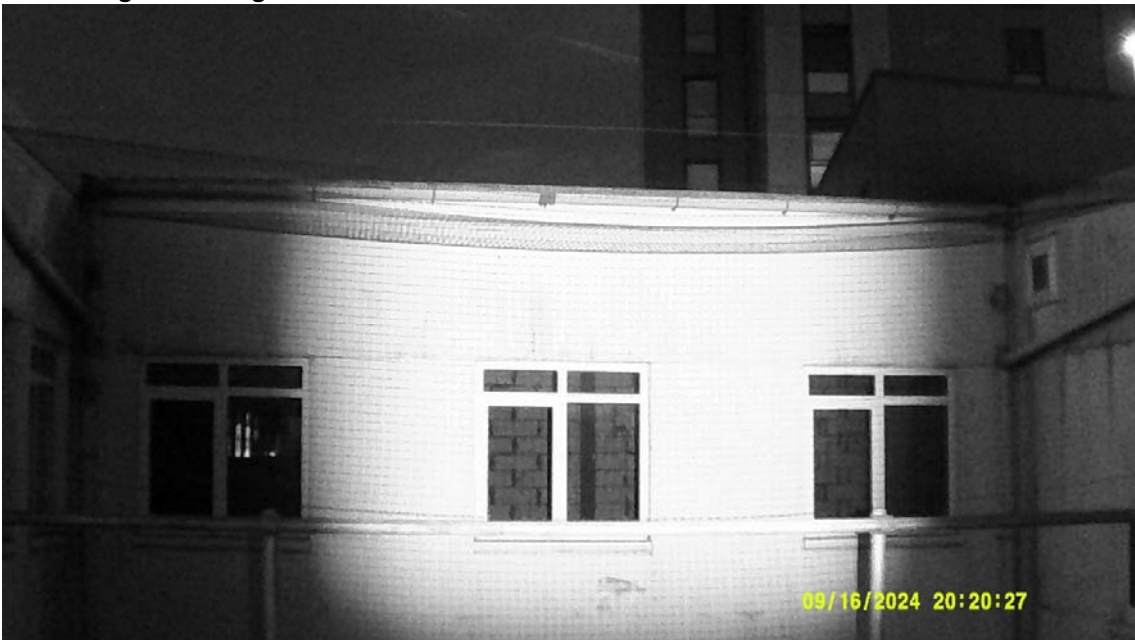
Plate 4 Night Fox Image of Part of Western Elevation

- the intensity of use (e.g., likely number of bats, time and duration of use).
- 2.11. The dusk survey commenced 5 – 10 minutes before sunset at 19.20h and extended for 90 minutes after sunset to 21.00h. Surveys were conducted using broad-band bat detectors (Peersonic, EMT-2 & Pettersen D240x). Bat calls were either identified in the field or using computer-based sonogram analysis software (e.g., Wavesurfer or Analook Insight). Surveyors (2) were positioned on the ground at the north west corner of the building and on the roof (2) to allow direct views of the roof-top structure on the garage building and the 4th storey element of the offices where desk study records (see 3.2) had identified individual records of roosting bats. To supplement the surveyor observations, Night Fox Whisker night vision camera was positioned to view part of the four storey structure – the camera was set up to record over the duration of the survey (i.e. from 19.20h – 21.00h). The features visible from surveyor locations are illustrated in Plates 1 - 3 with a still image taken from the Night Fox at 20.20h at Plate 4.

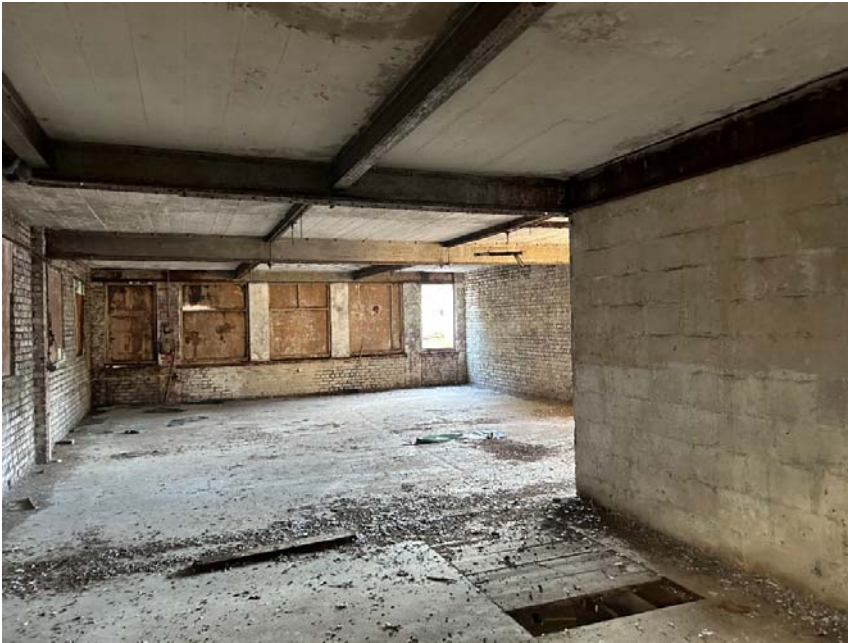
Plate 5 First Floor of Garage Building with evidence of use by Feral Pigeon.

- 3.12 The interior of the garage building has been similarly subject to a soft strip and only exposed steel joints and concrete panel ceilings remain – no features suitable for use by roosting bats were identified and the window openings are such that the first floor in particular is well lit (Plate 5).

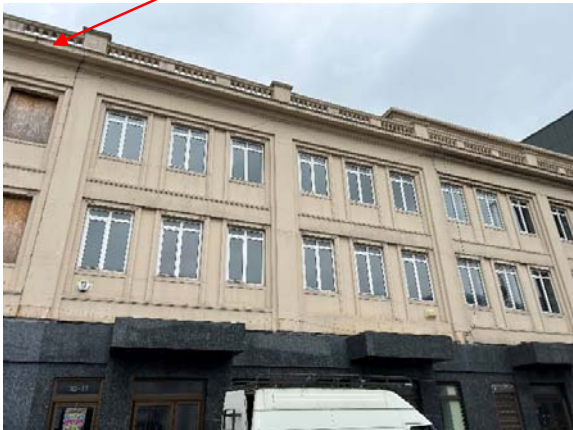
<p>Building is located along Kingsway which is a busy commercial road in the city centre. No notable green-infra-structure in the immediate or local areas with buildings and hard standing the dominant features.</p> <p>Overall Negligible/Low potential for use by roosting bats</p>

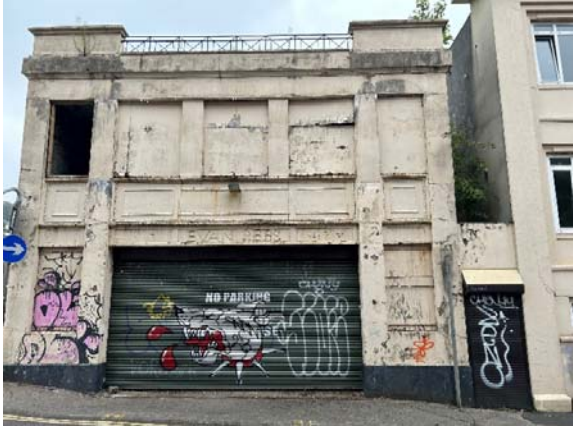
<p>Evan Rees Building</p>	<p>Separate 2 storey, flat roofed rendered building to the north west corner of the plot – Evan Rees is carved into the stonework above the large roller door.</p>

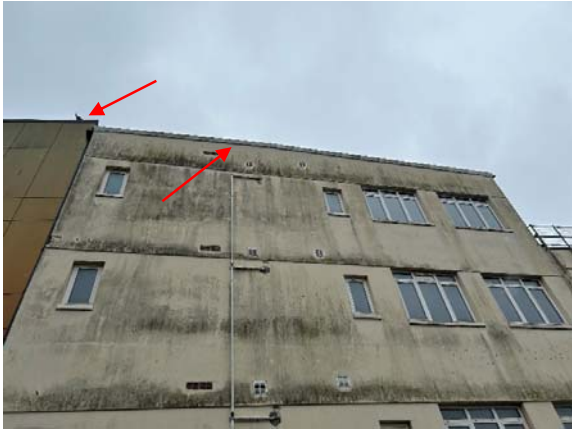
Fascia to north-east corner is slightly raised (zinc or other metal fascia) – no external evidence of birds or bats visible on render. Street lighting is present. Gull noted perching on corner of adjacent building to the east.

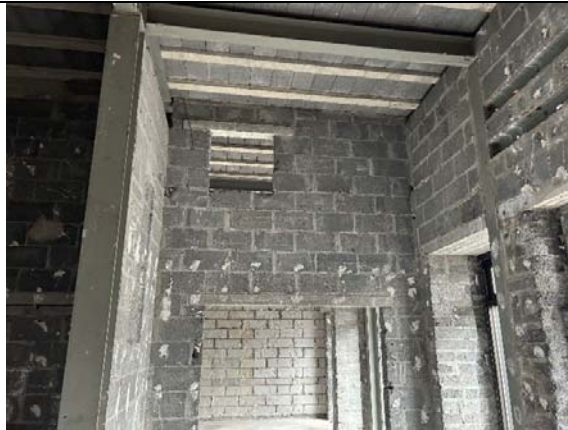
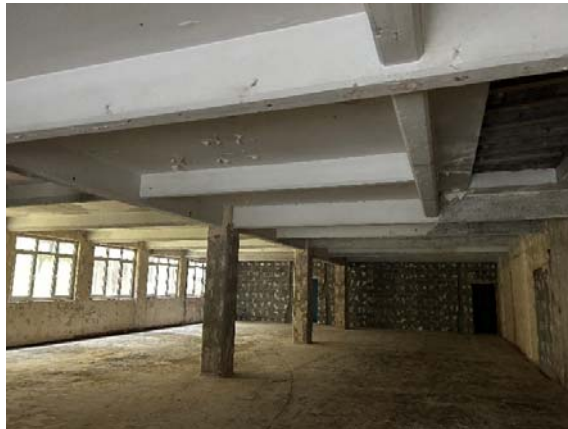
Interior – ground floor & basement

Soft strip and asbestos removal has been completed and walls/ceilings to ground, 1st & 2nd floor are exposed – bare block work and ceilings of concrete and steel beams. No obvious means of entry for birds or bats to ground floor and no evidence noted. Rooms are light/open and unsuitable for use by bats.

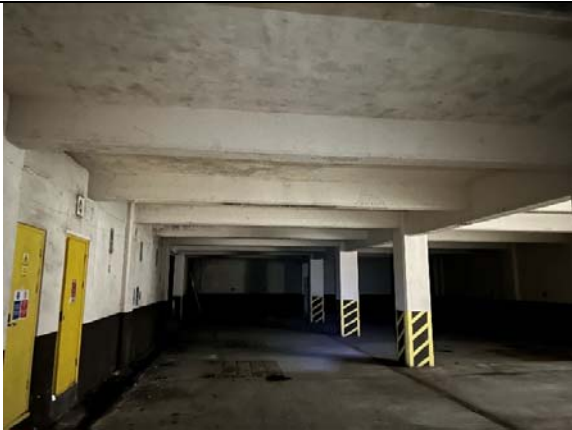
No internal evidence found on stairwell or in main car park area. Roller door to northern side of access ramp and switch/fuse room to east of door also lacking in any evidence of birds or bats.

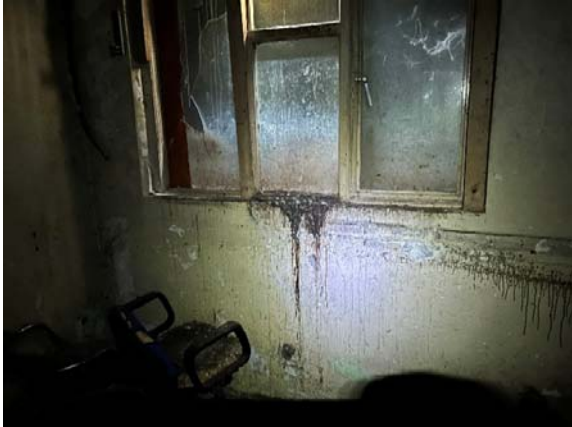
Old bird droppings noted within storage room to west side of basement car park – no recent evidence or live/dead birds noted.

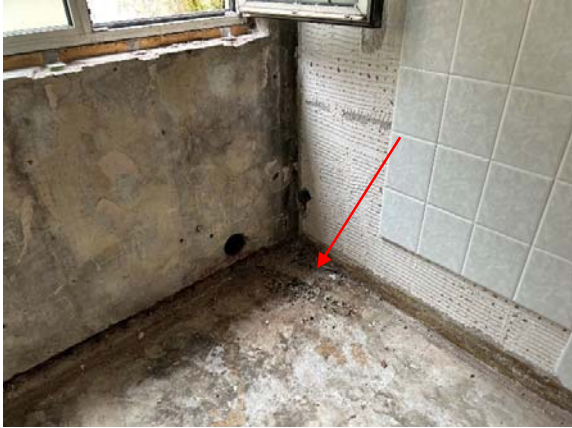
First floor

Open window to stairwell to first floor – no evidence of birds or bats noted. Scattered bird feathers and droppings to western side of first floor with larger accumulation of droppings to open window (in W/C) on western side.

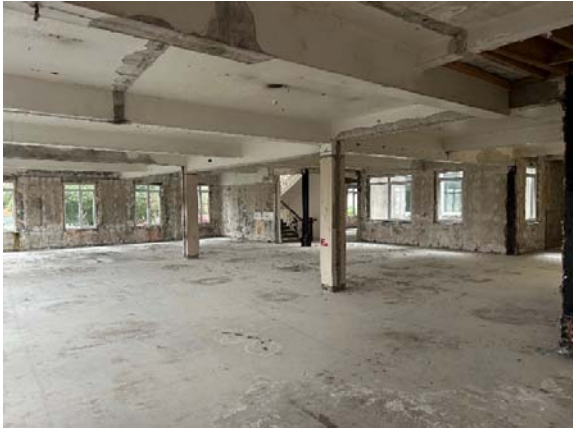
<p>Other areas of first floor as noted for ground floor – soft strip works done and ceilings/walls exposed. Light open spaces considered unsuitable for use by bats.</p>

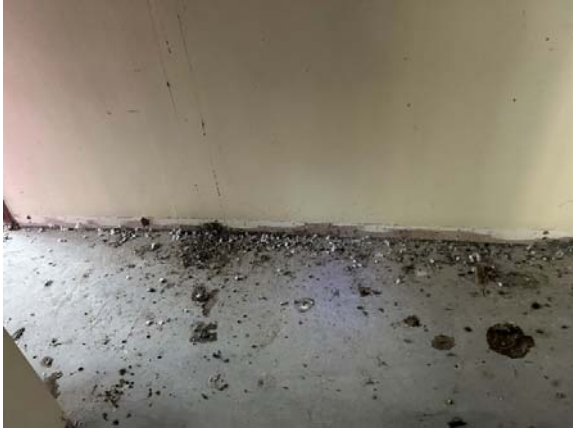
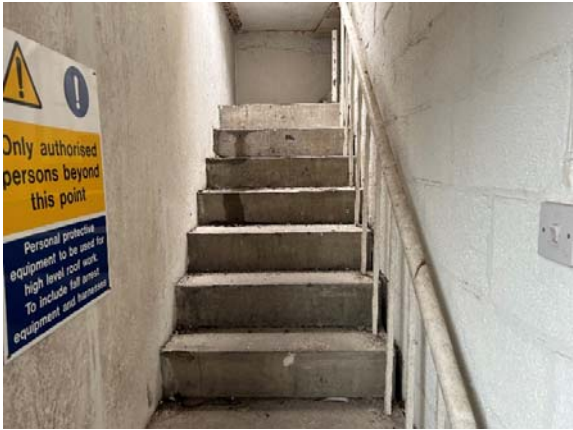
<p>Second floor</p>	<p>As noted for ground and 1st floors. Scattered bird droppings to stairwell to western side of building (open window to second floor noted during external check). No accumulation of evidence here – larger area of droppings noted to eastern side of building where open access to roof is present (covering to roof hatch is open/missing).</p>

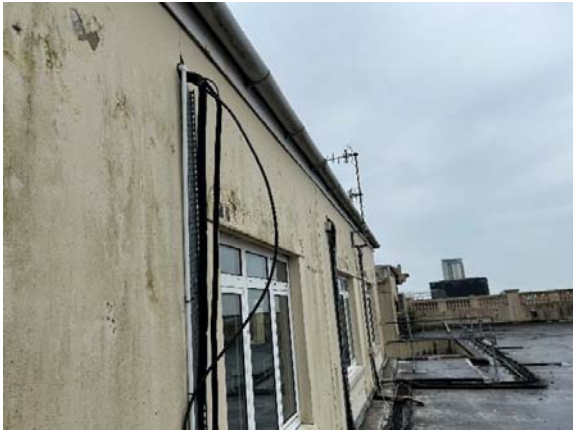
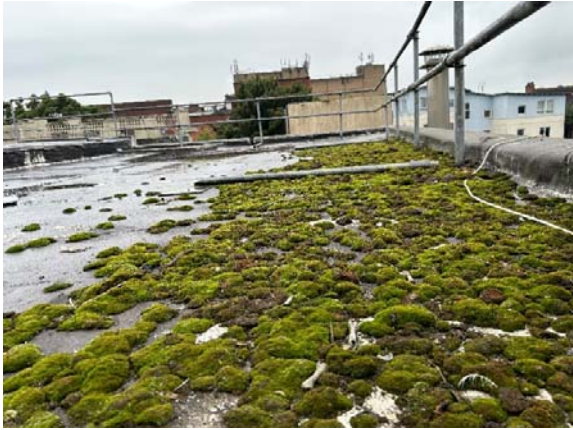
<p>Flat Roof</p>	<p>Flat roof area is sound and parapet walls with no obvious features for use by bats. Fascia and windows to 3rd floor rooms on roof are sound – no external evidence of bats noted. Numerous chicken bones scattered across roof suggest use by gulls/corvids. Could be used by nesting gulls during breeding season.</p>

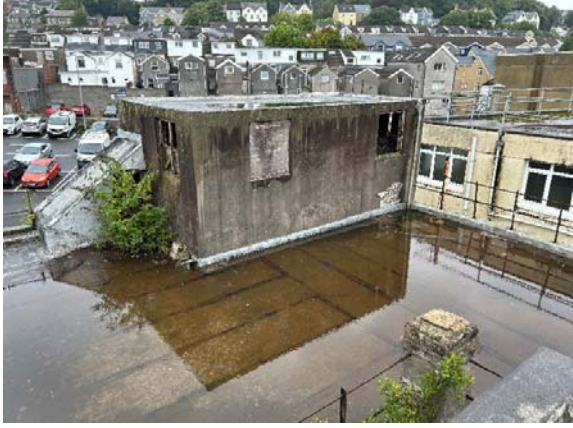
<p>Roof of Evan Rees Building</p>	<p>Separate flat roof to Evan Rees building with flat-roof structure with missing door/window coverings – no direct access but could provide opportunities for nesting birds.</p>

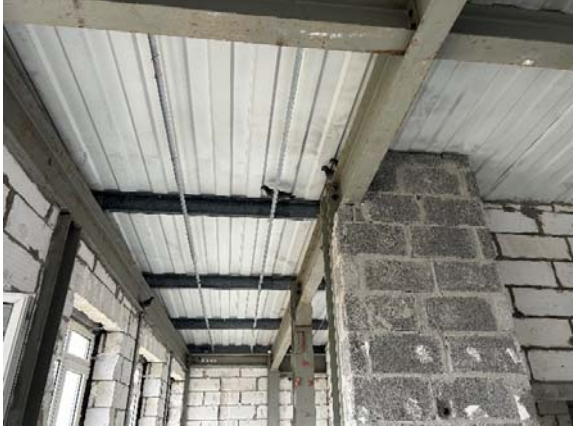
<p>3rd Floor</p>	<p>Open windows to southern and western sides of block provide access for birds. Minimum of 5no. live Feral pigeons seen along with 1no. carcass. Bird droppings frequent on this floor.</p>

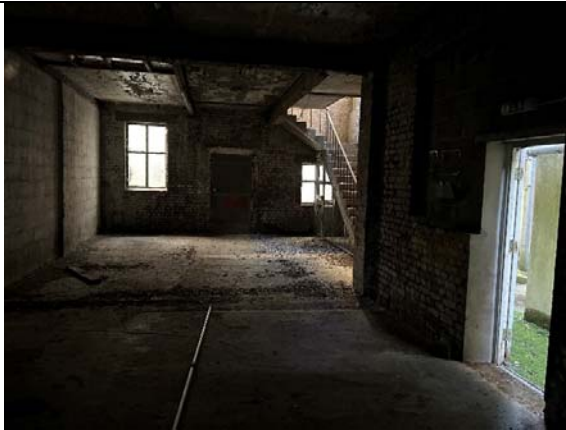
<p>Ground and 1st Floor of Evan Rees Building (Garage)</p>	<p>Follow up visit on 16 September after access route advised by client. Access via basement and external fire escape ladder to allow access to ground and 1st floors. Basement of Gwalia building as per conditions described above.</p> <p><i>Ground Floor</i> – Accessed via open fire door on southern side – door leads to narrow gap between this building and Gwalia offices with fire escape steps leading down into the basement of the Gwalia building. Doorway to west leading to Northampton Lane is secured by metal roller door. Open fire escape door and stairwell to first floor provide easy access for birds or bats.</p>

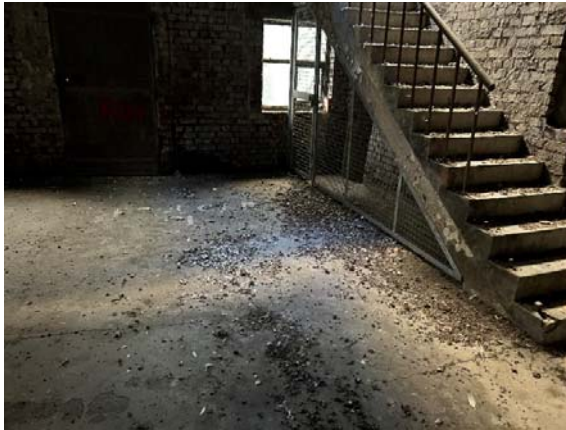
Feral Pigeon perched on main roller door (west side of building) and lots of bird droppings to floor and stairwell. No obvious bat features and no evidence of bats noted although amount of bird droppings could obscure individual bat droppings (if present). Stairwell to first floor with large amounts of bird guano to steps and handrail at first floor level.

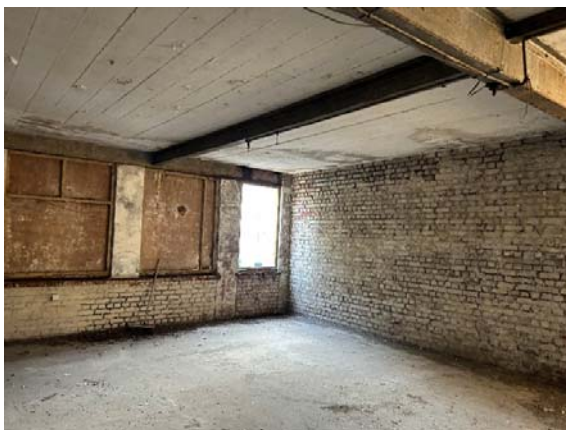
First Floor – Open window to north west corner and open hatch leading to roof-top room provide easy access for birds or bats. Lots of bird droppings to floor and Feral Pigeon seen exiting via window opening to north west. Steel joists and concrete panel ceiling with no obvious bat features noted.

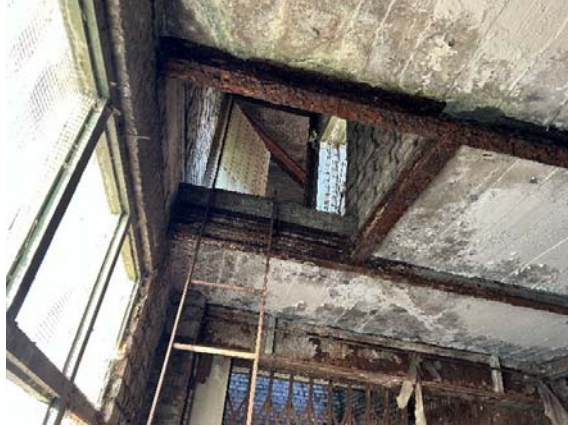
No direct access to roof-top room – existing ladder considered unsafe but rooms appear well lit with no glass to window openings as observed from roof of adjacent Gwalia building (see previous note).
