## **Arboricultural Survey, Impact Assessment and Tree Protection**

**Site: Maes y Droell**

**Client: Stephenson Halliday**

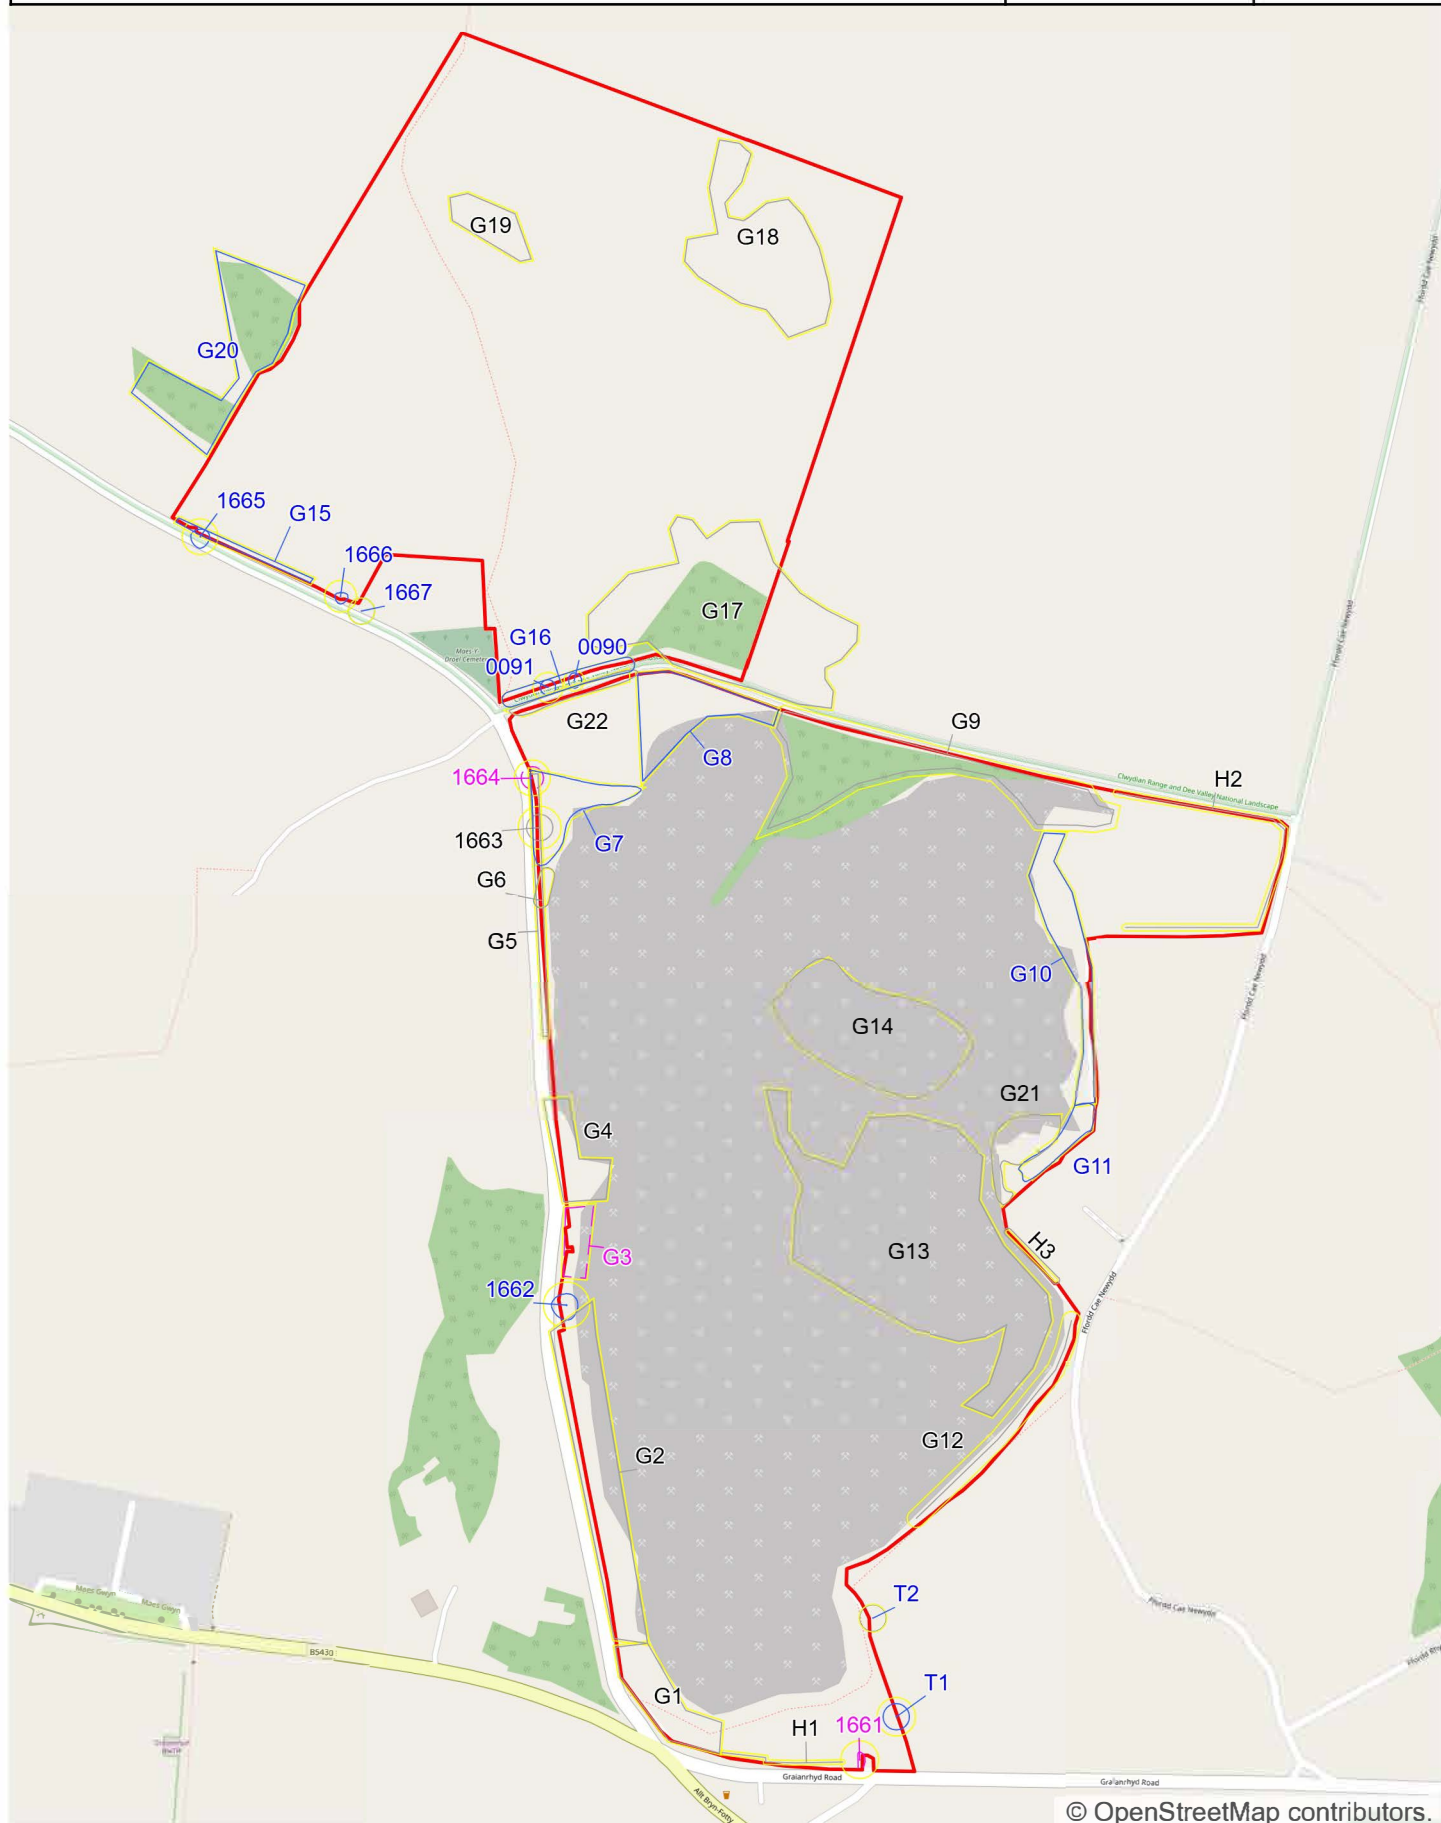
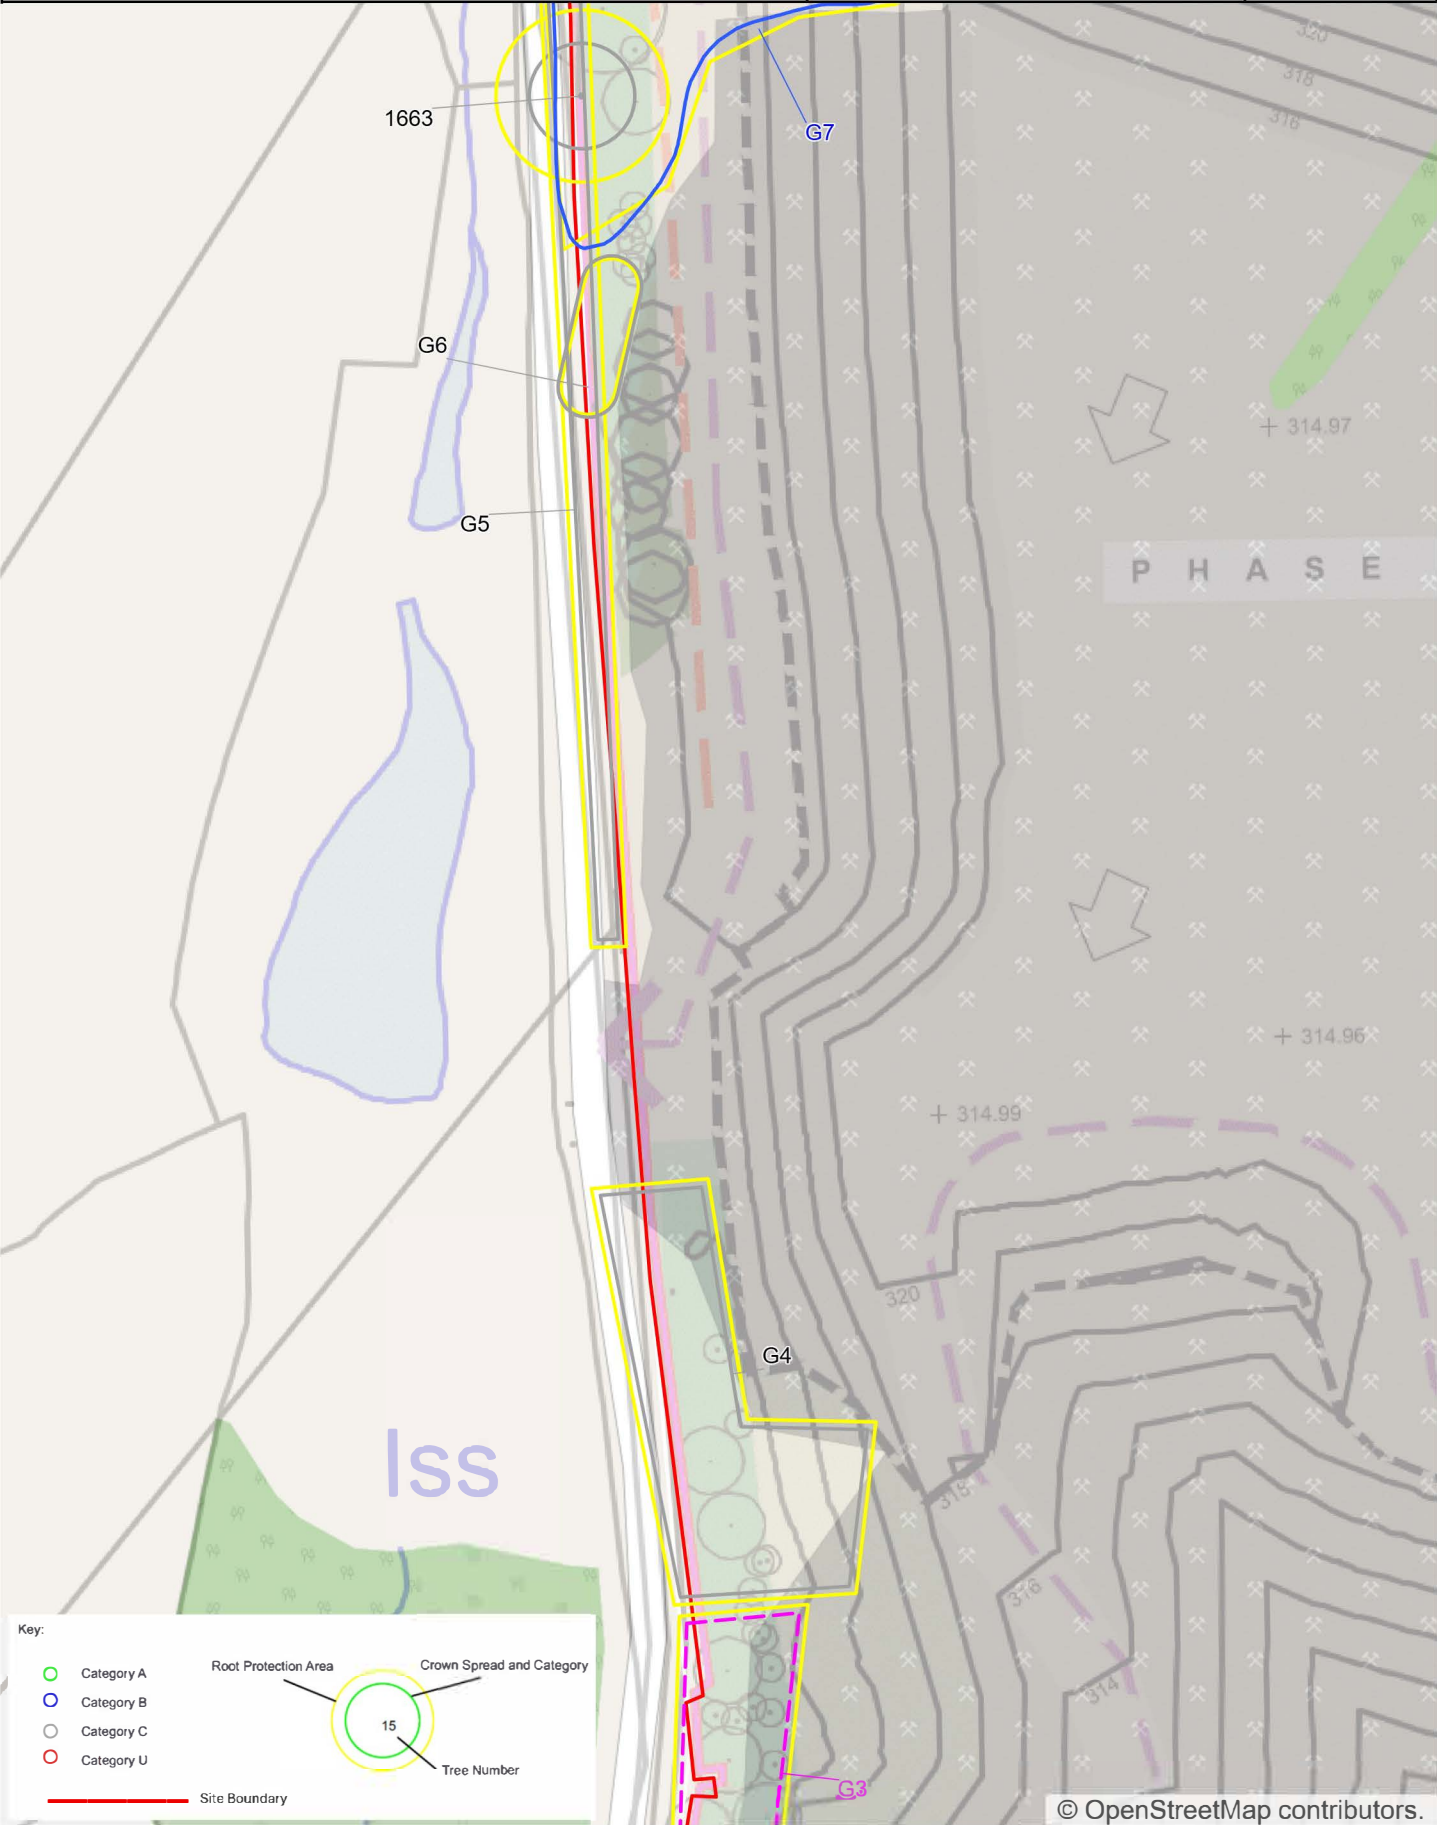
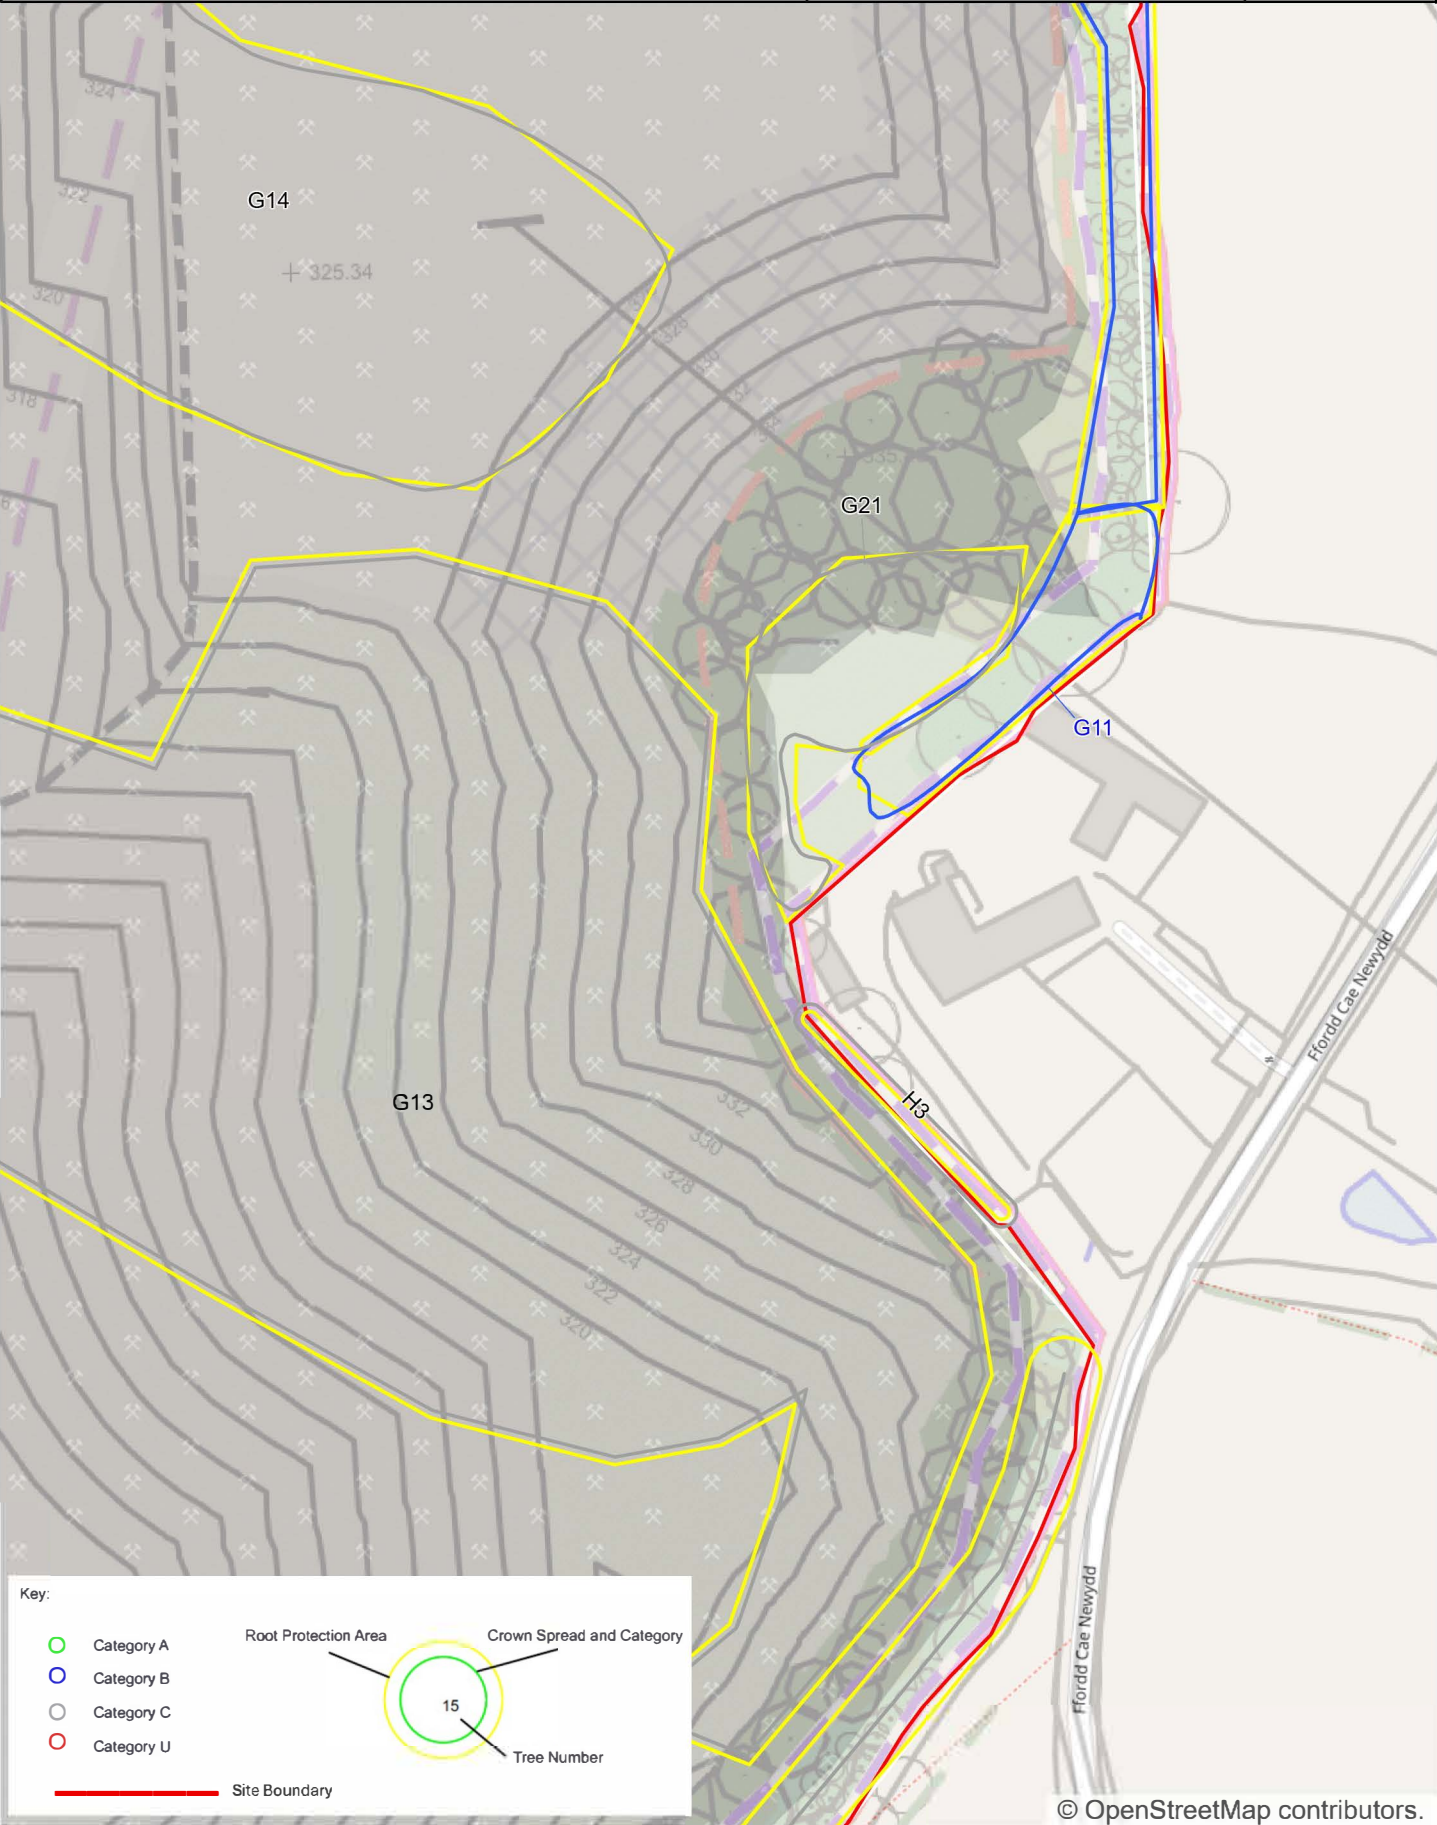
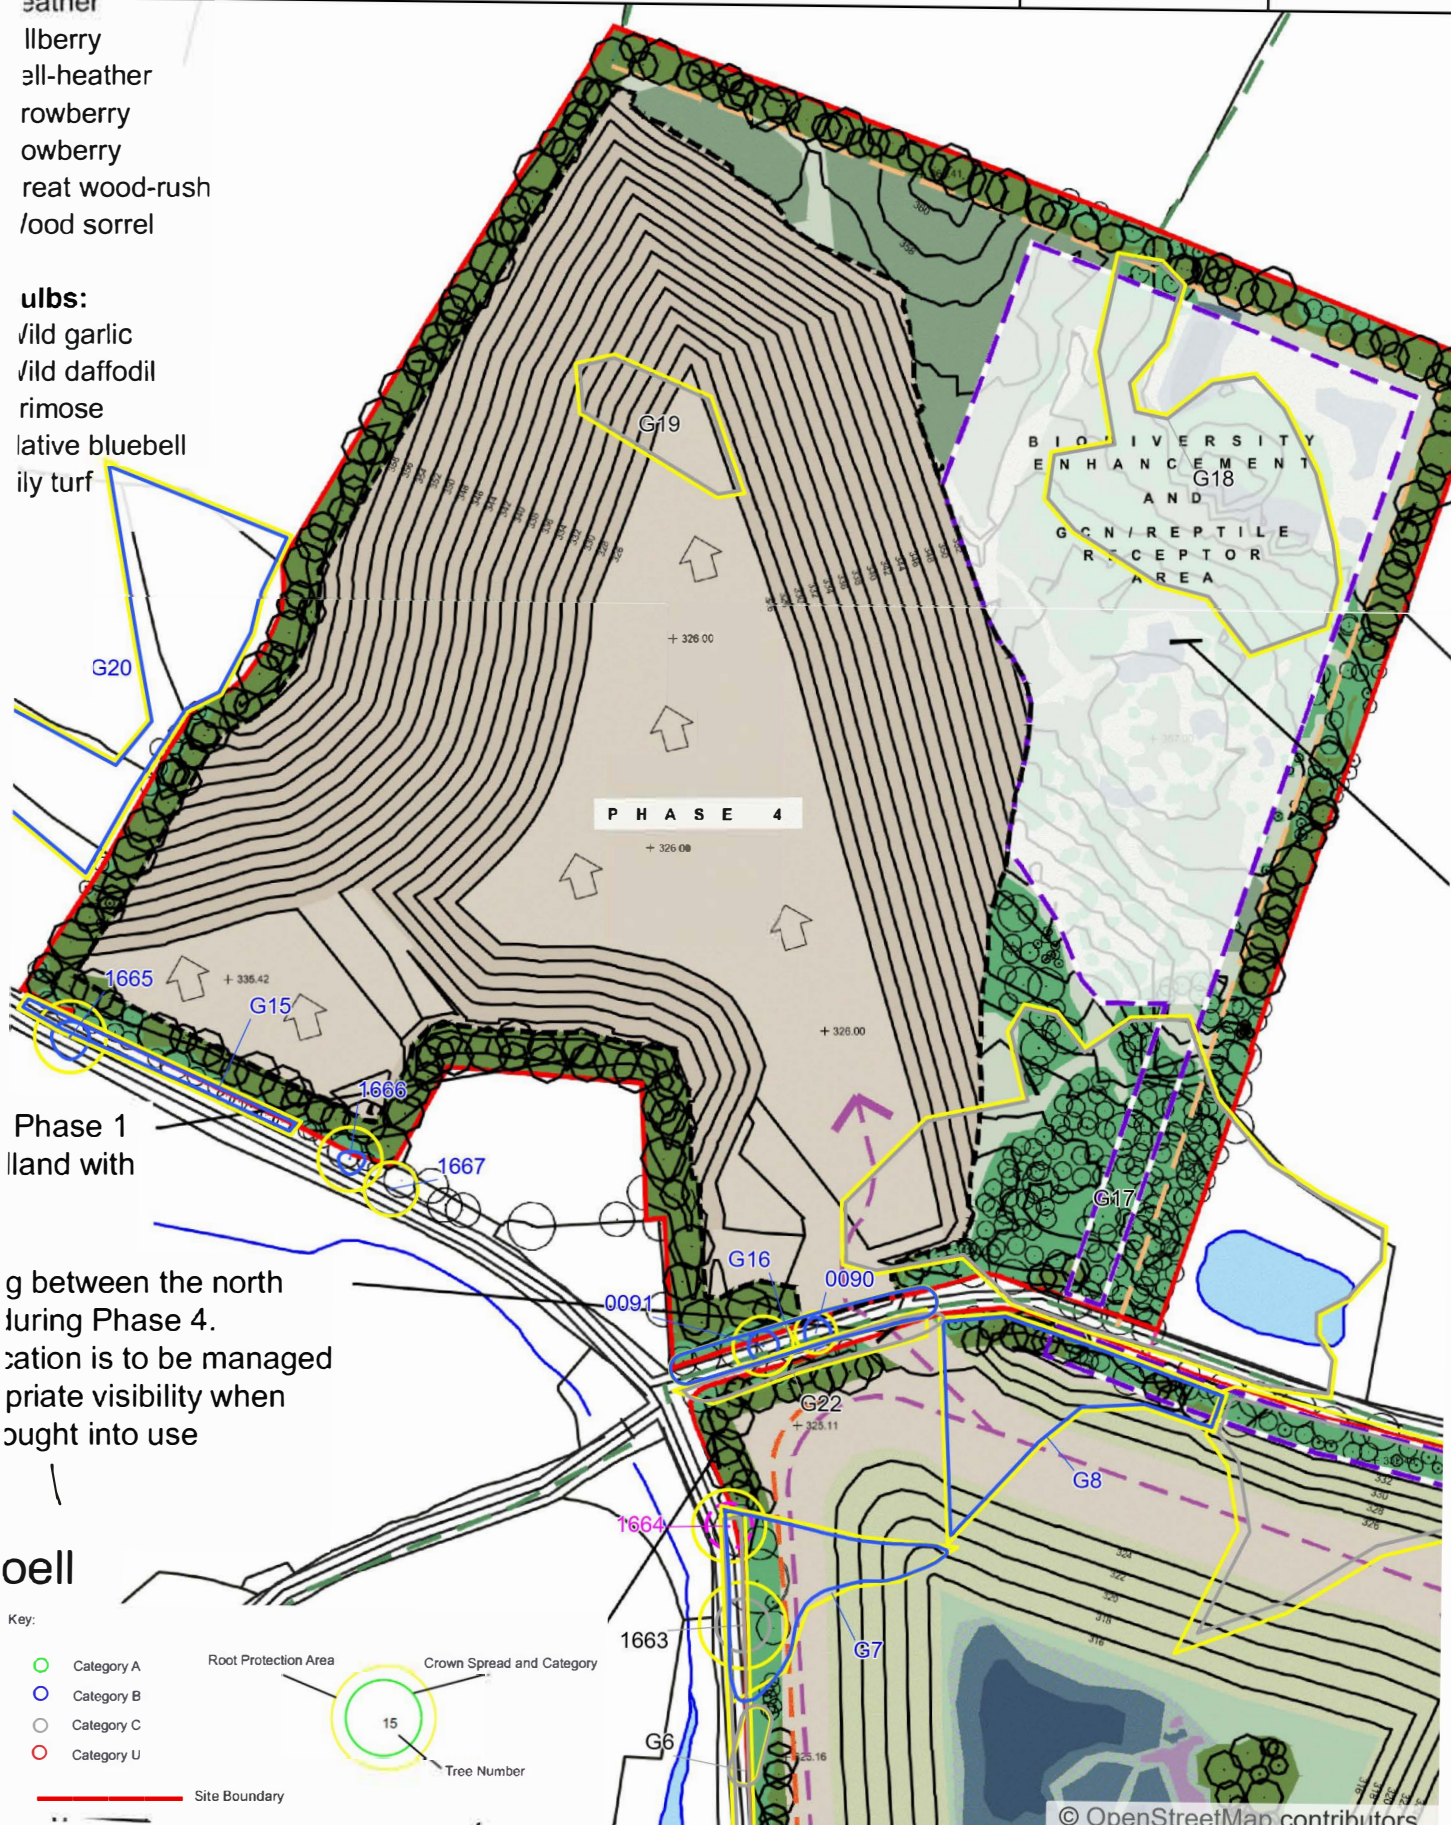
## **Appendix 2      Survey Area and Drawings**

- 1.9 Root Protection Areas can be seen in Drawing D01A, Tree Constraints Plan (F748-05-D01A). The proposed development can be seen in Drawings D02A-E, Arboricultural Impact Assessment (F748-05-D02A-E).
- 1.10 An Arboricultural Method Statement is included in this report to outline ways in which trees can be protected from unnecessary damage during the development.
- 1.11 Details relating to individual trees can be seen in Appendix 1, Tree Data Table.

- 7.3 All observations were made from the ground. Tools used include a clinometer, diameter tape, and tablet with GPS recording facility.
- 7.4 Data obtained from the survey was used to produce the Tree Constraints Plan (Appendix 2 – Drawing D01).

- 7.5 An Arboricultural Impact Assessment was then created (Appendix 2 – Drawings D02), overlaying the proposed design and showing the extent of crown spreads and Root Protection Areas (RPA's) in relation to the site.
